Review of Fatigue Failures in LWR
Plants in Japan

A review of fatigue failures in LWR plants in Japan

Kunihiro Iida

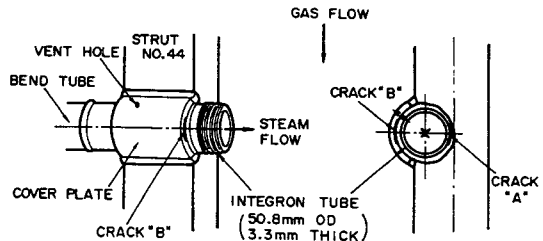
Fatigue cracks were found in a certain range of fillet toes, which is a localized area perpendicular to the coolant gas flow direction. This observation was considered to afford an evidence of fatigue cracking caused by bending vibration in the horizontal plane. Dynamic displacement measurement was carried out to prove the bending vibration due to Kármán vortex generated by the coolant flow. The fracture surfaces were examined by micro-fractography. Although most

Fig. 3. Fatigue cracks at fillet weld toes.

of the fracture surface was covered by heavy scale, it was successful to find, at some spots of the fracture surface, well-defined striations, which propagated from the inside to the outside of the tube. In order to obtain information about the striation spacing versus fatigue crack propagation rate relation for the material of the tube, displacement-controlled fatigue tests of full-size tubular specimens of the same material as that of the damaged tube were carried out in a laboratory. As a result of comparative examination of the fracture surfaces by service failure and by fatigue experiment, it was concluded that the repeated load at a relatively high frequency caused the service fatigue failure. High frequency bending loading could be caused by resonance when the frequency of the Kármán vortex generated by the gas flow matched with the natural frequency of the supported tube. Superimposed on this loading might be low-cycle thermal stress cycling, which was possibly caused from the restraint imposed by the rigidity of the supporting structure.

To prevent the resonant vibration of the low-pressure superheater tubes, chains with weight at the end were hung through the gaps of the tube bundles and the tubes were fixed. The restraint of the tubes by the supporting structure was released a little, and thermal stress cycling on the tubes was reduced by making them movable in the axial direction.

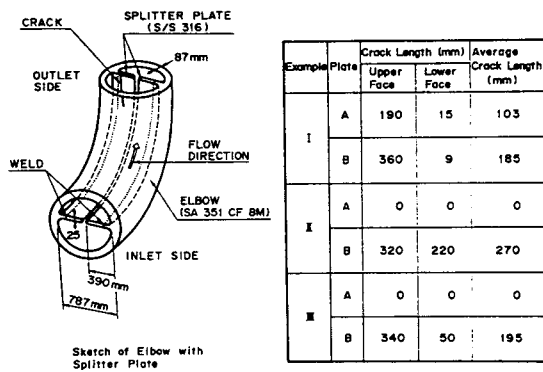
The next example of fatigue failure due to resonance vibration is fatigue cracks that occurred in splitter plates in pipe elbows in the primary coolant system in PWR plants [4]. As shown in fig. 4, splitter plates were butt-welded to extruded ribs on the inside surface of an elbow, which was assembled just before the

Fig. 4. Fatigue crack initiated at toe of fillet welds joining splitter plate and elbow.

The splitter plates and the elbows were respectively made of stainless steel of type 316 and cast stainless steel of type 316. The table in fig. 4 lists examples of fatigue crack lengths in plate A and plate B, which make a pair in an elbow. Fatigue cracks of this kind were observed in almost all splitter plates of the similar design. In the worst case a fractured fragment plunged into the pump. Figure 5 shows a sketch of the typical fracture appearance. In all cases, the fatigue crack started at a toe of the welds and propagated mainly in the longitudinal direction, with a tendency of curving to the centre side free edge of the splitter plate. Microfractographic examination revealed evidence of crack propagation in a very high cycle fatigue regime.

Extensive experimental and analytical studies, such as fatigue crack propagation tests of curved plates, FEM fracture mechanics analysis on crack path, and so on, provided information available to explain the behaviour of fatigue failure of splitter plates. Based on further experimental results that showed little advantage of the splitter plate for the suction efficiency of the pump, it was decided to remove all the splitter

plates from elbows in the primary circulation loop. For this purpose a remote-operating cutting and removing machine was developed, and removing work was executed.

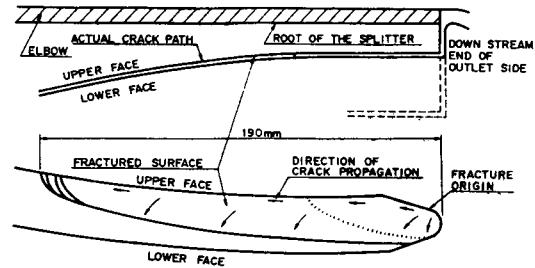
Fig. 5. Schematic view of fracture surface of splitter plate.

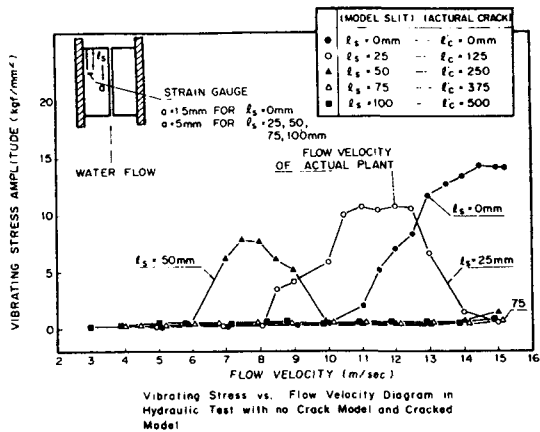
Fig. 6. Vibrating stress amplitude against flow velocity.

stress due to vibration of the tail of the splitter plate. The experiment was carried out with two kinds of models, one free from cracks and the other with a crack-like slit along the fillet toe. As shown in the figure, the splitter plate with a slit of 25 mm in length, which corresponds to 125 mm long crack in the actual case, became apparently into the resonance condition if the flow velocity reached 11 to 12 m/s, which roughly correspond to the real flow velocity in an actual elbow. In the case of no slit condition, the resonance phenomenon may be observed at the flow velocity of approximately 15 m/s.

The fluctuating stress at a point close to the crack tip changes as a function of flow velocity and slit length. If the splitter has no slit, the value of the fluctuating stress is about 150 MPa, which is high enough to initiate a fatigue crack [5]. The results of the experiment indicated that the crack in the splitter might be caused by the resonance with von Kármán's vortex street occurring in the downstream edge of the splitter, and that if the crack propagates beyond a certain length, the vibrating stress decreases considerably, because the natural frequency of the splitter plate begins to decrease and it gets out of the resonance range.

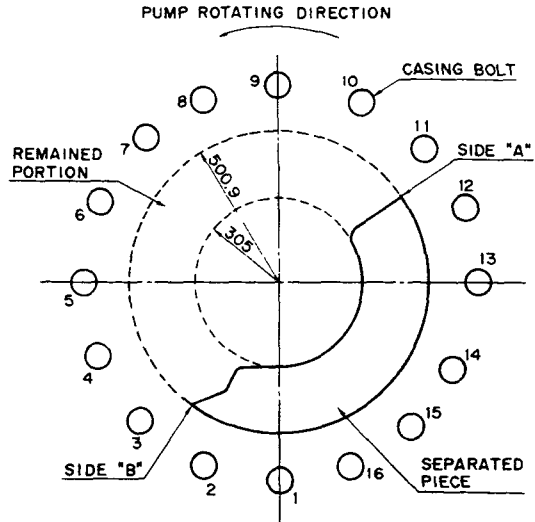
Fig. 9. Sketch of removed bearing ring plate.

It was assumed from the observation of the fracture surface and fracture path that a crack might have started at one or multiple points located in the centre portion of the cracked circumferential welded joint, and propagated in both clockwise and counterclockwise circumferential directions along the joint until the critical point where the crack was forced to curve out to the radial direction, as shown in fig. 9.

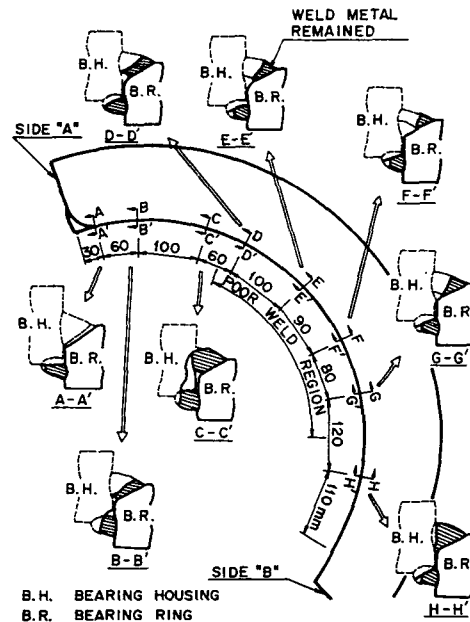
Figure 10 shows the cross-sectional weld shape at several sections. Despite the welding requirement of full penetration in upper and lower edge preparations, as shown in fig. 11, lack of penetration is obviously found in the greater part of the girth length of the fractured welded joint. In particular, very poor penetration, approximately one-half depth penetration, was observed in the range of about 30 degrees of the angle at the circumference. These joints were welded by manual arc welding. A quantitative examination on the percentage of lack of penetration, which is the ratio of the lack of penetration depth to the designed penetration depth, was made, showing the following results: 50% at a maximum and 23% on average for the upper side fillet joint, and 3% at a maximum and 1% on average for the lower side fillet joint. Microfracto-

Fig. 10. Cross-sections of bearing ring welds.

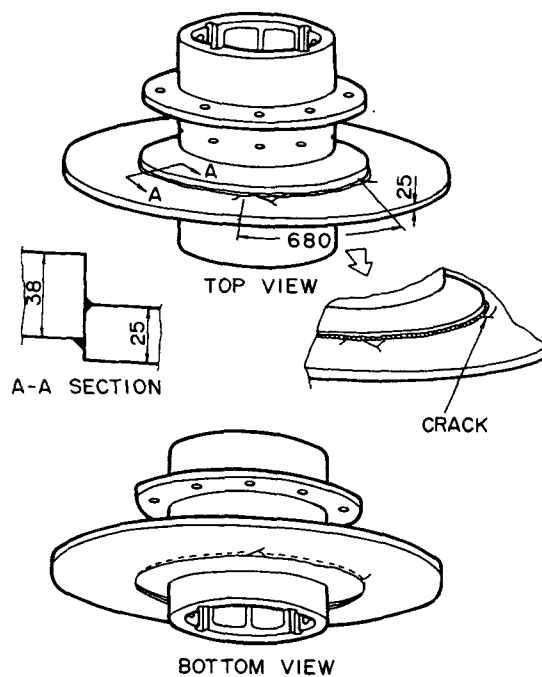
fillet-welded joint was fully cracked along the total girth length of the circumference, as shown in fig. 12. An examination of the percentage of lack of penetration again revealed poor penetration. The results were 31% at a maximum and 26% on average for the upper side fillet joint, and 7% at a maximum and 4% on average for the lower side fillet joint. Fractographic examination of the fracture surfaces showed striations that propagated from the weld root to the outside of the weld metal.

Fig. 12. Fatigue cracks in welds of bearing ring plate.

The basic cause of all three cases of fatigue failure of the hydrostatic bearing ring welds was the lack of penetration in the fillet welded joints. The problem is a possibility of leaving poor penetration, if the welding conditions are not appropriate, and if the welder's skill or the setting and performance of the welding machine are inadequate. It may be worthy of mention that the fillet joints of the first case were welded by manual arc welding, and the fillet welds in the second and third cases were welded by automatic machine welding. The reason why a remarkable lack of penetration was found only in the range of about 1/4 of the circumference of the fillet joint in the first case may be due to unstable scatter of skillfulness of the welder. For the second and third cases, it can be said that the results are quite contrary to the preconceived idea that machine welding should be much better than manual welding in providing uniform quality of welds. As mentioned above, the lack of penetration was localized in the first case, and on the contrary the lack of penetration was not localized but uniformly distributed in the upper side fillet welds in the second and third cases. In other words, a lack of penetration of roughly equal depth was observed over the total circumference of the upper side fillet welds. According to the investigation of the causes of the lack of penetration, it was proved that such uniformly distributed lack of penetration might be formed by a higher feeding speed of welding wire, incorrect setting of the welding machine against the edge preparation, and an over-snipped corner edge of the root of edge preparation.

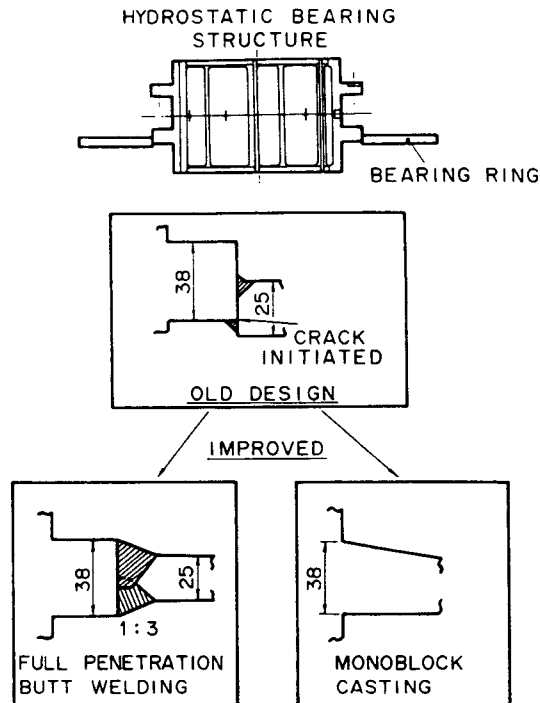
Fig. 13. Old and improved designs of hydrostatic bearing structure.

A lesson obtained from the failures mentioned above is that use of a welded joint, whose soundness is difficult to check by non-destructive inspection, should be avoided in a strength member. Following this philosophy, all hydrostatic bearing rings in all BWR plants were replaced, as a countermeasure for recurrence prevention, either by full penetration butt welded type or monoblock casting type, shown in fig. 13.

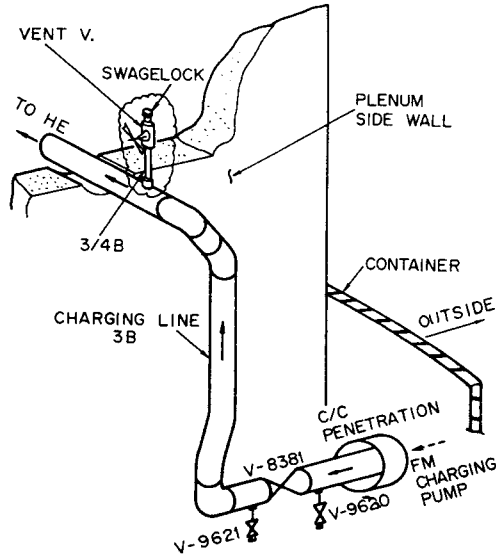
Fig. 15. Leakage from vent valve in charging line in chemical and volume control system.

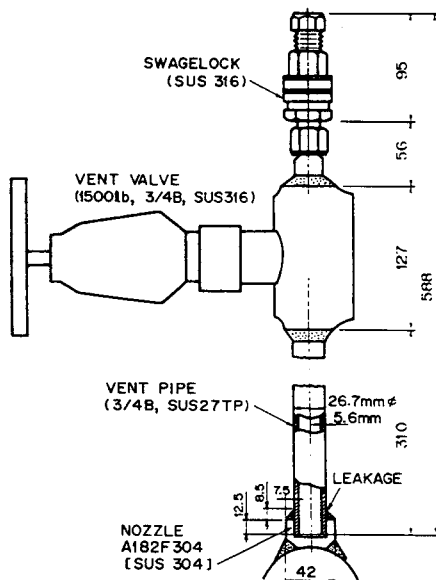
Figure 16 shows a detailed sketch of the valve and the pipe. The crack was extended along the weld toe up to a length of 35 mm. The cracked location is roughly the opposite side of the vent valve. The leg length of the socket welds was 7.5 to 8.5 mm, which is a

Fig. 16. Vent valve and connecting pipe.

that two main cracks started at two points on the weld toe line and propagated in thickness direction by forming shell marking. These two cracks coalesced, and finally penetrated to the inside surface of the pipe. Well-defined striations were observed on some spots close to the crack arresting contour line. As far as the starting and propagating zones are concerned, well-defined striations were not found, showing only non-characteristic and smooth topography. It has been recognized that such a non-characteristic and smooth fracture surface can be formed by very high cycle fatigue with very low fluctuating stress.

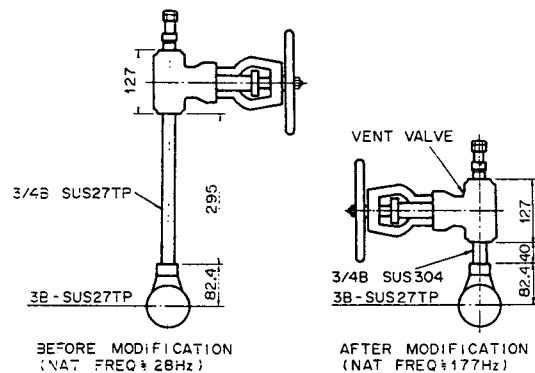
Fig. 17. Vent valve piping before and after modification.

The length of the pipe was initially designed to be 180 mm. But, after fabrication a field engineer found that the handle operation of the valve was not easy due to the level of footing. Then, without consultation or discussion with the design engineer, the pipe length was extended by the field engineer on his own judgement. It seems that he paid no attention about a decrease in resonance frequency due to lengthening of the pipe. This case of failure seems to provide us a valuable lesson that a lack of communication or discussion between design and fabrication engineers may result in a possibility of unexpected failure. Finally the straight pipe was shortened as shown in fig. 17.

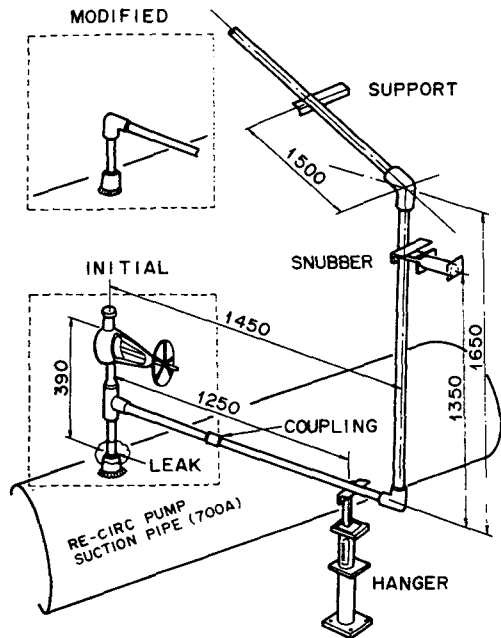
Figure 18 shows another example of service fatigue failure that occurred in a different pressure measuring instrument line for a primary re-circulation line due to the resonance vibration of the piping system. As shown in the dotted line frame labelled "initial," the structural component was top-heavy and the rigidity of the horizontal pipe branched from the tee was not high enough to prevent oscillation of the pipe-valve system. Details of the weld design of the set-on and socket welded joints are shown in fig. 19. Leakage occurred

Fig. 18. Fatigue failure in different pressure measuring instrument lines.

As a countermeasure to prevent recurrence, the assembly was modified, as shown in the left upper dotted line frame labelled "modified" in fig. 18, by removing the valve.

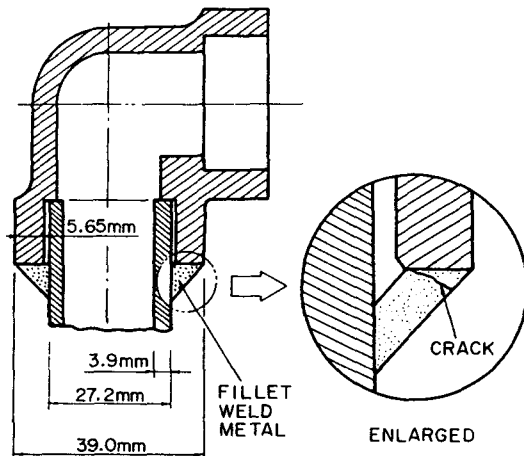
from a crack, which initiated from a toe of the welds. Microfractographic examination showed well-defined striation on the fracture surface. The valve was temporarily assembled only for the trial operation. Although the valve was not used after the trial operation, it was left as it was, while the opening of the pipe downstream of the valve was stopped by a welded plug.

Fig. 20. Fatigue crack started from root of socket welds.

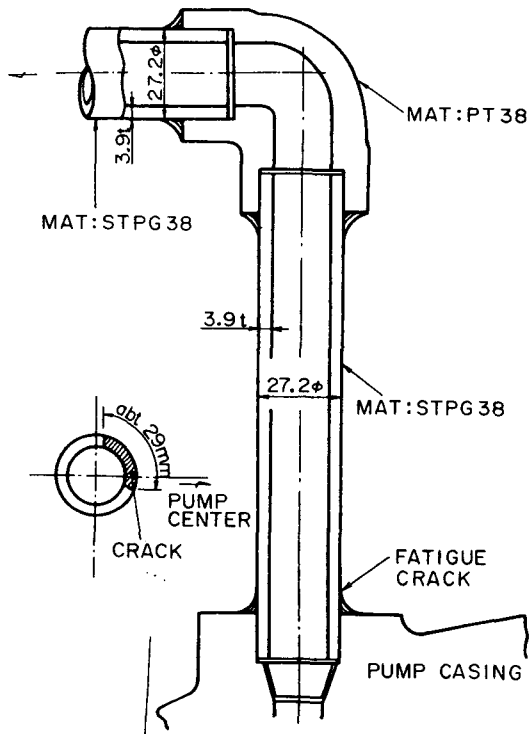
Several cases of fatigue failure that started from the root or the toe of fillet welds are further presented in the following. An example of a fatigue crack that started from the root of socket welds is shown in fig. 20. The elbow was welded to a discharge valve of a PLR pump. Striations were found on the fracture surface. Figure 21 illustrates a fatigue crack initiated at the toe of the fillet weld in a mechanical seal line for a high-pressure condensate pump. In this case the recognition of insufficient fatigue strength of a 27.2 mm outer diameter tube resulted into a modification, shown in fig. 22. An example of a vibration-induced fatigue crack that started at the root of a socket weldjoint is shown in fig. 23. It may be noteworthy that the structure, where the fatigue crack was experienced, is also top-heavy, and with low bending rigidity, which means low natural frequency. In the case of a top-heavy structure of a piping, it may be better to restrict bending deflection by supports or to increase bending rigidity in order to increase the natural frequency higher enough than the global natural frequency of the piping, approximately 15 to 30 cycles.

Fig. 21. Fatigue crack occurred in high pressure condensate pump mechanical seal water line.

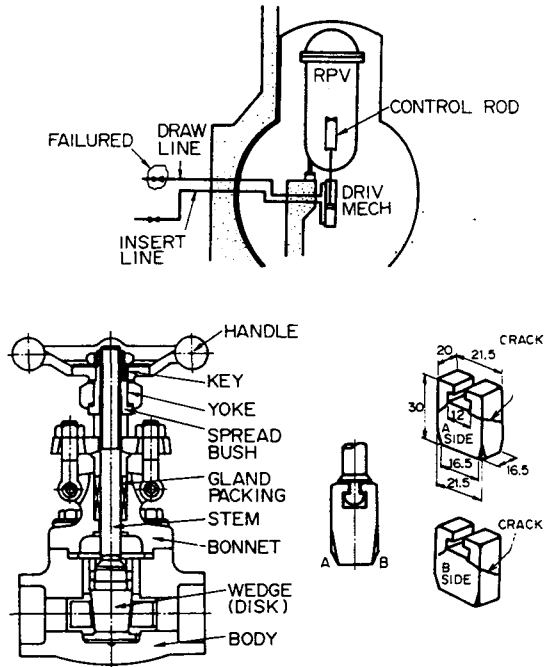
Figure 24 illustrates fatigue failure of a valve component. A fatigue crack started from a corner of a cut-out in the yoke. Fatigue failure of a valve stem rod is shown in figs. 25 and 26. Such fatigue failures are due to vibration of a valve disk, which is forced to vibrate by by-path turbulent flow, when the disk is pulled up.

Fig. 24. Fatigue crack in yoke of valve disk (CRD hydraulic system).

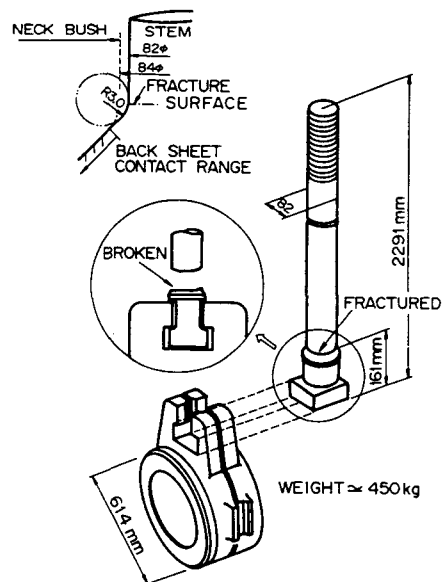
Fig. 26. Details of broken stem and disk.

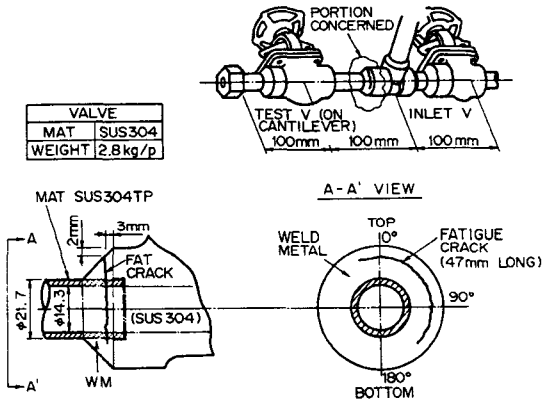
The final example of vibration-induced fatigue failure is shown in fig. 27 and fig. 28. In this case a lack of root penetration of the socket welds contributed to the initiation of the fatigue crack.

Fig. 28. Fatigue crack started from root of socket welds.

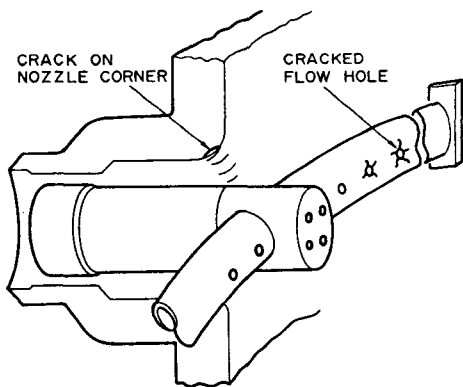
It was around 1977 when thermal fatigue cracks were experienced at the crotch corner of a feed water nozzle and at edges of circular holes in a feed water sparger in BWR reactor vessels (see fig. 29). The former crack occurred by the following mechanism:

Cracks at the edge of the circular hole in the sparger result from the thermal fluctuation due to mixing of cold water and hot water at the circumferential edge of the hole.

Fig. 29. Thermal fatigue cracks on nozzle corner and sparger hole edge.

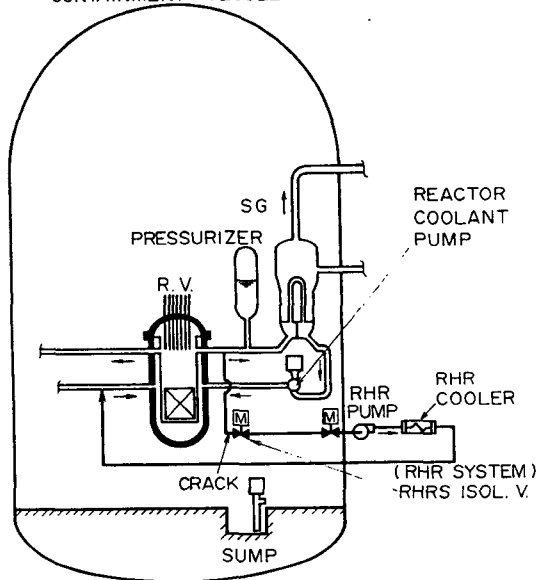
Recently an interesting and extraordinary fatigue failure, which was experienced for the first time in Japan, occurred in a PWR plant. Because of an increase in flow rate to the containment sump pit, the plant was brought to a shut-down for inspection. Leakage was found at the butt welded joint between an elbow and a straight pipe, which was welded to the first isolation valve in the A-loop residual heat removal system piping, as shown in fig. 31. A sketch of the

Fig. 31. Location of cracking in RHR piping.

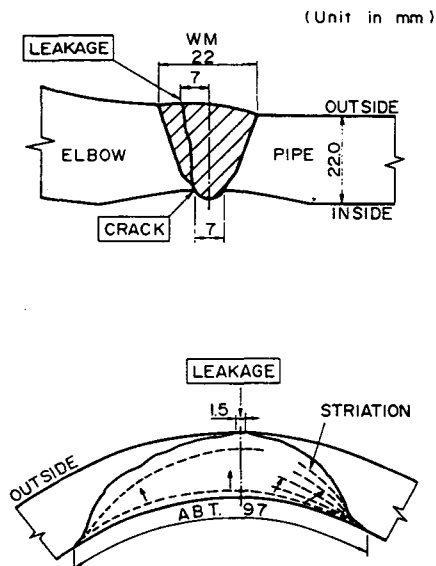
layout of the pipes and valve is shown in fig. 32. An examination showed, as shown in fig. 33, that multi-site cracks initiated on the elbow side toe line of the welded joint, and propagated through the weld metal

Fig. 33. Details of welded joint and fatigue crack shape.

toward the outer surface by coalescing to form a semi-elliptical crack shape. The crack length was about 97 mm in circumference on the inner surface and 1.5 mm on the outer surface. The leaked position, the final opening point of the crack, was located just on the top generatrix, which is an extension of the generatrix passing the crotch point of the elbow concerned. Fractographic examination proved the existence of striations of spacing 0.3 to 1.0 μm .

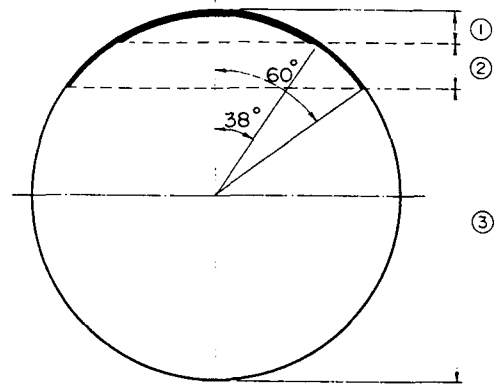
Fig. 34. Oxide on inner surface of straight pipe.

As a result of observation of the inner surface of the elbows and the horizontal straight pipes illustrated in fig. 32, it was found that the inner surface of the straight pipe, which was welded both to the upstream side flange housing of the isolation valve and to the cracked elbow, was covered by oxide, showing classification into three regions depending on colour and oxide thickness, as shown in fig. 34.

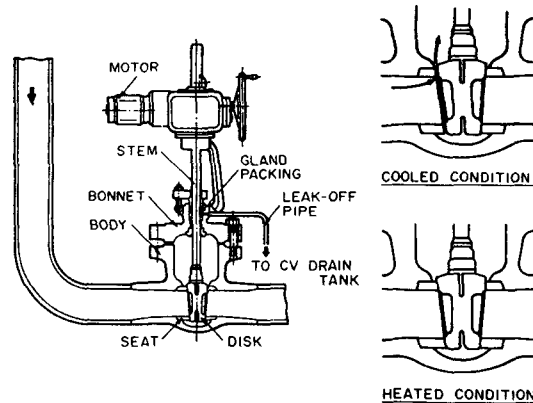
No abnormality was found by Vickers hardness distribution measurements and chemical analysis. Finally it was provisionally concluded that the fatigue failure concerned was caused not by fluid-induced mechanical vibration, but probably by thermal cycling. This conjecture was supported by the fact of a difference in colour and thickness of the oxide deposited on the inner surface of the straight pipe and traces of the leakage through the gland in the isolation valve. To confirm this conjecture, two kinds of thermal stratification hydraulic tests were conducted:

Thermal stratification was obviously observed. Also found were the thermal stress range at the top generatrix of the pipe, which was enough amount to cause high cycle fatigue, the relation between the leak rate and the cycling speed of repetition of thermal stratification, and others. The thermal stratification was concluded to be produced by the mechanism described below (see fig. 35).

Fig. 35. Mechanism of repeated thermal stratification.
