A Case Study on the Fire of Factory Buildings in Korea

*Nam-Yong Jee¹⁾, Kyung-Ku Lee²⁾, Chee-Ho Suh³⁾

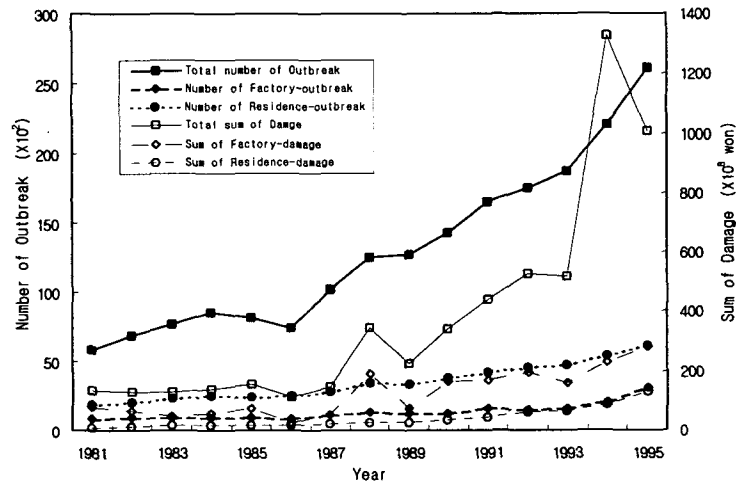
[Figure 1] Trend of Fire Incidents and Financial Loss

The figure 1 shows that the factory fire is 10 times more than house fire in terms of the financial loss per a fire. At a glance, such a fact can be seen as certain if we compare the scale of a factory and a house. However, it can be also said that it results from the total destruction by fire because a factory has lots of movable property as seen in the case study.
