배전용 피뢰기사고 조사분석

박중신* 정종욱 곽희로
 한전 중앙연구소* 송실대학교

The Survey and Analysis on Lightning Arrester Failures in Distribution Systems

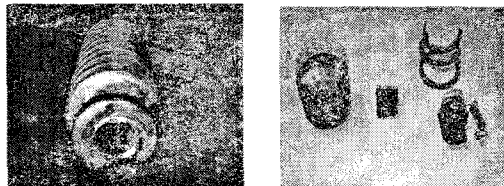
Photo 3.

If there is the cause of failures, e.g. the impurities are in the lightning arrester in the process of putting together, the moisture by a loose gasket, the low gasket pressure, and the bad quality in the design of sealing housed to prevent against impurities after installing, the failures may occur even under commercial voltage since the elements are aged and the performance of the discharging gap is lowered, and it cannot be re-sealed when the surge breaks in the lightning arrester. In other words, the breakdown caused by the internal impurities or moisture in lightning arresters leads to the explosion of them.

Traces left by current which passes through the ZnO element of the lightning arrester damaged by power frequency current were at about 5(mm) inside from its surface, and the disconnecting device was also damaged⁽²⁾.

The lightning arrester damaged by moisture (left) and the destroyed ZnO elements(right)
