주상변압기 고장원인분석

Failure Cause Analysis of Pole Transformers

Jong-Wook Jung^υ, Byung-Sung Lee, Jae-Bong Lee, Jae-Keun Joun*, Hee-Ro Kwak*
KEPRI, *Soongsil university

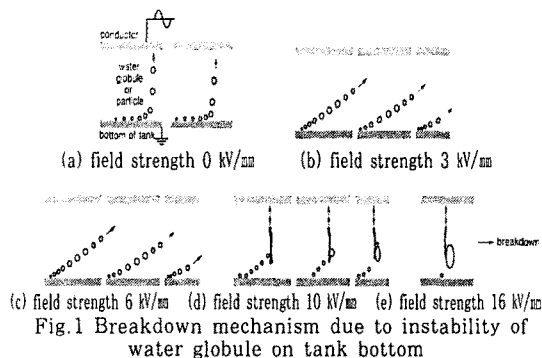
As shown in Fig. 1, as the field strength increases, the water globules on the tank bottom are arranged in the direction of the field to ultimately bridge between the conductor and the tank[7].

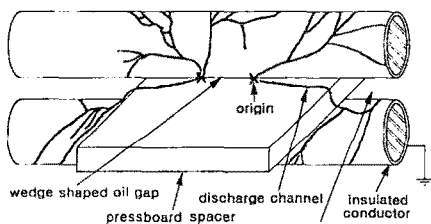
Fig. 2 Surface flashover paths under impulse voltage superimposed ac

As shown in Fig. 2, according to the experiment simulating the transformer conductors subjected to impulse voltages superimposed with ac, the discharge due to the surge mostly shows the surface flashover[6], and the discharge channels are originated from small oil wedge in pole transformer. Similarly to most of surface flashover, however, the breakdown due to the discharge channels does not inflict damage on the insulating materials. Generally, the follow current flowing through the channels formed by the surge voltage causes larger failures.

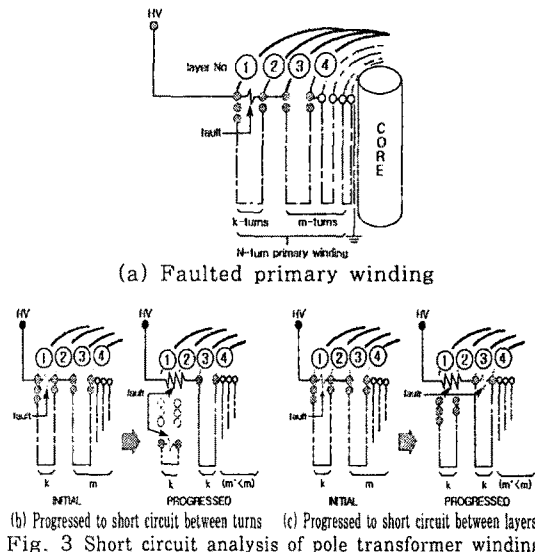
As shown in Fig. 3(a), the faulted primary winding can be divided into 2 parts—the faulted turns(k turns) and the remaining turns(m turns) and analyzed as a 2 winding transformer. The unfaulted turns will be energized at the system voltage and act as a “secondary” winding with a turns ratio of m/k . The voltage induced in the shorted turns will be k/m times the primary or source voltage and the current in the shorted turns will be m/k times the primary current(ignoring the magnetizing current). The primary winding fault current will be limited by the leakage reactance between the faulted and unfaulted windings(not the same as the short circuit reactance) and the effective primary resistance.

Fig. 3(b) schematically describes the progression of a fault within initially faulted layer 1 and 2. The fault involving k shorted turns burns into the layers 1 and 2 bypassing some of the turns and reducing the number of shorted turns to k'/k .

Fig. 3(c) schematically describes the progression of a layer 1 to 2 fault to an adjacent layer-to-layer fault(layers 3 to 4). The involvement of the 3rd and 4th layer can occur without the original layers because the turns are simply burned off by the fault current. This type of progression is observed during transformer tear-down[5].
