# ASTUDY ON THE FORMATION OF IMPERFECTIONS IN CW CO<sub>2</sub> LASER WELD OF DIAMOND SAW BLADE

by Minhyo Shin<sup>1\*</sup>, Changhee Lee<sup>1</sup>, Taiwoung Kim<sup>2</sup>, Heedong Park<sup>2</sup>

## ABSTRACT

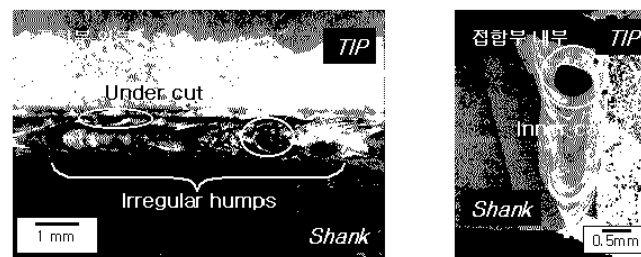
Fig. 2 shows the typical appearance of outer cavity, inner cavity and irregular humps with under cut in the laser fusion zone of diamond saw blade. Humps were divided into three types such as A, B, C depending on surface roughness and are shown in Fig. 3. Both A and B types are regular humps, which can be accepted as sound bead regarding to the guarding line in actual diamond saw blade industry whereas C type is rejectable. Table 2 shows that C type was only found in the specimens welded with 1.7m/min of travel speed at 1350W beam power and 1m/min at 1650W beam power and A, B types were found in other parameter combinations.

Fig. 2 Imperfections in CW CO<sub>2</sub> laser fusion zone of diamond saw blade

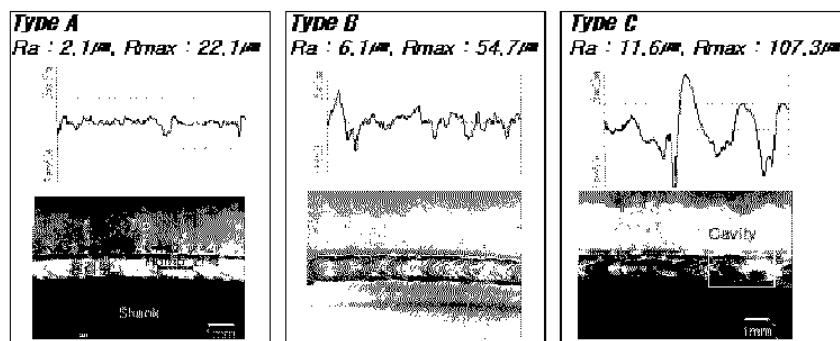
Because it is convenient to group beam power and travel speed into one parameter, heat input. The heat input with which A, B types were formed between 10.4~17.6 kJ/m heat input range (assumed absorption efficiency was 20%). It was known that irregular humps were from the resonant oscillation of molten metal in rear keyhole [2-3]. Considering this, It is thought that resonant oscillation can be reduced between 10.4~17.6 kJ/m heat input range. However there was no evidences, which can explain the relations between heat input and oscillation. More works are needed to confirm.

Fig. 3 Humps types in diamond saw blade fusion zone

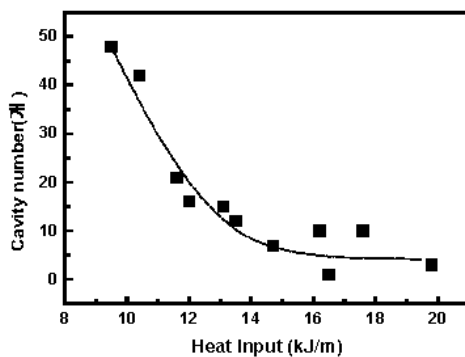
A typical appearance of outer cavity is shown in Fig 6 a. The number of outer cavities was decreased with the increase in heat input as shown in Fig. 4. As heat input was reduced, solidification rate of crown repulsed molten metal from keyhole increased and the velocity of molten metal flow to the rear part of keyhole increased [4-7]. This may have caused an insufficient refill of the keyhole and more outer cavities occurred with lower heat input. Fig. 5 shows the relations between inner cavity and heat input. Inner cavity was also reduced as the heat input increased. From the cross section shown in Fig. 6 b, it can be observed that inner cavities formed mainly near the sintered tip side and bottom side of the fusion zone. From the longitudinal sections shown in Fig. 7, it can be noticed that inner cavities formed in the upper fusion zone at high heat input whereas formed in the bottom of fusion zone at low heat input condition. Considering these results, inner cavities mainly have formed from the preexist pores in the sintered tip and the first bead, and metal vaporization at the bottom of keyhole. These metal vapor bubbles remained as inner cavities by trapping during floating in the molten metal pool. Fe was riched in preexist pores as shown in the EDS mapping of sintered tips (Fig. 8). The preexist pore was from lack of densification caused by surface oxidation scale.

Fig. 4 Effect of heat input on outer cavity formation

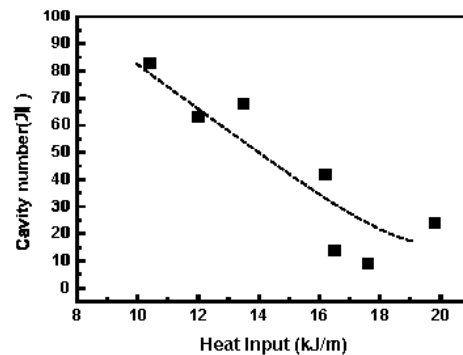
Fig. 5 Effect of heat input on inner cavity formation

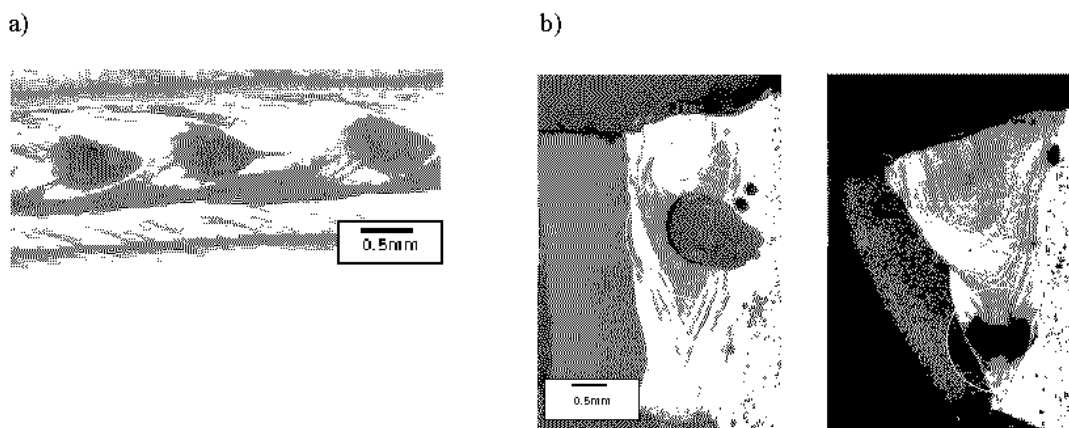
Fig. 6 Outer a), Inner b) cavities in cross section of weld

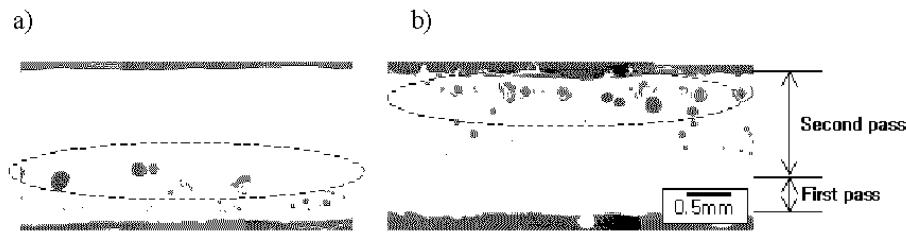
Fig. 7 Inner cavities in longitudinal section of weld a) 1350W, 1m/min partial penetration  
b) 1650W, 1.2m/min full penetration
