## Failure of Hydraulic Oil Pipe and Transient Vibration

**Abstract** : This paper presents a case history of piping failures on power plant. The root cause of the failure was defined to set the optimal countermeasures. The failure comes from transient vibration and the 1st stress increased at the hydraulic oil supply system of control valves for high pressure steam turbine.

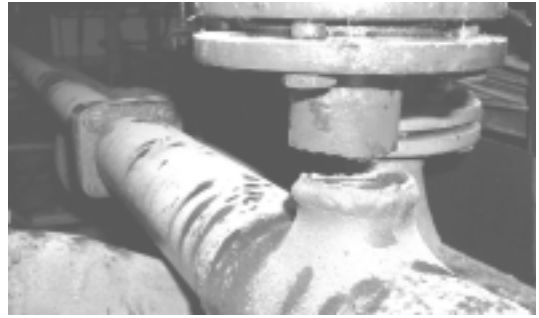
Figure 4. Damage shape(I) of hydraulic oil Line

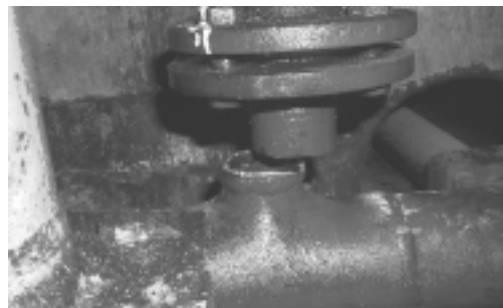
Figure 5. Damage shape(II) of hydraulic oil line

Fig.5 Fig.6

16mm

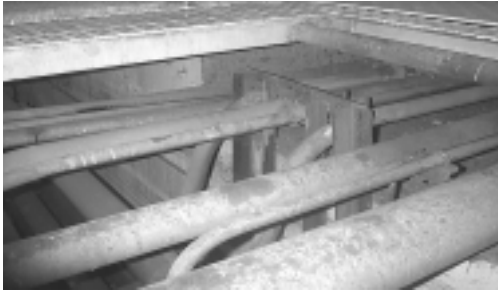
-Angle(Fig. 6 )

Figure 6. Supported condition of hydraulic oil line

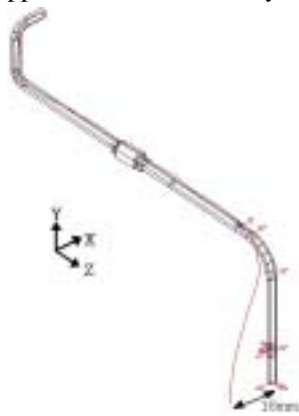
Figure 7. Effect of external force by misalignment

Table 1. Effect at root-part of pipe by misalignment

브랜치 루트 부	힘 (lb)			모멘트 (inch-lb)		
	X	Y	Z	X	Y	Z
2번 제어밸브	-14	26	-704	23,289	2,935	-272
4번 제어밸브	3	20	705	-23,074	-3,870	69

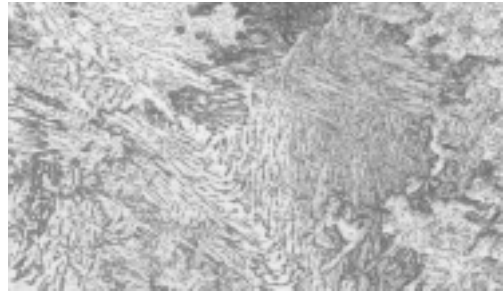
Figure 8. Metal face of welding part damaged ×200

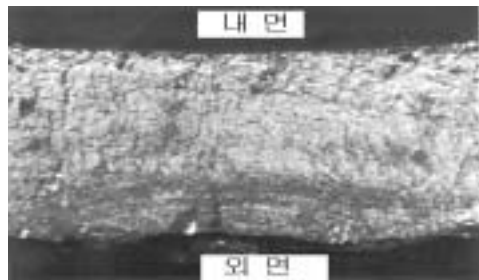
Figure 9. Damage surface after pipe rupture

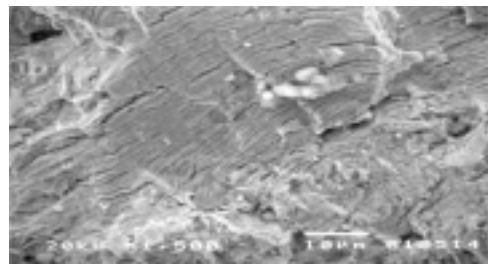
Figure 10. SEM×1500

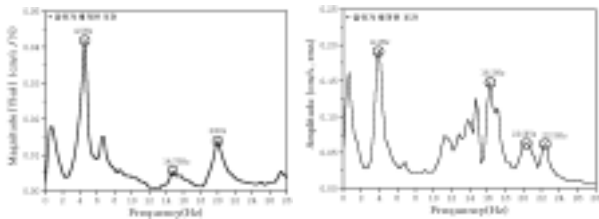
1.0mm, p-p 4Hz

0.73mm,p-p x

6.9Hz 0.60mm,p-p

Figure 11. Vibration on hydraulic oil header

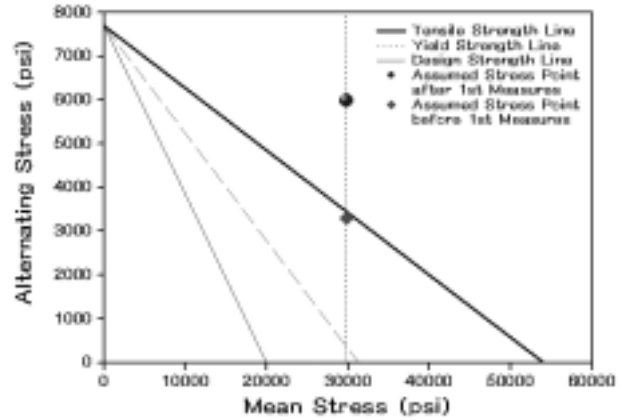
Figure 12. Fatigue stress assumed on damage pipe

, 4Hz 6.9Hz , 1.0mm,

p-p 1,500psi,o-p

(1) 3,300psi,

o-p (Fig.12 ) 10<sup>11</sup>

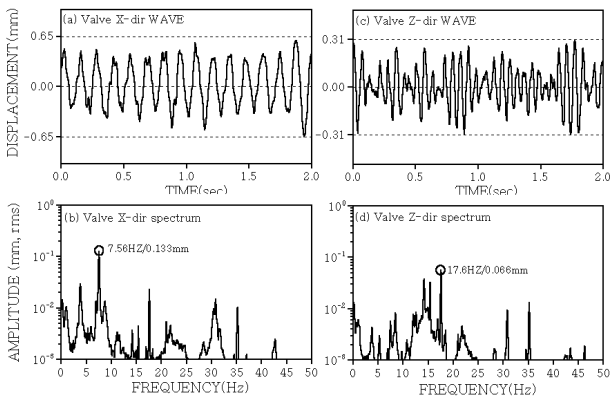
가 7.5Hz, 1.5mm, p-p

Figure 13. Normal state vibration of CV#4 pipe

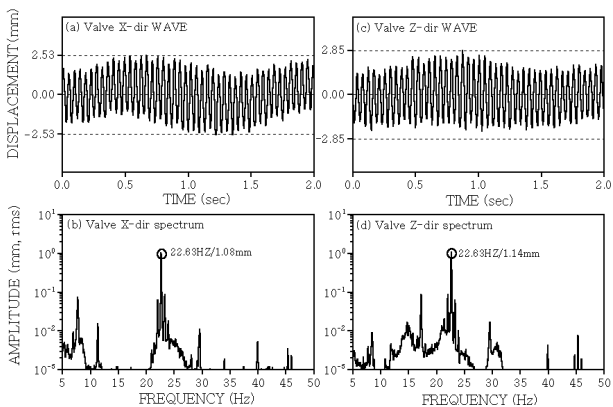
P1 5.11mm, Z

Figure 14. Excessive vibration of CV#4 pipe

5,984psi,o-p (1)

13,400psi,o-p

$1.3 \times 10^5$

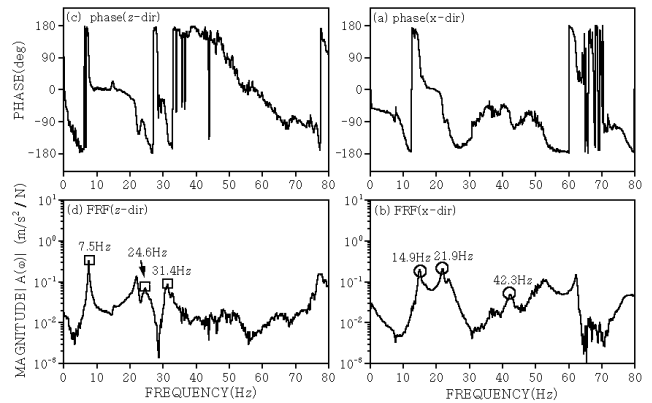
Figure 15. Frequency response function at CV#4 hydraulic oil pipe

21.9Hz(Fig.15 )

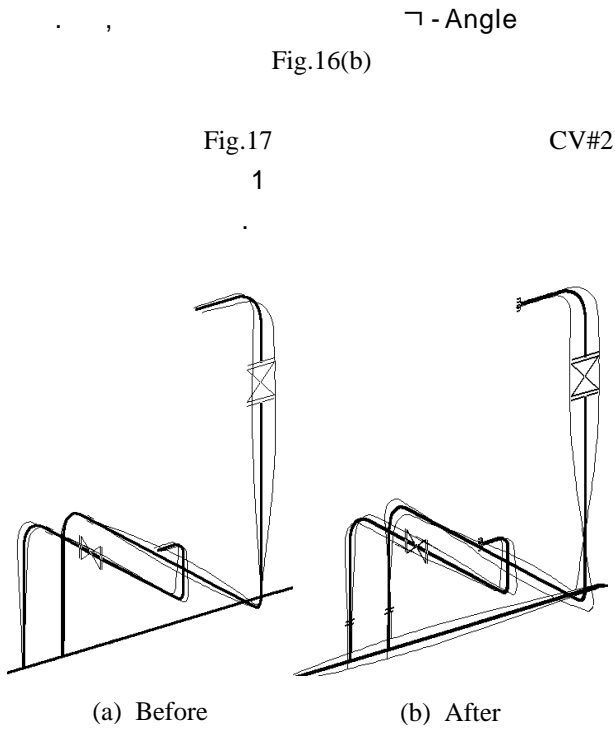
Figure 16. Main natural mode by 1st measures

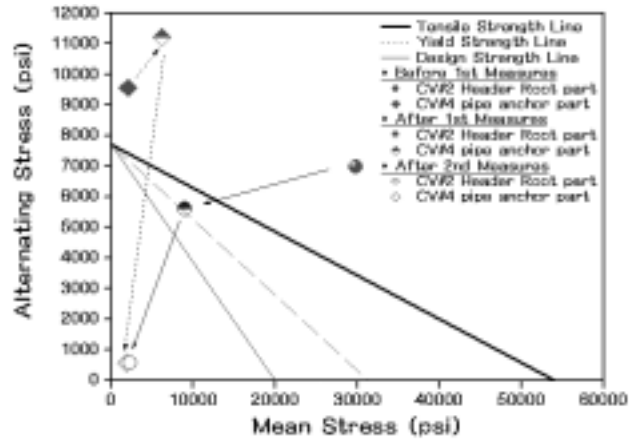
Figure 18. Effectiveness changed by measures
