# IMPROVEMENT OF COOLING TOWER GEAR REDUCER

Apr. 10, 2004

Yeoun Ho Ji

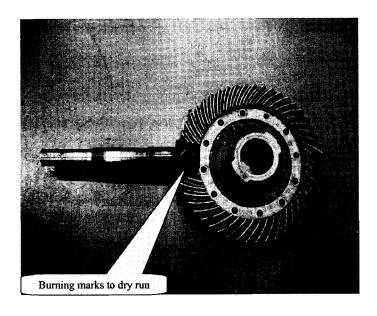
- ✓ Continue operation is impossible because wear and tear of gear was caused by oil leak.
- ✓ So it has to be replaced to new shaft.

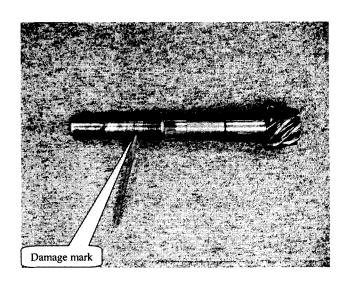
- ✓ Shaft is composed of one body with a pinion gear. Hence replacing shaft means replacing pinion gear.
- ✓ So, new pinion gear and shaft will to be replaced with new one at the same time.

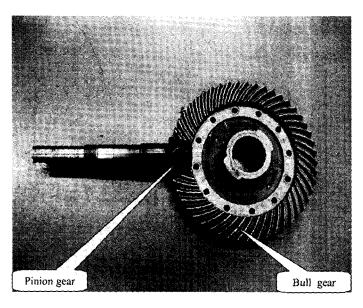
- ✓ When the pinion gears, replaced new one, Bull gear has to be replaced new one at same time.
- ✓ This is common request from gear makers.
- ✓ So, one gear set has to be replaced at once.
- ✓ But this was installed 10 years ago. So, we can not buy the assembly parts due to suspension of manufacture.

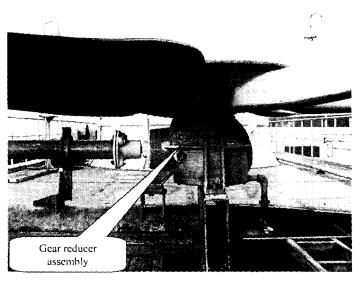
- ✓ Hence, we have to replace all of the gear reducer system.
- ✓ It is asked for a lot of cost for installation, removal and disassembly.

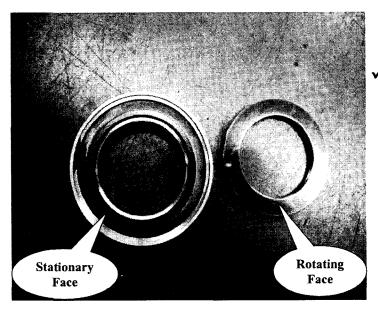
Stationary part & rotating part

Stationary face is composed of carbon graphite and rotating part is coated with ceramic on the stainless.

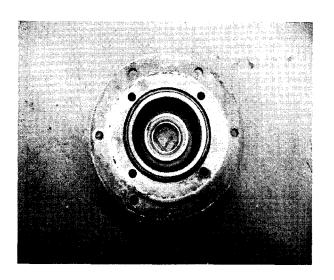
✓ Assembled stationary part in housing.

✓ New housing is modified within ranges of structures and intensity being not influenced by using existing oil seal hole.
 And in new above one, new mechanical seal stationary was attached.
