# CONSTRUCTION MANAGEMENT OF TUNNELLING IN SEVERE GROUNDWATER CONDITION

Young Nam Lee <sup>1</sup> and Dae Young Kim <sup>2</sup>

**ABSTRACT :** For a hydro power plant project, the headrace tunnel having a finished diameter of 3.3m was constructed in volcanic rocks with well-developed vertical joint and high groundwater table. The intake facility was located 20.3 km upstream of the powerhouse and headrace tunnel of 20 km in length and penstock of 440 m in height connected the intake and the powerhouse. The typical caldera lake, Lake Toba set the geology at the site; the caving of the ground caused tension cracks in the vertical direction to be developed and initial stresses at the ground to be released. High groundwater table (the maximum head of 20 bar) in the area of well-connected vertical joints delayed the progress of tunnel excavation severely due to the excessive inflow of groundwater.

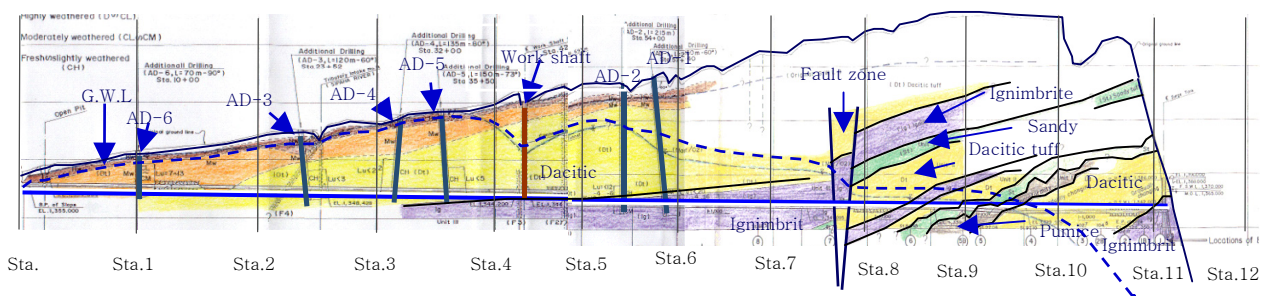
**Figure 3.** Geological Section of DHT Side Based on the Results of Additional Investigation and TBM Excavation (The dashed line represents GW table when tunnel face was at Sta.56+00)

As shown in Figure 3, rock formations along the tunnel alignment turned out to be much more complex than those obtained during the tender design stage. However, the mechanical behaviour of rock core sample tested was in general competent and in good agreement with the results of compression wave velocity measurement from the tender design, as can be seen in Table 1. The most important geological feature encountered from tunnel excavation was the presence of vertical fault zone at Sta. 76, found to be a hydro-geological barrier. The hydro-geological condition, 3.5 years after the excavation started, for a section between this fault zone and Surge Tank area may be classified as dry(see Figure 3). The dry condition, that is, the initially-low groundwater table, may have been resulted by the presence of well-developed vertical tension cracks. As shown in Table 1, Lugeon values obtained from horizontal boreholes, in which the influence of vertical joint could be

On March, 2002, the tunnel face reached at Sta. 56+00 and the groundwater table for the upstream side of the fault zone at that time was established from the measurement of water table inside vertical boreholes AD1 to AD6, as shown in Figure 3.

The excavation of tunnel from Surge Tank to fault zone took about 1.5 years and that from fault zone to Sta. 56 another 2 years. As shown in Figure 3, the influence of the excavation on the groundwater level is clearly shown in the lowering of groundwater level between the fault zone and Sta. 56 due to the presence of well-connected vertical fractures. The lowering of high groundwater table was made possible by draining high pressure groundwater to the tunnel excavated and resulted in the large inflow of water to the tunnel.

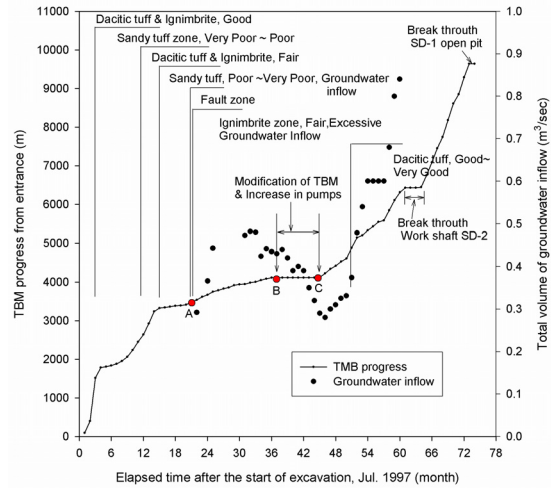
**Figure 4.** TBM Progress and Volume of Groundwater Inflow with Time

At the initial phase of headrace tunnel excavation near the cliff, both rock and groundwater conditions were favorable to the excavation and the progress was rapid, as shown in Figure 4. However, as the tunnel face reached at Sta. 96, the bedrock changed from dacitic tuff to weak sandy tuff, but groundwater condition was still dry, resulting in the slower progress of excavation. As soon as the tunnel face passed through the fault zone at Sta. 76, excessive amount of groundwater poured into the tunnel from the area between crown and springline, as shown in Figure 5. Soon after the tunnel face passed the fault zone, the groundwater having the head of 200 m spouted through open vertical joints and the amount of groundwater

measured at the tunnel entrance near Surge Tank area was as high as 292 liter/sec. As the tunnel face moved away from the fault zone and the excavated length of tunnel became longer, the water head decreased, but not the amount of inflow.

As shown in Figure 4, TBM progress significantly decreased as the inflow of groundwater became excessive after TBM passed through the fault zone at Sta. 76(point A). As the tunnel excavation progressed, groundwater discharge rapidly increased up to 482 liter/sec from 292 liter/sec and decreased slowly when the tunnelling work stopped for the modification of TBM and drainage system(point B). The excessive inflow of groundwater slowed down the progress of TBM due to the slime. The excavated rock fragments broke down to gravel size or smaller when mixed with water and became slime. This material could not be easily removed by the fork-type scraper and hence piled up at the back of TBM head to an approximately 20 to 30 cm thickness at the invert. The crew had to remove this material manually with shovels to allow the power unit trailer to pass and permit the installation of the railway tracks on the tunnel invert. Removing the slime took on average 23 % of the available working time during the period May to October 2001. Due to the excessive water inflow and the material piled up at the invert, the water level inside the tunnel rose to the maximum of 70 cm.

As can be seen in Figure 4, after the improvement in TBM and discharge capacity(point C), the monthly progress of TBM significantly increased and the excavation of tunnel was completed without further delay. Once the tunnel face passed large water inflow zone between Sta. 59 and Sta. 52 and reached a more competent rock formation, the tunnel excavation was made with a rapid progress.

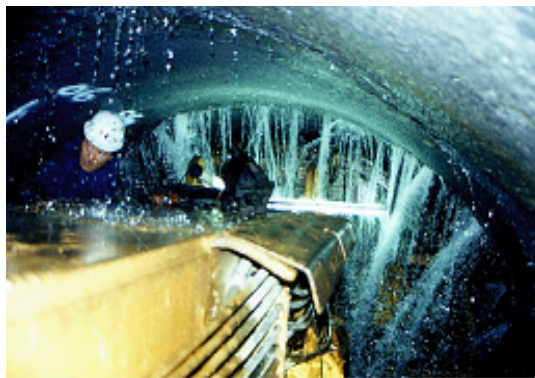
Figure 5. Sketches and Photos Showing Excessive Groundwater Inflow

LOCATION OF EXCESSIVE INGRESS UNDERGROUND WATER IN D.H.T

STATION	LOCATION	STATION	LOCATION
71+90		74+70	
74+100		75+81	
74+05		75+01	
74+55		75+16	
74+80		76+06

Due to the water and dirt conditions, the locomotive and mucking cars derailed frequently. As the rolling locomotive ran on debris-laden tracks, it resulted in high wear of wheels, breaks and bearings. The adverse operating conditions for TBM, power unit trailer and the locomotive in this tunnel led to a high percentage of down time caused by the equipment failure and net boring and re-gripping time on average 10% of the available working time.

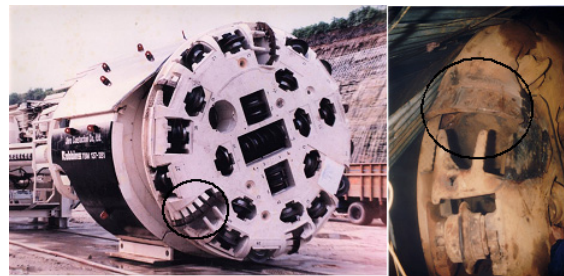
Figure 6. Modification of TBM Scraper; Before Fork-Type(Left), After Bucket-Type(Right)

Since the initially-adopted fork-type scraper could not remove the slime efficiently, the unremoved slime travelled to the back of TBM head through the space between the rock surface at the invert and the bottom part of TBM head. To improve the efficiency in the removal of slime, the

scraper was modified from the fork-type to bucket-type, as shown in Figure 6, and a slime-proof cover was installed at the space between TBM head and rock surface at the invert, as shown in Figure 7. The locomotive was modified for a better operation inside the tunnel by re-locating the engine upward, so that the engine would not be submerged. Besides, all the wheels were sealed and all rotational parts replaced with O-ring and oil seal, resulting in the longer life of these parts.
