Re-Analysis of In-Service Inspection of Pressure Tubes and Feeder Pipes in Wolsung Unit 1

Sung-Sik KANG, Seok-Hun KIM, Young-Hwan CHOI, Suk-Chull KANG, Youn-Won PARK
 Korea Institute of Nuclear Safety (KINS)
 19 Gu-Sung Dong, Yu-Sung Gu, Daejeon, 305-338
 sskang@kins.re.kr

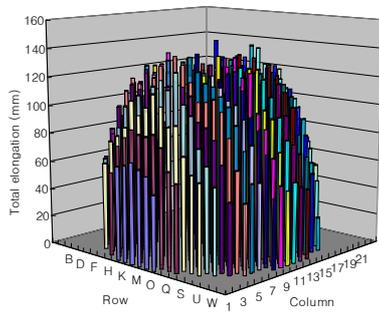
Figure 1. Total elongation of Wolsong unit 1 pressure tubes

Pressure tubes of Wolsung unit1 were elongating somewhat faster than had previously been predicted. So, some channels can reach the total allowable elongation before design life of 30 years. Since the analysis in 2001, the maximum elongation rate is somewhat increased from 6.69 to 7.8mm/EFPY. It shows that the maximum elongation rate is somewhat accelerated with increasing the operating time and the power. As of May 2005, H-16 channel shows maximum elongation and rate. Figure 1 is total elongation of Wolsung unit 1 pressure tubes. It is closely related with CANDU fuel channel refurbishment which is planning by utility. So an

appropriate life time management program (such as, less than full power operation) is needed before the refurbishment. Also, the effect of thermal expansion of Zr pressure tube alloy will be discussed in this section.

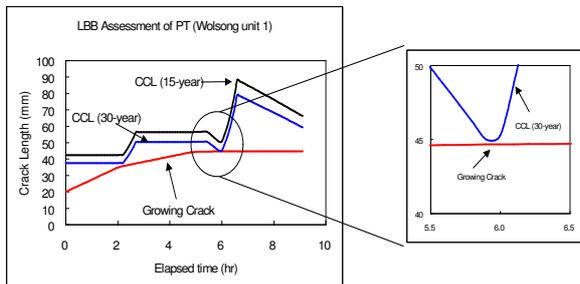
Figure 2. LBB assessment of Wolsong Unit 1

On the other hand, the LBB assessment of Wolsong Unit 1 reactor is shown in Fig. 2. As shown in this figure, the LBB can be satisfied not only for 15-year but also for 30-year operation whereas it is barely marginal for a 30-year operation case. The background of LBB assessment, leak detection and location will be presented in this paper[5].

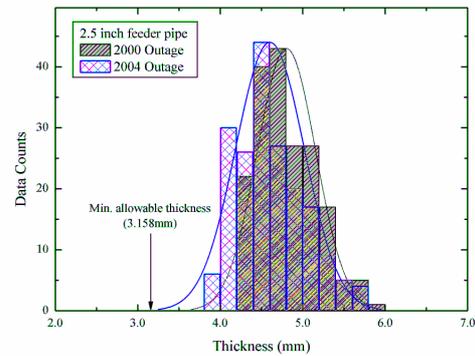
Figure 4. Distribution of thickness measurement in 2.5 inch feeder pipes

The results with the recent in-service inspection data show that the wall thinning degradation in feeder pipes is still progressing, and it can be reached the minimum allowable thickness calculated by the ASME Section III NB-3640 before the design lifetime. Figure 4 is the distribution of thickness measurement for the 2000 and 2004 outage. It shows that the distribution shape is shifted to the minimum allowable thickness.
