Development of Dismantling Techniques for Irradiated HANARO Instrumented Capsule (03M-06U) in IMEF

Yong-Sun CHOO, Do-Sik KIM, Wan-ho OH, Seung-Je BAIK, Byung-Ok YOO,
Dae-Kyu Park, Sang-Ryul Baek, Ki-Nam JOO
Irradiated Materials Examination Facility, Korea Atomic Energy Research Institute,
P.O. Box 150, Yuseong, Korea, 305-600

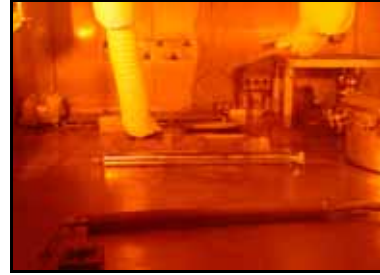
Figure 1. The appearance of 03M-06U transferred from pool to M1 Hot cell.

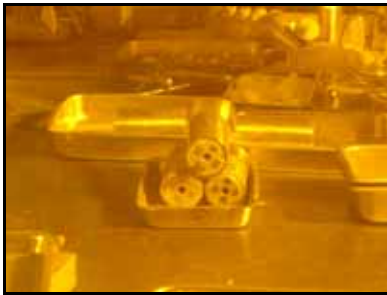
After cutting the bottom and top of capsule by capsule cutting machine, the dismantling process was tried many times by using a master-slave manipulator. During this process, a little problem such a jamming between outer pipe and inner structure was occurred and observed.

Figure 3. Cut and dismantled thermal media with outer pipe.

It is assumed that this kind of problem was occurred following reasons:

1) This capsule has probably a problem during manufacturing process at shop before irradiation.

2) The gap between outer pipe and thermal media is not enough to meet design criteria for thermal expansion during irradiation at HANARO

During the cut and dismantling process of HANARO irradiated instrumented capsule(03M-06U), a little different phenomenon like a jamming was observed and occurred. So to release jamming between outer pipe and inner thermal media, the outer pipe will be cut piece by piece by capsule cutting machine installed in M2 hot cell until the outer pipe was eliminated or reduced as we could.

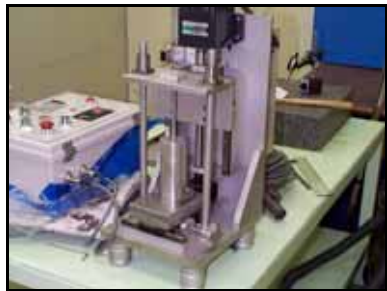
Figure 4. Specimen disassembling from specimen holder by specimen press machine in M5a hot cell.
