Is stereographic projection valid for predicting slope stability?
A proof from a topographically controlled plane failure at KhunYongJe
village, Korea

QuocPhi Nguyen^{1)*} · SangGi Hwang¹⁾ · KyoungYeol Yun¹⁾

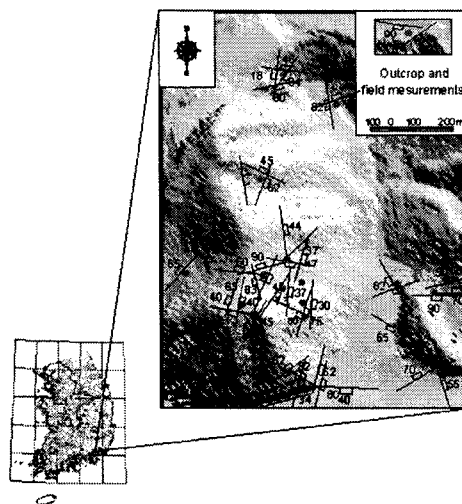
Figure 1. Study area and fracture data from field survey. Unloading joints are presented in red symbols.

Previous rock slides stripped vegetation cover from the mountain slopes and expose barren wide fracture surfaces. The stripped vegetation areas are mapped by detailed satellite images and aerial photographs and the occurrence of talus are confirmed during field survey. Fractures orientation (strike/dip) and their properties (space, length, roughness, JRC, rock strength) are investigated at these source sites of the rock falls. Field survey indicated that the sliding surfaces are sheeting joint planes which are parallel to the topographic slope geometry.

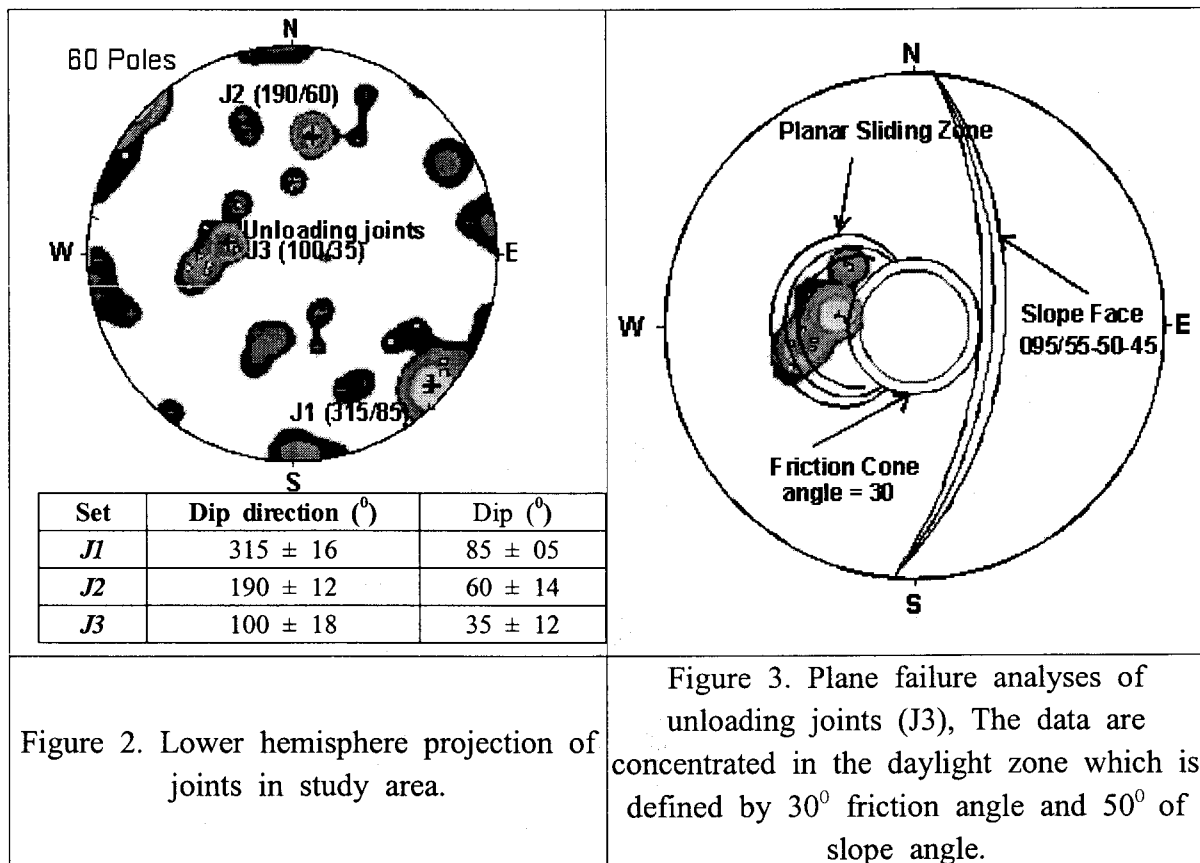
Three major joint sets (J1, J2 and J3 in Figure 2) are found at the back slope of the KhunYongJe village. Field survey indicated that the joint group J3 (100/35) is the unloading joints which are sub-parallel to the topographic slope faces. Other high angle joint sets J1 and J2 intersects the J3 joints and the intersections create separated rock blocks as is shown in Figure 5. Sliding of these blocks along the J3 plane is the cause of the talus flow.

Figure 3 illustrates the stereographic analyses of the plane failure of J3 joints. The natural slope of this area dips toward 095° (±30) with 55° (±25) dipping angle. Fixing the dip direction of the natural slope at 95°, different sizes of daylight zones of the plane failure can be generated by changing the friction angles and the dipping angles of the natural slope as in Figure 3. The resulting plots in figure 3, clearly shows that the concentration of unloading joints starts when the slope angle

is higher than 50° and a friction angle is larger than 30° . This result implies that the rock sliding (plane failure) occur in areas where the dipping angle of natural slope exceeds 50° and the friction angle of the fracture surface in this area is about 30° . Friction angle of the sheeting joint (J3) has not been investigated; however, the 30° could be general angle for fractures with smooth surface as the sheeting joint set J3.

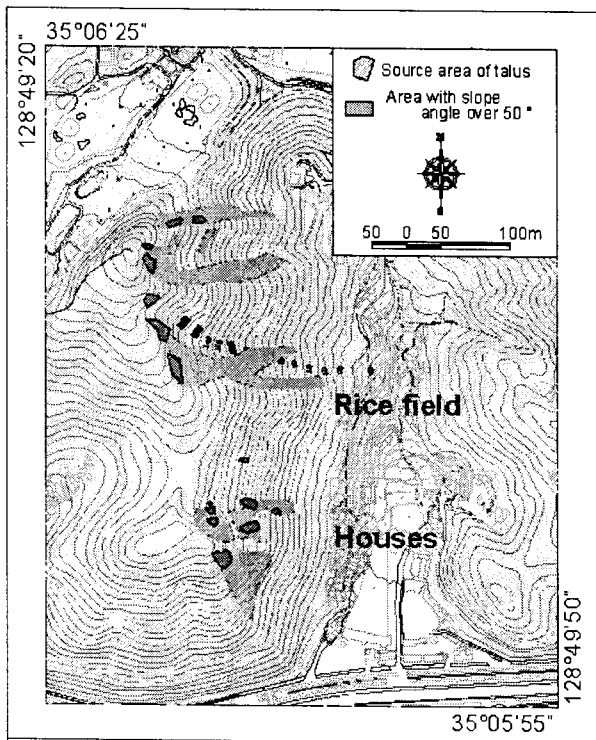
To verify the instability of the sheeting joints at over 50° dipping angle of the natural slope, a topographic analyses is conducted. Area with topographic slope angle higher than 50° are delineated by DEM analyses in GIS, and they are illustrated in Figure 4. The source area of the talus, that are defined by area photos and satellite images and verified by field survey, are overlapped to the high slope locations as in Figure 4. It can be seen that, the source area of talus are mostly located in the areas where the slope angle is over 50° . This matching proves that the daylight zone, which is bounded by the friction angle and the slope angle, is valid. Assuming that the J3 joints have 30° friction angle, if the dipping angle of the sheeting joint is less than 50° , then they are outside of the daylight zone of the plane failure. Since sheeting joints in this area are sub-parallel to the topographic surface, the sheeting joints at areas with less than 50° slope angle of this area were stable from the talus flow.

Figure 4. Location of talus sources overlaid in areas where slope angle are higher than 50° .

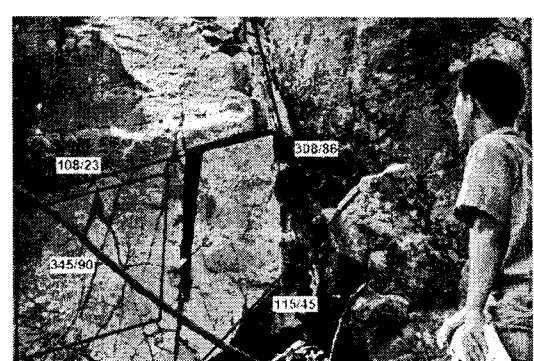
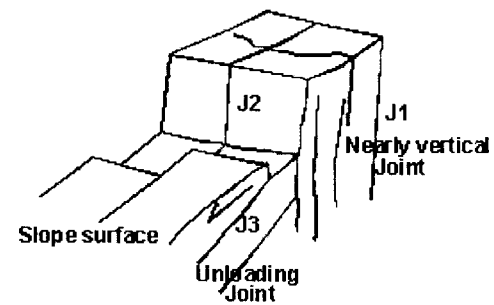
Figure 5. Field photo and schematic model of planar slides
