Damages, Human Behaviour and Recovery of Urban Residents in the 2005 West off Fukuoka Earthquake

H. Murakami ^{1*}

¹ Division of Environmental Science and Engineering, Yamaguchi University, Ube, Japan

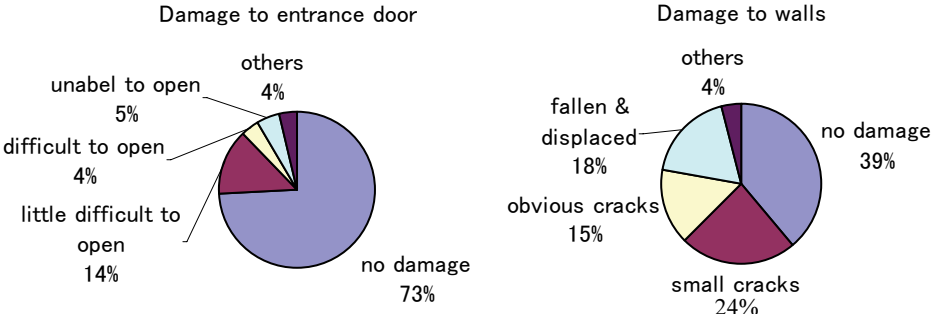
Figure 2 shows damage distribution of distorted doors and non-structural walls. As for architectural damage, difficulty or unable to open the doors is 9%. As for the wall damage, 18% answer fallen and displaced walls. Some occupants had to evacuate thru balcony partition to their neighboring dwelling units.

Fig. 2 Damage frequency of entrance doors (left) and walls of residential units (right) (N=196 cases).

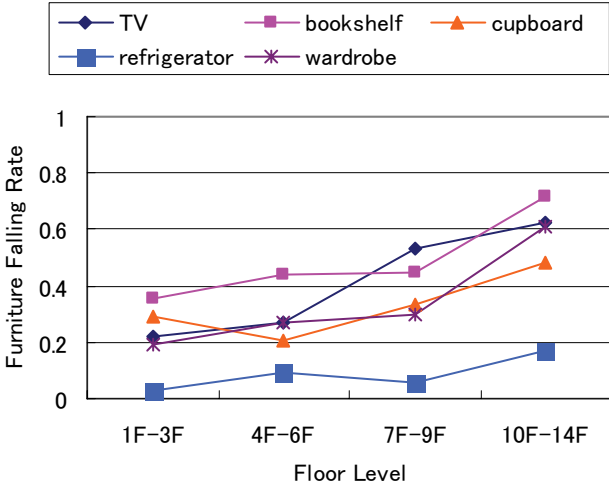
As for the interior contents damage, Fig. 3 indicates rates of falling furniture along floor levels. Rates of falling in 10-14th floors are 2 to 4 times higher than those in 1-3rd floors as reasonably explained by higher floor response in upper floors. Falling rates are highest for bookshelf and TV, and are medium for wardrobe and cupboard. Damages are severest for living rooms and kitchens followed by

Fig. 3 Furniture falling rates vs. floor levels (N=196 cases).

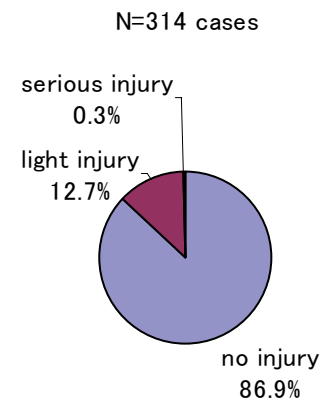
Fig. 4 Injury distribution of family members.

Effective responses for family member of 339 cases are examined here regarding casualty risk. Males are 39% and females are 61%. Sixty two % of people were at home, 20% were indoors except for one's home, 10% were outdoors at the time of the earthquake occurrence. Injury rate of those people reach as high as 13.1% (Fig. 4). Causes of injury are falling furniture, broken glass, one's falling and falling objects. Out of the injury cases, 26.8% were treated as out-patient o
