A CASE STUDY OF GROUND CAVE-IN DUE TO SUBSURFACE EROSION IN OLD LAND FILL

ABSTRACT

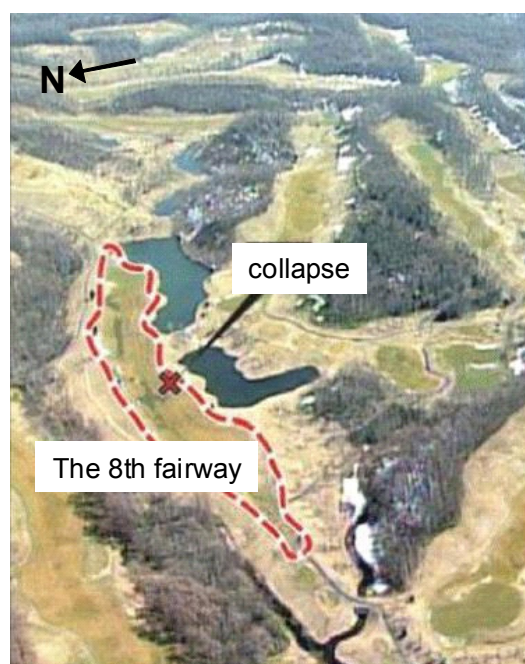
The hole was 5m deep and 7m wide at the bottom. Although the golf course was daily checked by maintenance staffs, they could not get any sign of the hidden hole even in the morning of the accident. The ground collapse seemed to have happened all of sudden, as the victim's son who walked just a couple of meters behind her saw her suddenly disappearing into the ground.

Figure 1. Photo at the location of collapse (after Asahi Newspaper 090417)

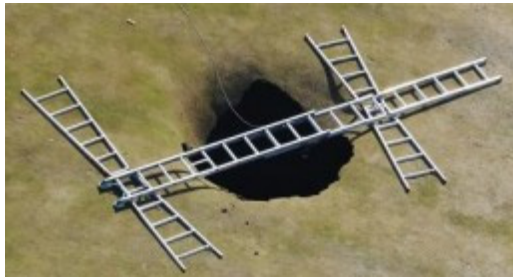
The hidden hole had a flask shape with a 1 m wide opening at the ground surface (see Figure 2), and was 5m deep and 7m wide at the bottom. There was an about 0.6m deep shallow water pool in the east side of the hole, and the water flew to the west direction. Noticeable erosion was found in both west and east sides at the bottom as schematically shown in Figure 3.

Figure 2. Opening at the ground surface (from Hokkaido Newspaper)

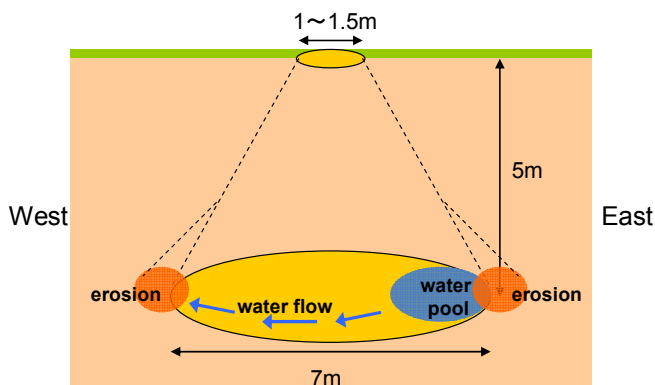
Figure 3. Schematic of the underground cavity

The volume of the soil for the hole is about 75m^3 . One of the questions is that where such amount of soil went. There is a water reservoir in the down stream of the 8th fairway, where large amount of soil sediment was found. It may be the possible destination of the soil flow from the hole.

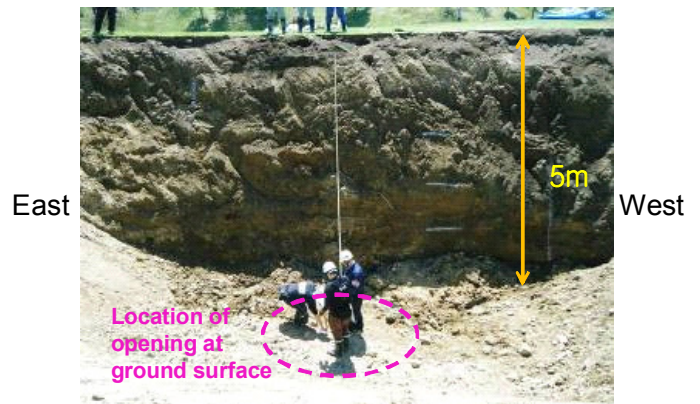
Figure 4 is a photo of excavation. Excavated soil was a mixture of volcanic clay, silt, sand, and relatively small gravel, as shown in Figure 5. Roots of plants

Figure 4. Excavation around the hole

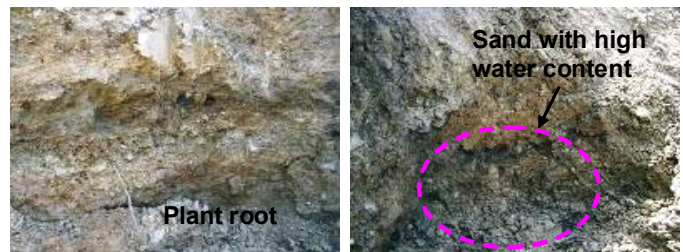
were also included, which indicates the excavated strata were filled soil. Atterberg limits and particle size distribution are shown in Table 1 and Figure 6, respectively.

Figure 5. Soil in the excavated wall (GL-approx.6m)

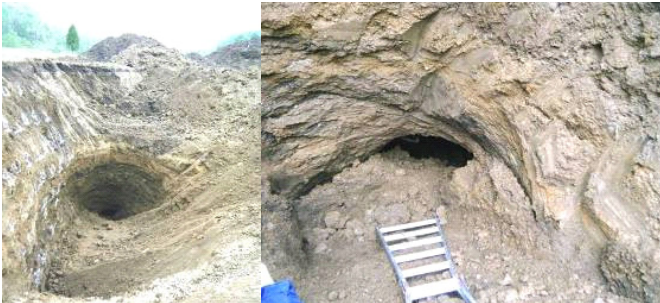
At the depth of 8m from the ground surface, there was the boundary between original stiff ground and filled soil, where a lateral ground cavity of about 2m

wide was discovered in about 20m west from the center of the hole, as shown in Figure 7. The sound of water flow was clearly heard in the cavity. The length of the cavity was at least 6m, but could not be confirmed as the further excavation was not conducted. It seemed to be a path through which soil with water was transported out of the hole.

Figure.7. Natural soil pipe due to the internal erosion

Water colored by fluorescent paint was poured into the cavity to search for the destination of the water flow in the soil pipe. After 20 minutes, the colored water started flowing out at the reservoir, 700m down from the cavity. It can be considered that a soil pipe is formed in the ground between the collapsed location and the reservoir where a large amount of soil sediment was found.

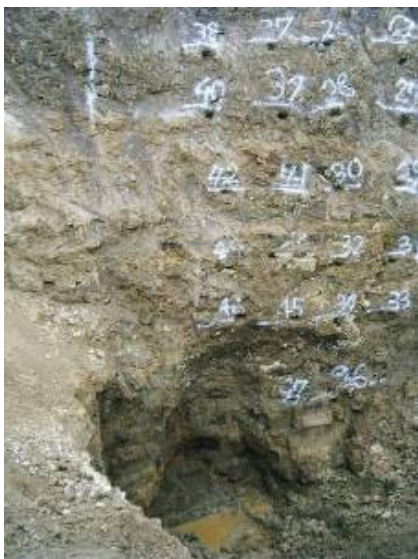
In the excavation on the east side, the point where the water flew into the hole was found at about 10m away from the center (Figure 8). It was indicated that the hidden hole was formed on the subsurface water stream.

Figure 8. Water inflow at the east side of the hole

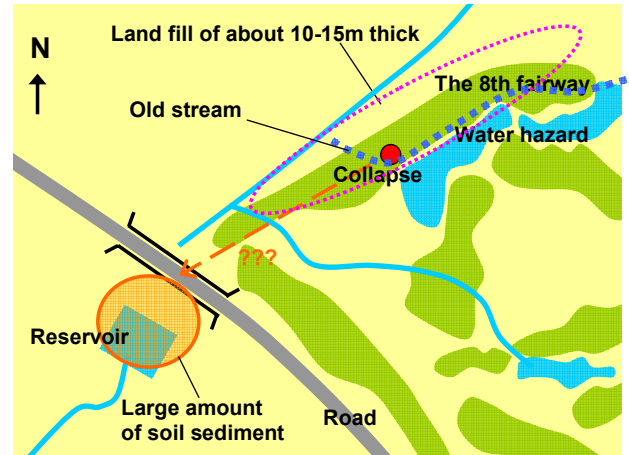
Comparison between old and current map of the location revealed that the ground collapse occurred at the land fill exactly on the old stream, as shown in Figure 9. The locations of the water inflow and outflow were identified at east and west side of the hole respectively.

Figure 9. Location of the old stream

Ground appeared to be internally eroded by the natural water path formed at the old stream. It is like a natural drainage pipe, so that it is generally called soil pipe. As the erosion of the soil at the location of the collapse seemed to be accelerated for some reason, a distinctive ground cavity was created. The hidden cavity grew silently, possibly due to the seasonal change of ground water level and eventually caused ground collapse. Such a process is schematically shown in Figure 10. However, the state and the condition of the installed drainage pipes are not yet examined. Further investigation is required in this aspect.
