Assessment of Degmay Uranium Tailing and Remediation Concept

2. Degmay Uranium Tailing Site

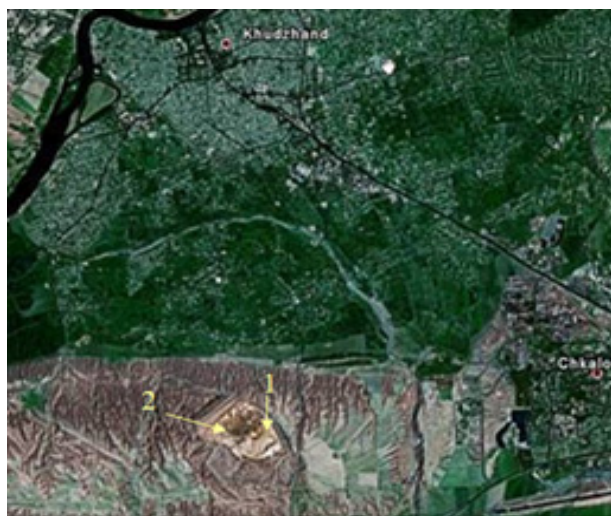
Fig.1. Scheme of Degmay tailings in the surroundings of Khudjand and Chkalovsk. Arrows 1 and 2 point place where aerosol samples were taken (Table 1).

Locations (See Fig.1)	Gamma-dose rate, μSv·h ⁻¹	Outdoor Rn-222 Bq·m ⁻³	*EEVA Rn-222 Bq·m ⁻³	Rn-exhalation Bq m ⁻² ·s ⁻¹
1a	3.9-4.0	102±24	5.2	9.18±2.75
1b	18.0-20	321±68	8.15	65.5±19.7
2a	6.5-7.0	187±36	15.85	50.8±16
2b	4.5-5.0	207±57	12.75	31.4±9.4
Regional background	0,15-0,2	15-20
