Fractographic Studies in Ballistically Damaged Polycrystalline Alumina

Chong-Hee Kim

Dept. of Materials Science, KAIS

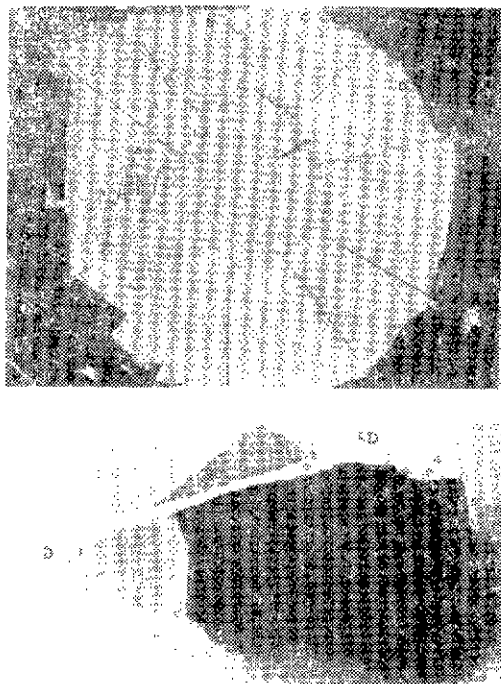
Fig. 1 Ballistically damaged polycrystalline alumina.
 a. Back face of tile after removal of spalled material, X1.6. Numbers identify areas from which surface replicas were taken.
 b. Detail of shear conoid surface (arrow) and radial crack for segment D, X1.4.

This category of fracture damage, though prominent in terms of total exposed area (see Fig. 1a), is thought to be representative of the final stages of cracking, occurring at the time when the kinetic energy of impact has been substantially dissipated. Both transgranular and intergranular fracture modes are observed. Cleavage is the most characteristic process for transgranular fracture, but the roughness of texturing is not as severe as in the earlier stages of fracture. Significantly, there is very little evidence of fracture fragments of the sort which were common on more severely damaged surfaces.

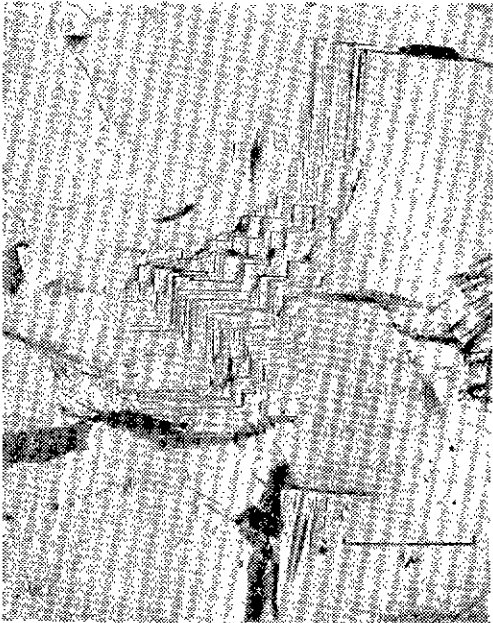
Fig. 3 Intergranular separations, transgranular cleavage steps, conchoidal fractures and in situ fracture fragments contribute to the very complex topography of a smoothly textured portion of a radial crack in ballistically damaged polycrystalline alumina tile. Two stage plastic-carbon replica, Pt-shadowed at 30° .

In Fig. 3, conchoidal fractures, intergranular separations, two very characteristic forms of rhombohedral cleavage, and several examples of fracture fragment formation are illustrated. The central grain shows a very well defined shift from intergranular separation to transgranular cleavage. In Fig. 4, the long central boundary surface shows a distinct transition from boundary separation on the right (which grades off into parting and conchoidal fracture) to transgranular fracture on the left. Of particular interest is the strong redirection of the transgranular fracture (just to the left of the boundary trace) together with the unusual sheared appearance at the left of the boundary flat. Such a configuration possibly is associated with some grain boundary sliding¹⁰ at a constrained triple grain edge, causing a small amount of shear. Relaxation of the strains imposed by a sliding mechanism would require either generalized plastic deformation or transgranular fracture of one or more of the adjacent grains, as observed here.

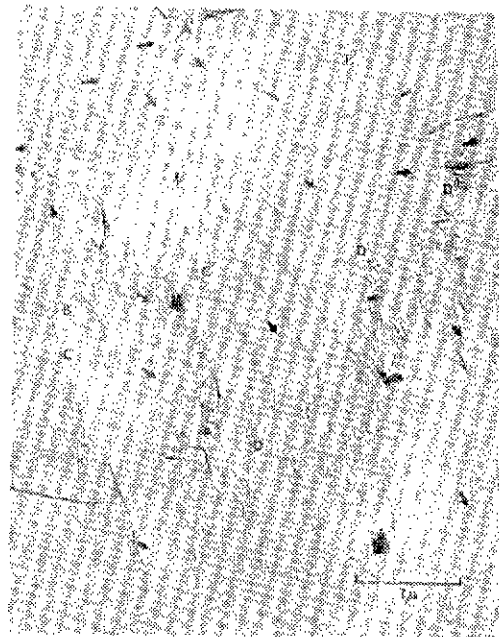
Fig. 5 River pattern cleavage steps on transverse secondary crack in ballistically damaged polycrystalline alumina tile. Two stage plastic-carbon replica, Pt-shadowed at 30° .

Smooth Transverse Fractures The surface studied in Figs. 5-6 is considered to be a secondary crack (probably a consequence of reflected stresses) and thus may be representative of a relatively late portion of the fracture time sequence, and hence of a proportionally lower segment of the energy dissipation spectrum. The principal fracture features include both grain boundary separations and transgranular breaks, together with generation of fine fracture fragments. The transgranular portions range in texture from conchoidal to imperfect parting to well defined cleavage. The orthogonally stepped cleavage mode commonly observed on single crystal fracture surfaces and on primary radial cracks in this polycrystalline material is less evident in this

secondary crack. The intensity of texturing is significantly reduced from the more severe cases previously cited. At the higher magnification provided by Fig. 5, there are several interesting examples of interactions between the advancing crack and the crystalline substructure (principally subgrain boundaries). Multiplications and redirections occur at the grain boundary marked by line A-A', other changes along B-B', C-C', D'-D'', B'-D' may be indicative of the influence of subgrain boundaries. These interactions apparently result in very local alterations of the fracture texture, as noted by Low⁴.

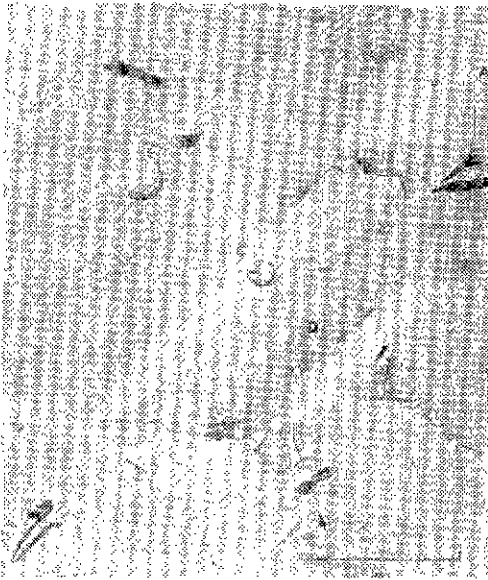
Fig. 6 Interactions between cleavage cracks and microstructural features on transverse secondary crack surface in ballistically damaged polycrystalline alumina tile. Two stage plastic-carbon replica, Pt-shadowed at 90° .

Some interesting examples of interactions between advancing cleavage cracks and microstructural features are shown in Fig. 6. Angular grain boundaries (A) at the upper right are typical of polyphase ceramic bodies which rely in whole or in part upon liquid phase sintering¹¹⁻¹³. The crack was not significantly altered in perpendicularly traversing these thickened (presumably vitreous) boundaries should produce hackled, splintered and/or conchoidal textures typical of fracture in glassy materials¹⁴.

After changing from boundary separation to transgranular fracture at (B), the crack produced finely textured but very irregular stepped cleavage fractures in moving toward pore (C). Since the nearby and nearly parallel grain boundary (D) appears to have been already separated, it may be that these cleavage anomalies resulted from stress relaxation associated with the separated boundary, coupled with the normal resistance to cleavage within the grain and at its other boundaries. At the pore (C) several changes in fracture behavior can be noted, both in the immediate pore vicinity, and at longer distances extending to the end of the grain. Related fracture tails at microstructural discontinuities in ceramics and glasses have been reported elsewhere¹⁵⁻¹⁶.

The downstream tailing effect is less prominent for the faceted pore (E), but the pore possibly did cause the unusual cleavage perturbations oriented in a perpendicular direction at (F). The discontinuity represented by the pore may have caused stresses associated with the crack front to be resolved into new components, including those capable of producing this anomaly.
