필름 Capacitor의 전기적 Damage에 관한 연구

Electrical Damage of Metallized Film Capacitors

徐 光 錫* · Chathan M. Cooke**
(Kwang S. Suh · Chathan M. Cooke)

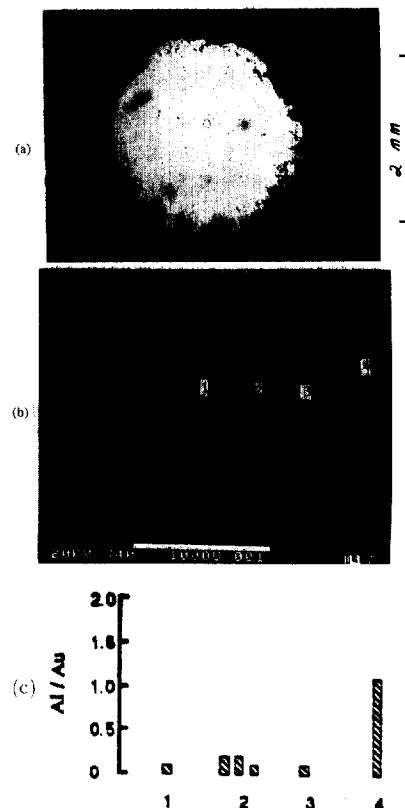
3.1 Surface morphology and elemental analysis

Fig. 1 Photos and EDX results of a single cleared site: (a) optical microscope, (b) SEM, (c) EDX result

examination at higher magnifications has revealed that the metallized layer looks peeled off, leaving many Al patches behind in the interface region. While the main eroded area shows a very rough surface, the interface region shows somewhat clean surface.

The present analysis on the nature of electrode erosion indicated that a permanent removal of electrode (metallization) may be one possibility for a capacitance loss during the qualification test. Major portion of electrode is physically removed by the discharging activity, so that the main erosion area becomes an insulator and correspondingly a capacitance loss resulted in by reducing an effective electrode area. It is questionable, however, whether this type of electrode damage occurs in film capacitors or not. It may depend on the level of applied voltage. If high voltages are applied, then permanent removal of electrode may occur. In film capacitors, however, the applied voltage is much lower than about $100\text{V}/\mu\text{m}$. In film capacitors, therefore, the permanent removal of electrode may not occur or at least much less, if any, than the one observed in the present work. In that case, the electrochemical conversion of the metal to the metal oxide may be dominant, as pointed out by Shaw et al.[2, 3] and Taylor[4], and the damage will be more cumulative. Nevertheless, once the discharging event occurs the possibility of such permanent removal of electrode material may not be excluded.

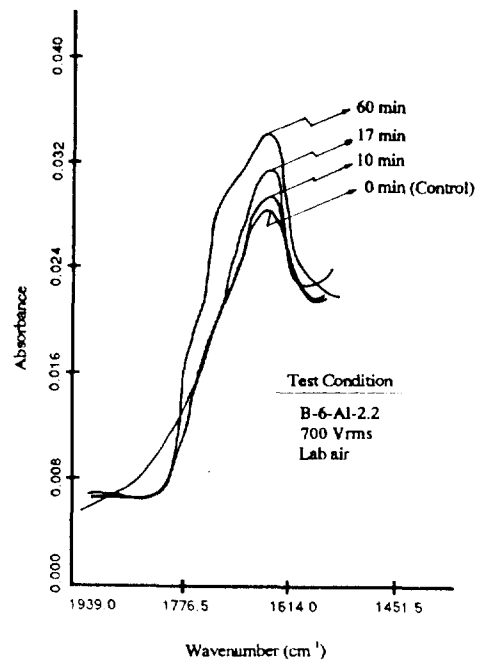
FTIR-ATR spectra of plain and electrically damaged films ($6\mu\text{m}$ thick and 2.2 ohms/square) were collected. A comparison at an expanded scale shows a systematic change depending on the duration in an electric field, as shown in Figure 2. Two or more peaks are identified in the range of $1600\sim 1800\text{cm}^{-1}$. Peaks are at 1637 , 1703 , and 1747cm^{-1} . It seems that as the duration in an electric field increases, the absorbance of the peaks at $1700\sim 1750\text{cm}^{-1}$ increases. This result indicates that the electrical activity can impose the chemical change. However, the absorbance of these peaks is still very small, so that similarly

Fig. 2 FTIR-ATR spectrum of electrically damaged BOPP films: Test conditions: 700V_{rms} , Lab air, film thickness: $6\mu\text{m}$, metallization: Al, 2.2 ohms/square .

Instrumental analysis using FTIR and ESCA facilities indicates that the chemical nature at the surface of electrically damaged films has changed by the electrical activity. FTIR-ATR analysis shows new peaks at 1637 , 1703 , and 1747cm^{-1} . With the assistance of literature information[5-7], these peaks have been identified as unsaturated double bonds for the peak at 1637cm^{-1} and carbonyl group for the peaks at 1703 and 1747cm^{-1} .

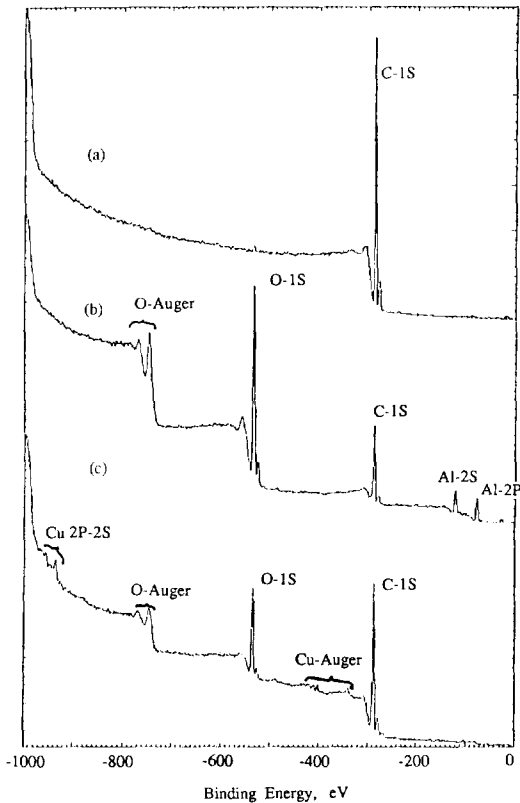
Figure 3 is the overall ESCA spectra of the plain(a) and electrically damaged(b and c) BOPP films. As shown in Figure 3, the plain BOPP film contains mainly carbon and a trace amount of oxygen in its surface. On the other hand, both metallization and polymer sides show large oxygen peaks. In particular, the ratio of oxygen to carbon peaks is very large compared to that of the plain BOPP, which indicates that the oxygen is one of the major species at both metallization and polymer surfaces. In addition to the oxygen and carbon peaks, the metallization side has Al peaks possibly from the Al metallization and the polymer side Cu Auger peaks coming from the copper electrode. Figure 4 is the curve fitting of C-1s peaks of the plain and electrically damaged BOPP films. Figure 4 shows that the carbon of the plain film(a) is composed of only one peak at -286eV , whereas that of the electrically damaged film(b and c) is composed of three

Fig. 3 ESCA response of electrically damaged BOPP films: (a) control, (b) metallization side, (c) polymer side. Test conditions & films: same as in Figure 2,

peaks at -286 , -287 and -298 eV, respectively. The fact that the C-1s peak can be resolved into three peaks implies that the environment around the main chain carbon has changed.

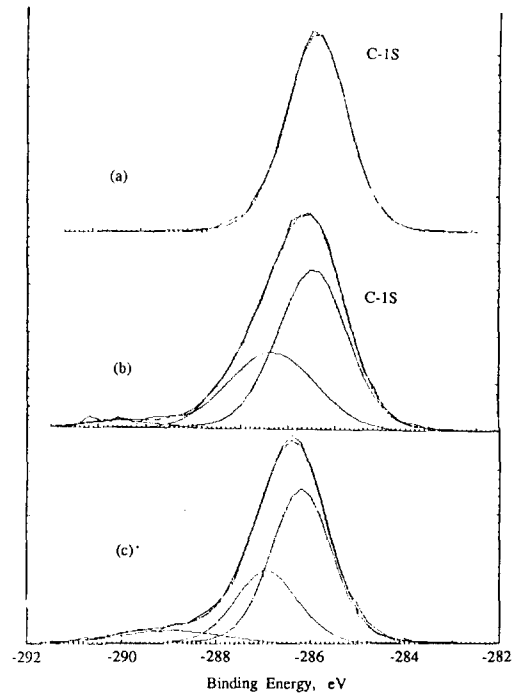
Fig. 4 Curve fitting for C-1s peak: (a) control, (b) metallization side, (c) polymer side. Test conditions & films: same as in Figure 2,

The peaks in an ESCA analysis have not been carefully characterized. Along with the results from a FTIR analysis, however, it seems that the peak with the largest area in Figure 4 must be the C-C bond and the other two the C=O and C=C bonds. These results suggest that the BOPP films are oxidized by the electrical activities. This suggestion can be supported by the observation of hazy (opaque) color and autoadhesive characteristic of the tested films. All observed features, i.e., carbonyl and unsaturation groups, polar groups and low molecular weight waxy layer, are well known to form at a result of the oxidation and subsequent chain scission reaction[5-8].

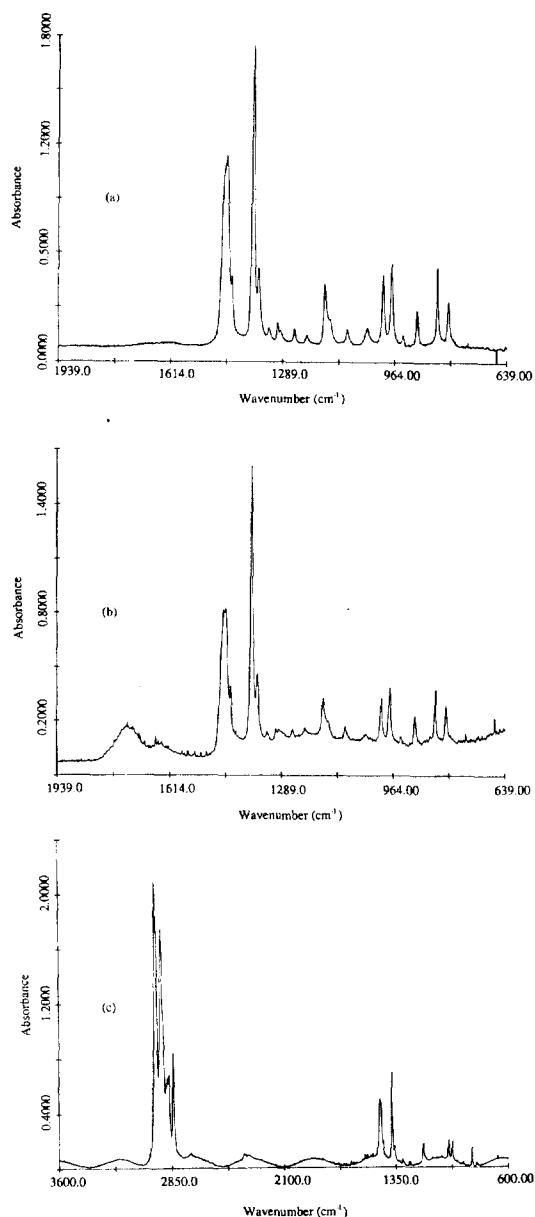
FTIR-ATR spectrum of non-treated BOPP film, (b) that of corona treated one, and (c) the FTIR-transmittance spectrum of corona treated BOPP film. FTIR-ATR spectra were taken at the incident angle of 45° and the corona was generated at 4 kV_{rms} at a gap distance of 1.5 mm. FTIR-ATR spectrum of the corona treated BOPP film (Figure 5-b) shows a considerable difference compared to that of the non-treated one (Figure 5-a). A major appreciable difference is the formation of broad new peaks, one at 1750 cm^{-1} and the other at 1640 cm^{-1} . A broad peak at around 3220 cm^{-1} was also observed. Appearance of these peaks indicates that the chemical nature of the surface of BOPP film has changed considerably due to the corona treatment. A broad peak at 3220 cm^{-1} is associated with the hydroxyl ($-\text{OH}$) group, and the peaks around 1750 and 1640 cm^{-1} can be assigned as the carbonyl and unsaturated double bond groups, respectively [5-7], as already mentioned. Such changes of BOPP films can be attributed to the chemical nature of polypropylene. Chemically, polypropylene has a weakness in the sense that the polypropylene is prone to the chain degradation, although the orientation can suppress degradation a lot. The reason for this is that polypropylene has a high population of tertiary hydrogen atoms which induces the degradation very easily [8].

Peak positions corresponding to the carbonyl and unsaturation groups are the same for both grape-clustered and corona treated films. For this, compare Figure 2 and 5-b. In addition, the absorbances at many peaks changed by the corona treatment. In particular, three peaks at 841 , 998 , and 1167 cm^{-1} decrease considerably. These peaks are known to originate from the crystalline part of polypropylene [9-12]. Of these, two peaks at 841 and 998 cm^{-1} are usually used for the estimation of the surface crystallinity. The crystallinity estimated from the ratio of these peaks decreased from 71.7% for non-treated film to 56.6% for corona treated film. Note that these values are different from the ones which will appear in the next section. Remember that specimens are different.

Figure 5-c, a FTIR-transmittance spectrum of the corona treated film shows no peaks at

Fig. 5 FTIR-ATR spectrum of non-treated BOPP film (a), FTIR-ATR spectrum of corona treated BOPP film (b), and FTIR-transmittance spectrum of corona treated BOPP film (c). $\theta = 45^\circ$ for FTIR-ATR spectra, film thickness: $8 \mu\text{m}$, corona: 4 kV_{rms} at 1.5 mm gap distance.

wavenumbers around 3220 , 1700 cm^{-1} , which implies that no appreciable oxidation can be detected when a transmittance technique is em-

ployed even though the film surface is considerably oxidized. Considering that no differences were found from the transmittance method while appreciable differences were found from the FTIR-ATR method, one can notice that chemical and morphological modifications in BOPP films by the corona discharge are confined only to the surface region.

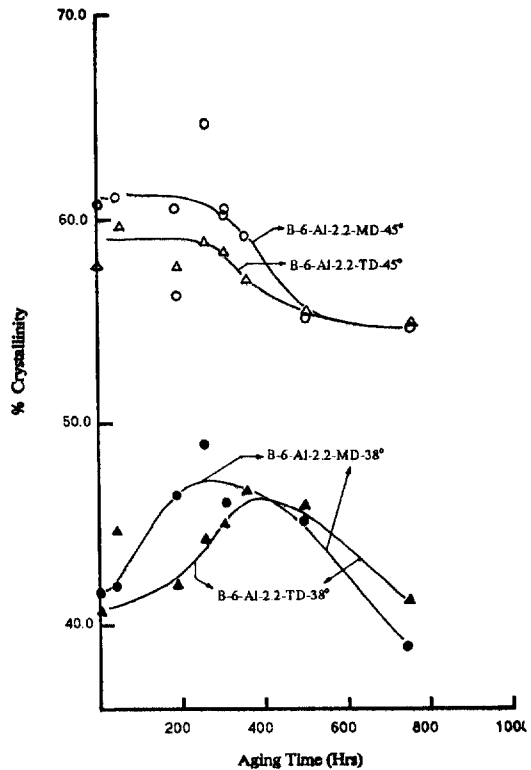
Figure 6, in which the surface crystallinity was plotted against the aging time, shows that the surface crystallinity changes as a function of aging time at 90°C. In the figure, 38 and 45° indicate the angle of the incident IR beam and can be used as a measure of the penetration depth of IR beam [9]. In the case of 45°, the IR beam penetrates into the deeper region of the film than 38°. At the very surface(38°) the degree of crystallinity increases first and then decreases, whereas at a little deeper surface(45°) it decreases monotonically. The crystallinity of the fresh film has less than 50% at the very surface and higher than 70% in the bulk. Therefore, the surface region has a higher amorphocity than the bulk region. In this region, the crystallinity may get increased at an early stage of thermal aging due to the "annealing" effect, but eventually will decrease as the surface degradation starts developed. On the other hand, deeper region can be considered as a highly oriented state, so that the chains will be relaxed immediately upon thermal aging. Also, the results indicate that the film is more oriented to the machine direction than to the transverse direction.

Fig. 6 Surface crystallinity of thermally aged BOPP film: Temp: 90°C, film thickness: 6 μ m, metallization: Al, 2.2 ohms/square, oven: air-blowing oven
