LASER CONSOLIDATION OF THE PLASMA COATED CHROME CARBIDE LAYER

레이저를 이용한 크롬카바이드 플라즈마 용사층의 특성향상

Abstract This paper evaluated the feasibility of laser consolidation for improving the properties of the plasma coated layer. Further, the mechanism of the degradation sequence of the chrome carbide layer applied on the turbine blades was postulated.

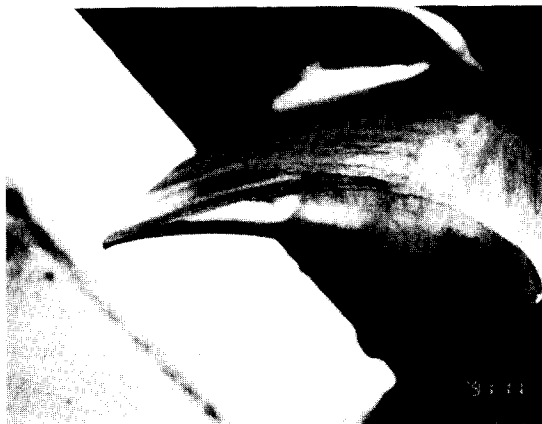
The blades in the Top-over gas Reduction Turbine (TRT), which is running by the blast furnace gas(BFG : mixture of CO₂, CO, H₂, H₂S and N₂) in the iron & steel making mill, are significantly impaired by erosion and corrosion. Although the BFG is cleaned and cooled (to about 50°C) by passing through both dry and wet type dust catchers before flowing into the turbine, it normally includes a small amount of dust(5mg/m³) and mist(mixture of dust and moisture, 1.0 g/m³), which may be sufficient enough to damage blades under the flowing speed of about 35m/min[1]. Therefore, the chrome carbide type protective coating which is known to have a good corrosion and erosion resistance to the turbine environment was applied on the blade surface by the high power plasma spraying process. Though the applied coating served very well for a short period of operation, it was eventually peeled off by the impacting action of the residual dust and mist, and thus it did not noticeably improve the campaign life of the blades. A typical edge debonding of the plasma coated layer is shown in Fig. 1.

Fig. 1. A typical appearance of the debonded plasma coating.

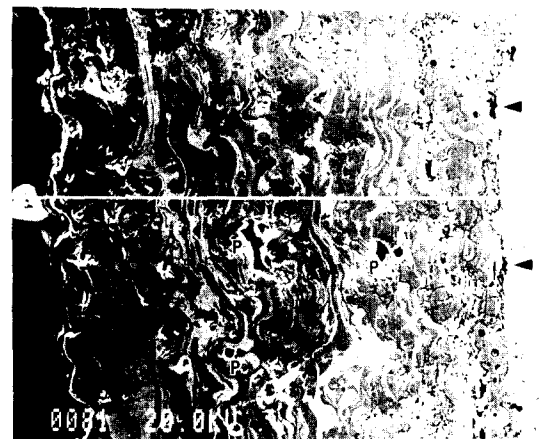
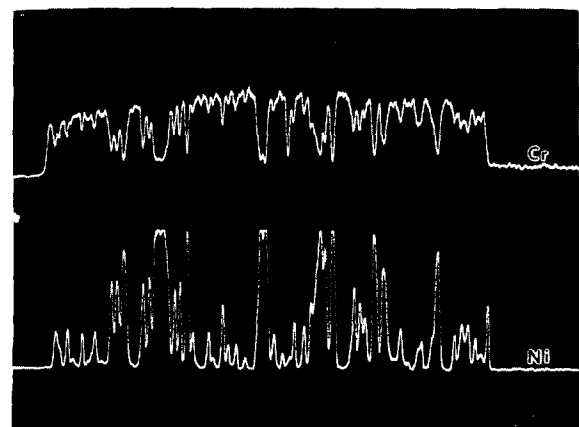
A typical microstructure with a Cr, Ni distribution in the thickness direction of the as plasma coated layer is shown in Fig. 4. The coating appears to have repetitive layers of dark and bright features. While Cr is enriched in the dark region, the bright region is enriched with Ni, revealing that the dark and bright regions were from the chrome carbides and NiCr self-flux, respectively.

Microstructure also reveals significant of pores formed along the interlayer region(see P). The measured area fraction of the pores was about 5.5%. Imperfections or misbondings can also be found along the coating-substrate interface(see arrows), which can reduce the bond strength significantly. The measured bond strength was varied from 4.6 to 8kg/mm² depending upon the amount of the imperfections along the interface in the sample, and the average strength was 5.8

Fig. 4. Typical cross sectional view of the plasma coating and Cr, Ni distribution

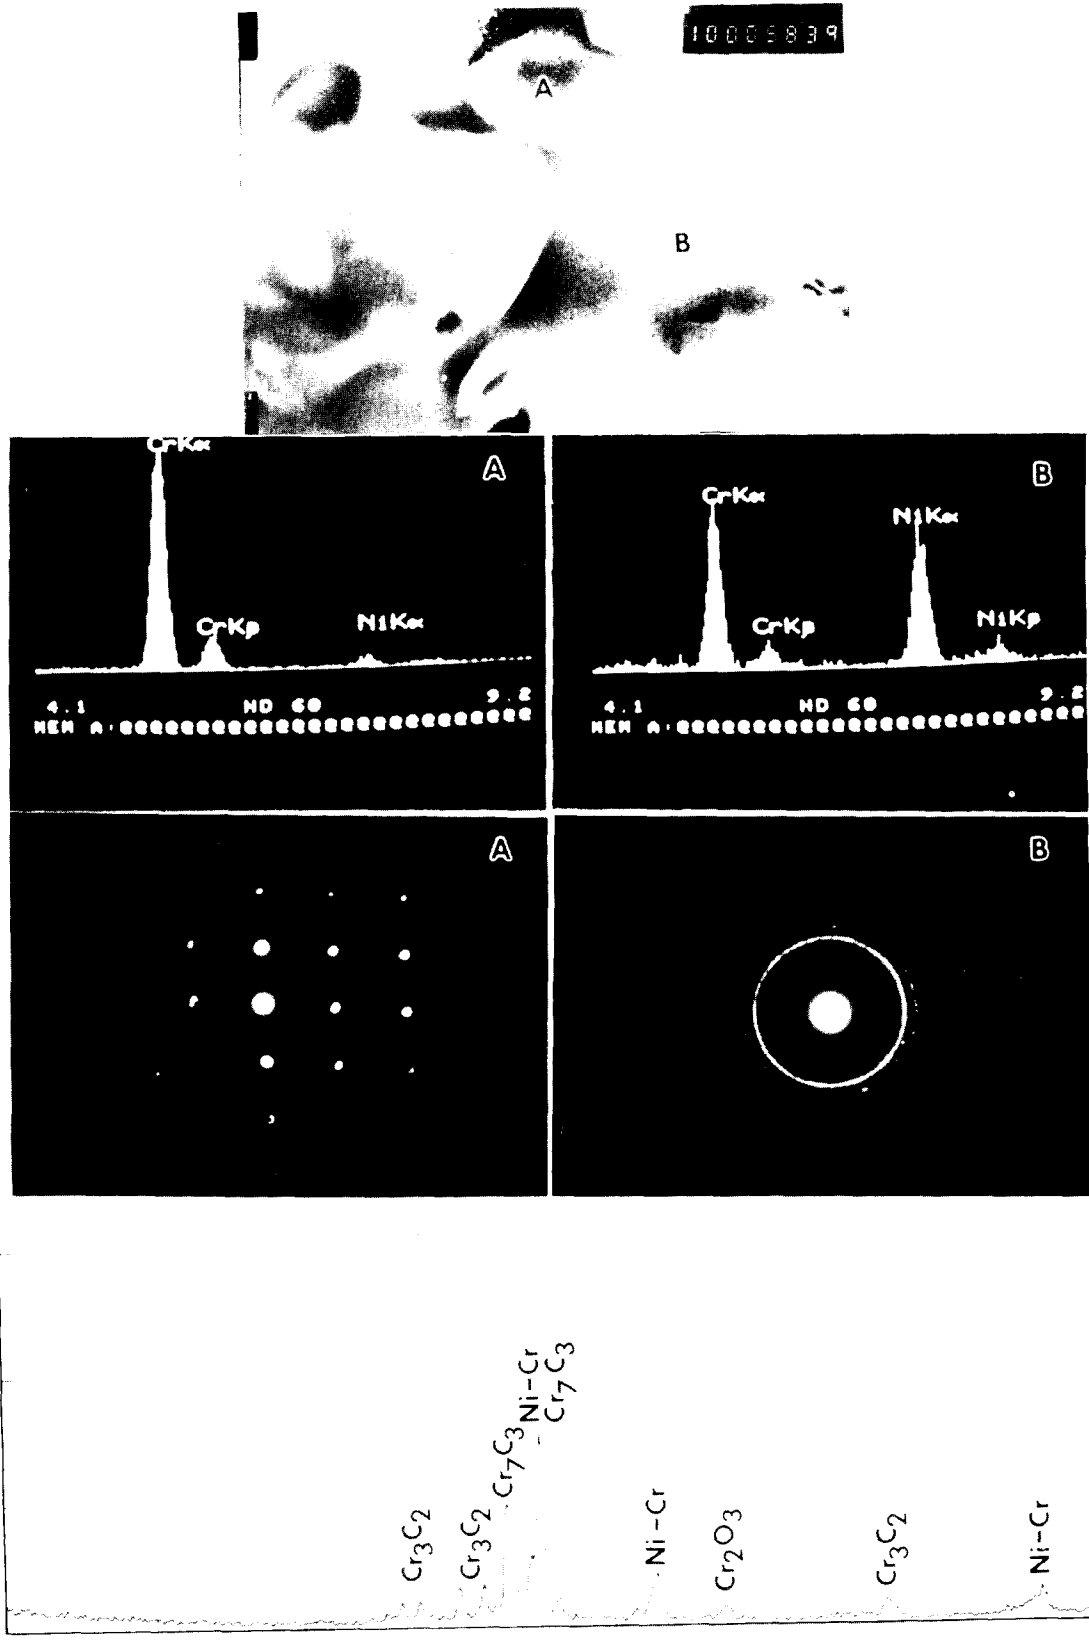
Fig. 5. Microstructure, SAD and XRD from the non-treated plasma coating

ing, as given in Fig. 5, show some of the unmelted Cr_3C_2 and glassy NiCr structures. The glassy structure, which was unexpected, was found only in the outer surface region of the coating. In the other regions near the interface, the originally formed glassy structure may have transformed to the crystal structure by the heat of the subsequent layers. Further, transformation of the Cr_3C_2 to Cr_7C_3 during solidification and cooling can also be noticed from XRD in the bottom of Fig. 5.

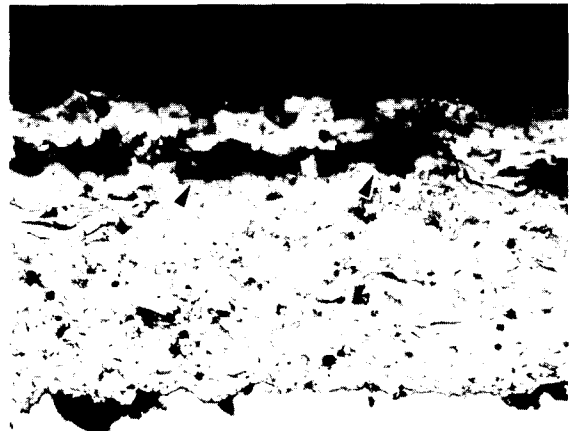
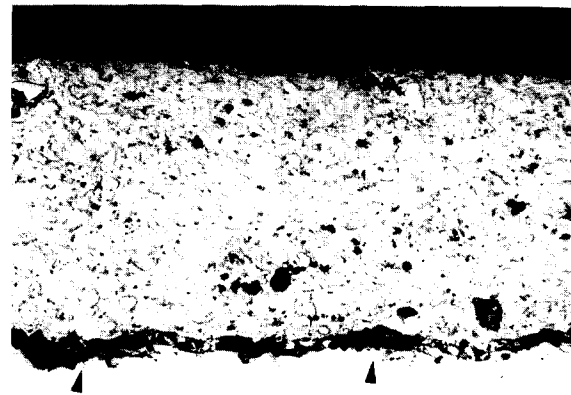
The pores and other discontinuities in the coating did not seem to exert detrimental influence on the corrosion resistance in the test. This may be due to a relatively short time exposure to the corrosive environment in the polarization test. Therefore, some selected samples were dipped in the 1N H_2SO_4 -3.5% NaCl solution for one month, and then the surface and cross-section were carefully examined to see if any corrosion damage had occurred. There was no detectable corrosion damage on the surface. However, as shown in Fig. 7, a severe corrosion penetration into the interlayer boundaries, which was found to be decorated by the pores and oxide films, and into the coating-substrate interface can be found from the cross-section. The corrosion penetration into the interlayer and interface may have played a critical role in debonding of the plasma coating layer during the operation of a turbine blade. A similar corrosion penetration in the plasma coating was also

Fig. 7. Corrosion penetration through pores/discontinuities into the interlayer(a) and the interface between substrate and coating(b).

found by other investigators.^{2, 3} Once the corrosion penetration has occurred along the interlayer, impacting dust and mist particles can easily spall the layer off. The measured bond strength after a corrosion test was as low as $1.2\text{kg}/\text{mm}^2$ which is significantly lower than that of the as-coated condition.

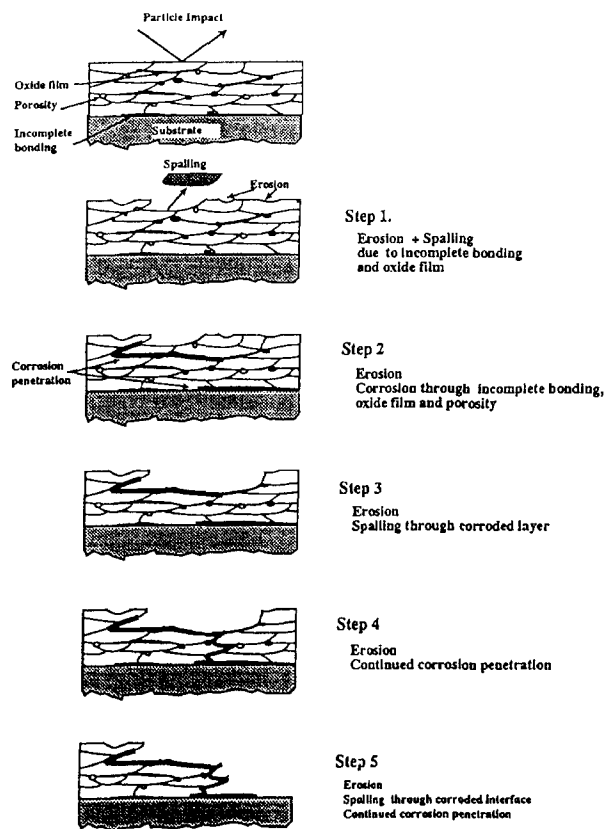
solid particle erosion, corrosion penetration and impact spalling. A proposed degradation sequence of the plasma coating is schematically shown in Fig. 9. Before the corrosion penetration decreases the interlayer bond strength, impacting particles erode the surface and detach some layers whose interboundaries are decorated with oxide films and pores, resulting in a low interlayer cohesive strength which will result in an accelerated spalling of the layers by the subsequent impacting particles. These repetitive actions of the erosion, corrosion penetration and spalling proceeds until the bare substrate is exposed to the severe erosive and corrosive environment. Therefore the plasma coating itself does not noticeably improve the campaign life of the blade in the currently considered environment.

Fig. 9. A postulated degradation sequence of the plasma coating.

Therefore, a possible way of extending the campaign life of the plasma coating is the reduction of the pores and oxides either by the careful control of the process parameter or by the consolidating (remelting and densification) of the coating. In the following section, the microstructural characteristics and properties of the laser consolidated layer are discussed.

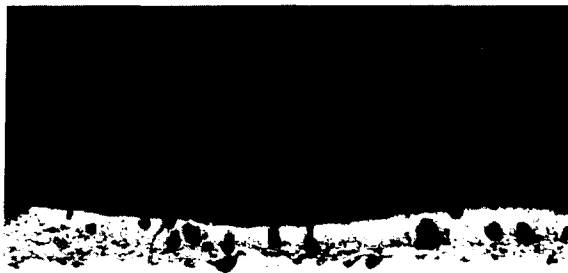
(b)

The cross-section of the layer, scanned with 4400mm/min, is shown in Fig. 13b. With this speed, only half thickness of the coating was remelted and thus there was no dilution with plasma coating and cracks appear to initiate from the large pores. The abrupt increase in the porosity is believed to be due to the agglomeration of the existing small pores in the plasma coating. Once pores agglomerate, these are entrapped in the melted region because of the rapid solidification rate. Therefore, the scan rate should be carefully controlled to ensure some amount of a dilution with the substrate.

Fig. 13. Variation of the areal fraction of pores as a function of scan rate(a) and cross section appearance of a layer(4400mm/min)(b)
