A Multidiscipline 35 kV Cable Failure Investigation

Abstract - Cable failure investigations must evaluate all facets of cable technology to reach a complete understanding of why and how an underground power cable failed. This paper presents the salient points of a recent investigation into an in-service failure after only several weeks of operation.

Several 35 kV, 500 mm² (1000 kcmil) cross-linked polyethylene, copper tape shield, PVC sheathed power cables feeding a new dc arc furnace at a Mexican industrial plant failed shortly after energization. The investigation followed a preliminary work plan and schedule that included a detailed analysis of cable manufacturing, installation, operation methods, failure events, power system topography, operation and power system protection. The work plan provided laboratory analysis to support all studies and conclusions. On site evaluations at both the cable manufacture facility and the industrial plant were carried out.

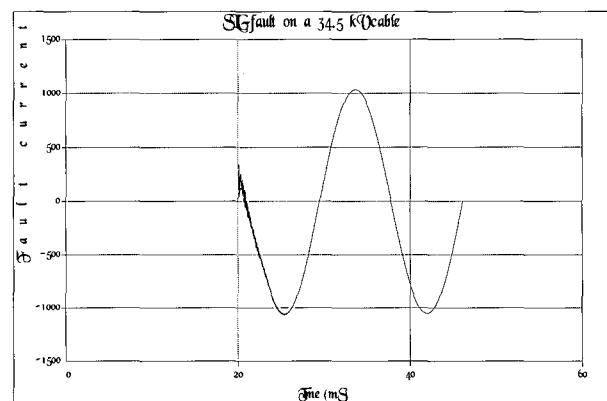
Fig. 1 shows the fault current for a single line to ground fault. The current shown is about 1100 A r.m.s. close to the 1200 A recorded during the actual incidence. Fig. 2 shows the voltages on phases B and C during the SLG fault on phase A. The voltage rise on the sound phases is 47 kVp, approximately the normal phase-to-phase voltage, 34.5 kV r.m.s.

Fig. 1 Closing onto a SLG fault. Fault current in phase A r.m.s.

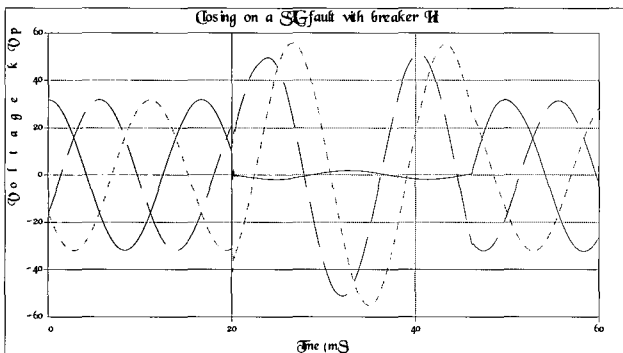
Fig. 2 Closing onto a SLG fault. Voltage rise on sound phases kV ph-g.

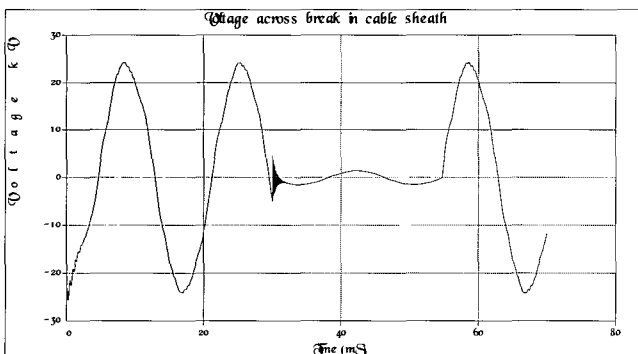
Fig. 3 shows the voltage stress across a discontinuity in the cable sheath (copper tape). This stress reaches the value of the phase-to-ground voltage across the gap in the tape. Depending on the length of the gap this would lead to arcing or tracking across the insulation and result eventually in insulation failure and a fault to ground.

Fig. 3 Voltage across gap in the shielding copper tape Sparkover followed by recovery

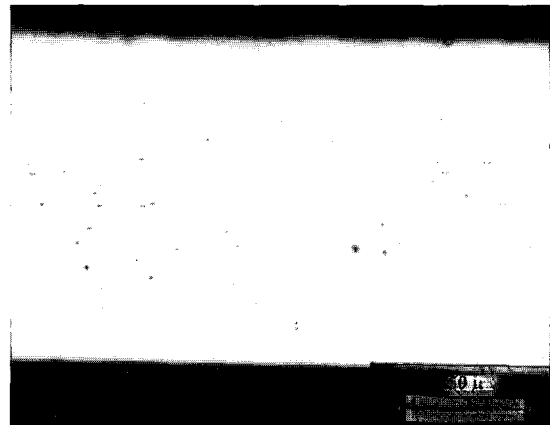
The first part of the metallurgical investigation assessed the copper tapes taken from a new cable (unused) from the manufacturer's plant (see Fig. 4). The second part assessed the integrity of the copper tapes taken from a failed cable (see Fig. 5).

in the material properties of the copper tapes. Fig. 5 shows the presence of tramp elements and oxide inclusions, while Fig. 4 is free of these contaminants.

Fig. 4 Microstructure of the edge of the copper tape taken from a new and unused cable.(Mag. 500X)

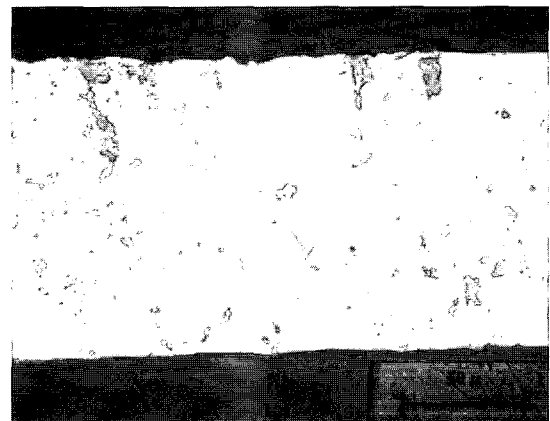
Fig. 5 Microstructure of the edge of copper tape sample showing tramp elements and oxide inclusions.(Mag. 500X)

- Tramp elements and oxide inclusions appeared at localized areas along the edge of the copper tape of the failed cable. These defects reduced the tape's tensile strength and elongation.
- Bending and pulling the cable through a sharp radius can easily wrinkle the copper tape of the failed cable. Certain parts of the cable can be exposed to an excess of 3000 lbs of load when the cable catches around the sharp bend. When the edge of the copper tape that contains the defect is caught in this way, the copper tape will fracture due to mechanical overload.

Hence, it is concluded that the fracture of the copper tape of the cable took place due to a combination of the defect on its edge and an abnormal bending operation. It appears that these two factors individually would not fracture the copper tape.
