Effect of Microstructure on Alternating Current-induced Damage in Cu Lines

Young-Bae Park^{1,2*}

Abstract: The effect of microstructure on alternating current-induced damage in 200 and 300 nm thick polycrystalline sputtered Cu lines on Si substrates has been investigated. Alternating currents were used to generate temperature cycles (with ranges from 100 to 300°C) and thermal strains (with ranges from 0.14 to 0.42%) in the Cu lines at a frequency of 10 kHz. Fatigue loading caused the development of severe surface roughness that was localized within individual grains which depends severely on grain orientations.

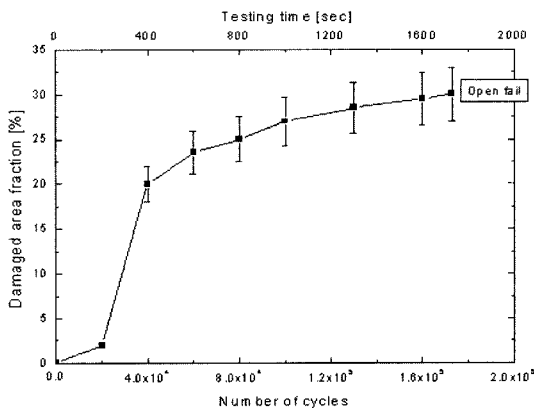
Fig. 3 showed the measured damaged area fraction (DAF) as the number of cycles where DAF was defined as total damaged area measured from high resolution field-emission SEM pictures of whole metal line divided by the whole metal line area. This *in-situ* SEM observation results showed that damages along the line evolved continuously with testing cycles until open failure. Damage growth rate is higher at early stage and then saturated at later stage

Fig. 3. Measured damaged area fraction (DAF) as the number of cycles where DAF was defined as total damaged area measured from high resolution field-emission SEM pictures of whole metal line divided by the whole metal line area.

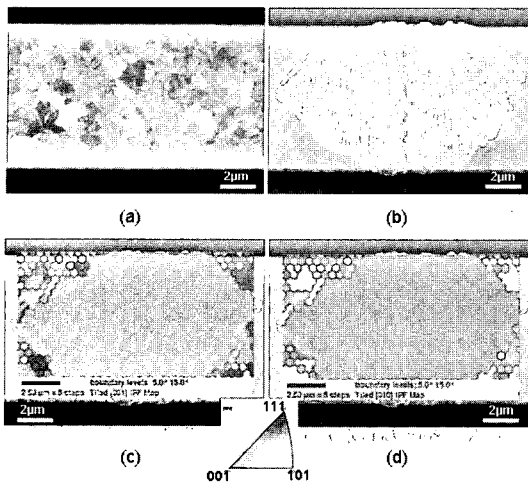
Fig. 5. Damaged (100) grain microstructure; (a) BSE image of the line before AC test, (b) SEM image, (c) EBSD map of out-of-plane orientation, and (d) EBSD map of in-plane transverse (line) orientation for a big damaged (100) grain after AC test at 10kHz frequency, $\Delta T = 190^\circ\text{C}$, and 7.5×10^5 cycles. Here, [001] and [010] directions marked in EBSD pictures corresponded to out-of-plane orientation and in-plane line orientation, respectively.

same as the untested Cu line (cf. Fig. 5(a)), as can be seen in Fig. 5(c). More cycles caused these long wrinkles break up into several sub-domains and rotate each other to the different orientations⁶⁾. While these shallow and uniform wrinkles were formed inside (100) grains, clear extrusions were located along grain boundaries and even outside the line edges to form faceted shape, as can be seen in Fig. 4(a) and 5. By the way, Fig 4(b) showed that different types of damage were observed mostly in (111) out-of-plane oriented grains where grain boundary grooving and deep thinning near grain and twin boundaries were dominantly observed. Compared to the damage morphologies in (100) grains like Fig. 4(a) and 5, wrinkles in (111) grains had rougher surface, wider spacing, relatively random orientations, and deeper thinned region, and seemed to transferred to the neighboring (111) grains. As the testing cycle numbers increased, surface roughness grew in amplitude, density, and size like Fig. 4(b). Later, crack propagation to the line width-direction, that is, normal to the line length-direction preferentially occurred through deep thinned paths inside heavily damaged regions, which eventually led to electrical open fail due to the localized resistance increases and so melting at the very end of the test.

There are three interesting points which are noteworthy to comment about damaged (100) grains shown in Fig. 4(a) and 5. At first, damaged (100) grain growth preferentially generated an orthogonal or faceted configuration of grain boundaries with the segments aligned in close 45° tilted from in-plane line direction. Secondly, boundaries of damaged (100) grains were always parallel to close (110) orientation which is also parallel to the slip trace direction of (111) plane in Cu (100) grain. Thirdly, the long, parallel, partially crosshatched, and evenly distributed wrinkles inside damaged (100) grains were preferentially arrayed in close (100) orientation which is not parallel to the slip trace orientation. The wrinkles inside grain boundaries which are tilted close 45° to the line length direction are close normal to the line length direction like Fig. 4(a) and 5 while the wrinkles inside grain boundaries which are tilted away from 45° to the line length direction are also declined around 15° from the line width direction, which consistently make wrinkles stay in (100) orientation like Fig. 5. Our preliminary transmission electron microscope (TEM) results¹⁰ showed that there were no typical dislocation structures similar as in bulk materials but individual dislocations, and segments of individual or tangled dislocations were arrayed along the same position with the wrinkles inside damaged (100) grains. The surface wrinkles in (100) grains seemed to be resulted from the dislocation interactions and possible dislocation dipoles annihilation¹⁰. This meant that extensive dislocation activity occurred inside (100) grains by the repetitive fatigue load during AC test and led to extruded wrinkle arrays at film surface which is similar with the mechanical fatigue damage of bulk metal⁸.
