## A Case Study on the Failure of Intake and Exhaust Valves for Marine Diesel Engines

Jong-Ho Kim<sup>†</sup>

It was stated by the shipmaster of a ship that while the ship was under sea trial after completion of overhauling main engines, the intake and exhaust valves, the cylinder head, the piston and the push rods for A2 cylinder of No.1 main

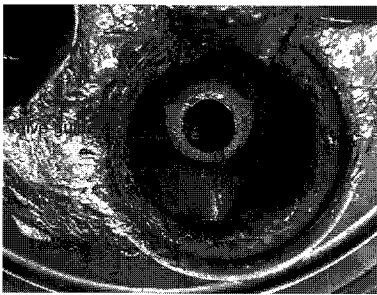
Fig. 1 Detail of No. 1 main engine A2 cylinder head

Fig. 1 shows the magnified view of the above cylinder head, and the tear of the valve guide was found to the direction marked as "I" in the figure.

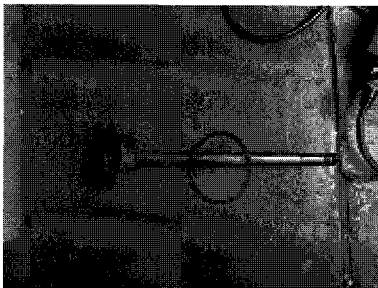
Fig. 2 A2 exhaust valve of No. 1 main engine

Fig. 2 presents the exhaust valve for the above cylinder head and the stick marks are revealed on the parts as indicated "O".

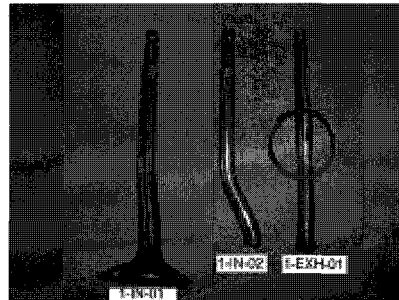
Fig. 3 The damaged valve of No. 1 main engine

Fig. 3 displays the damaged No.1 main engine valves. In this figure, the valve spindles of both intake valves were bent, and the valve heads of intake valve (1-IN-02) and exhaust valve(1-EXH-01) were fractured without deformation of valve spindles. The stick problem was not found on the valve spindle of both intake valves. However, the stuck part as marked "O" in the figure was found on the valve spindle of exhaust valve.

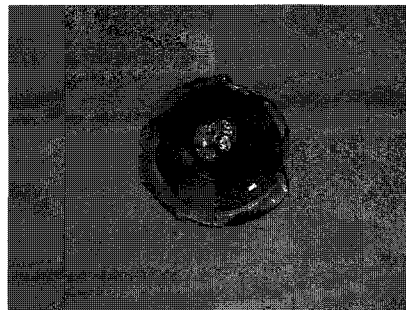
Fig. 4 The intake valve(1-IN-02) of No. 1 main engine

Fig. 4 presents the intake valve head (1-IN-02) which was found in the damaged

cylinder of No.1 main engine. As for this valve head, the plastic deformation is found but any mark of fatigue fracture is not observed.

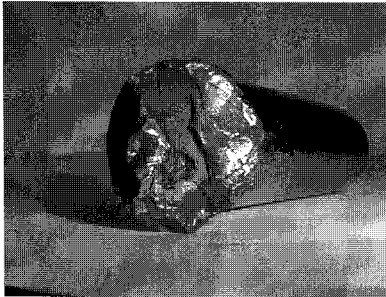
**Fig. 5 The Valve spindle of No. 1 main engine intake valve(1-IN-02)**

Fig. 5 presents the magnified view of the valve spindle of intake valve (1-IN-02). In this figure, the plastic deformation which was accompanied with change of diameter and sectional area and the mark of ductile fracture were observed.

As for one intake valve(1-IN-02) of which valve head was fractured, the fracture surface of it represents a typical ductile fracture and there is not any track of fatigue crack.

Therefore the intake valve has been fractured by the impact of foreign materials and subsequent load above yield strength of valve material and it shows no track of stick.

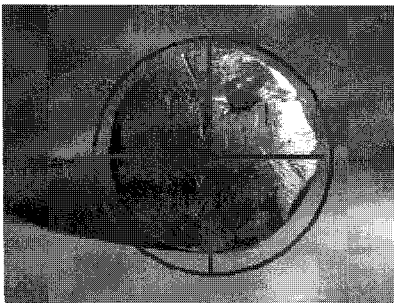
**Fig. 6 valve spindle of exhaust valve(1-EXH-01)**

Fig. 6 displays the magnified view and the sectional division of valve spindle of exhaust valve(1-EXH-01) for examining the fractured surface. As shown in Fig. 6, the valve spindle was flatly fractured without any change of diameter and sectional area. The above fracture is a

typical example of fatigue fracture which occurs when the material is subjected to cyclic loads below the yield strength.

- 1) As for the fractured exhaust valves(1-EXH-01), there is not any change in the diameter and the sectional area. Therefore, the valve has been subjected to the cyclic loads below the yield strength of valve material. The track of fatigue fracture by the above cyclic loads is revealed to the fractograph of the fractured valve spindle.

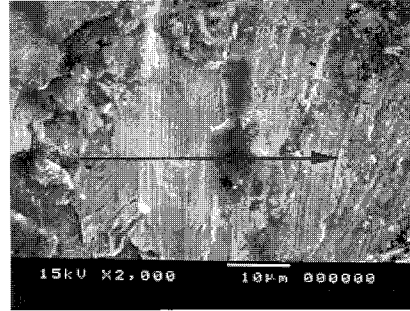
**Fig. 7 1-EXH-01, Division I**

Fig. 7-10 present SEM(Scanning Electro Microscope) fractograph of the valve spindle of exhaust valve(1-EXH-01) at 2,000magnification. Figs. 7-9 show striations which are a typical mark of fatigue fracture, and the propagation direction of fatigue crack is illustrated as arrow mark in the figures.

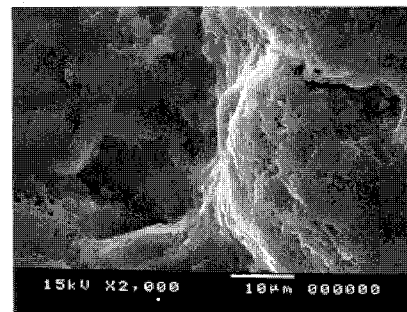
**Fig. 10 1-EXH-01, Division IV**

Fig. 10 shows a dimple which occurred at final stage of fatigue crack propagation.

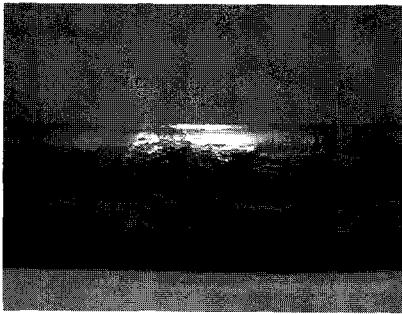
**Fig. 11 Exhaust valve(1-EXH-01) spindle**

Fig. 11 shows that the valve guide was fused into valve spindle due to the stick of valve spindle and valve guide. With a magnetic property test using the magnet, it is found that the valve guide is magnetic material and the exhaust valve spindle is non magnetic material, and hence the fused material on the valve spindle is originated from the valve guide.

According to the test results of chemical composition and micro structure of valve guide the material is ascertained to be gray cast iron classified as KS D 4301.
