# The Effects of Remedial Works to Control the Leakage Problem in Earth Fill Dam by Compaction Grouting

## 콤팩션 그라우팅에 의한 흙댐의 누수복원 공사효과 분석

The sinkhole and leakage in dam core were detected at one of earth fill dams in Korea. The damage areas in the core of the dam were repaired by compaction grouting method. This study is to evaluate compaction grouting activity by in-situ and laboratory experiments before, during and after the remedial work. The intensive site investigation and geophysical survey were conducted during and after the compaction grouting work. The compaction grouting work was carried out for the damaged dam core between June 16 and August 24, 2000. The leakage reduction generally occurred in the core of the dam after the remedial work. The use of compaction grouting was considered the proper countermeasures for repairing the damaged dam. It shows that the loose or voided zones have been properly filled and the leakage has been reduced by about 96% of that before the treatment of the remedial work performed at dam core by compaction grouting.

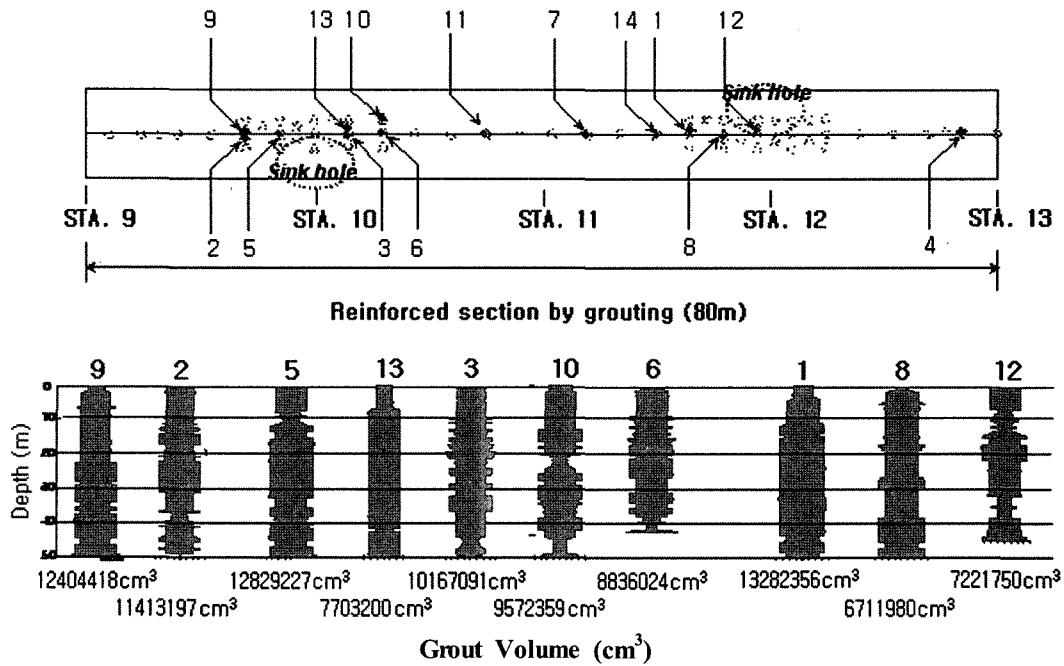
Fig. 4. The order and volume of compaction grouting works

Based on the logging data for the actual injected pressure and dosage, the core condition prior to the grouting activity was implied. The compaction grouting for the weakest regions was conducted at Sta. No. 10 and Sta. No. 12 from May 18 to August 24, 2000 (Korea Water Resources Corporation, 2000; Lim et al., 2004). A dry drilling method for the best application of compaction grouting was used. The compaction grouting was conducted in advance for every 0.3m from the bottom of excavation. It was reported that the grouting activity continued until the designed injection pressure-dosage. The injection pressure and slurry amount were automatically measured and recorded. It was speculated that the point in which a large amount of slurry was injected would be loose; it thus means the risky points in terms of stability. The grouting injection analysis on the pressure and dosage was intensively conducted through many sections of the dam core. Figure 4 demonstrates the order of drilling borehole and grouting works to confirm the grouting effects. The compaction grouting was applied at the distance of 80 m around Sta. No.10 and 12 as shown in Figure 4. The number means the order of compaction grouting works and the unit of cubic cm ( $\text{cm}^3$ ) at the lower figure means the injected grouting volume.

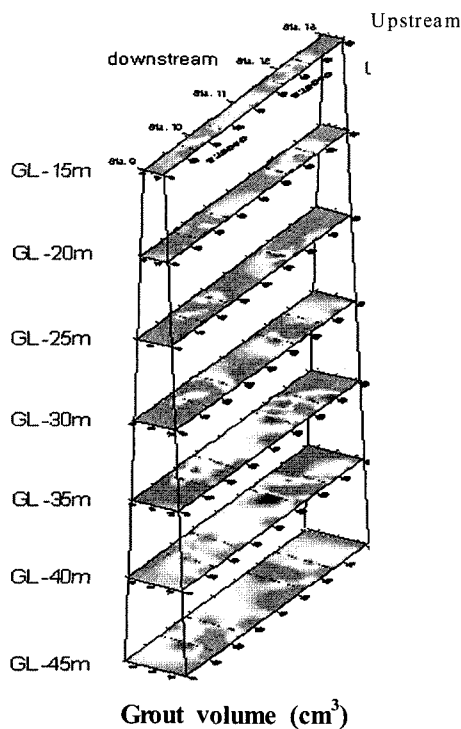
Fig. 5. Injection of the compaction grouting

Figure 5 presents the injected amount results through the dam axial section and the depth with repaired distance of 80 m. In the contours, it can be known that a large amount of grouts was injected at 20~30 m distance around Sta. No. 10 and Sta. No. 12. Namely,

it seems that there was a possible symptom of relatively loose condition before remedial work in this section. This figure shows the distribution of dam core injection amount by depth and the station where it was reinforced near Sta. No. 10 and Sta. No. 12 preponderantly is indicated with dotted line square. The regions of loose state resulted in transporting of the injected grouting slurry that is recognized by the injected slurry with a pigment.

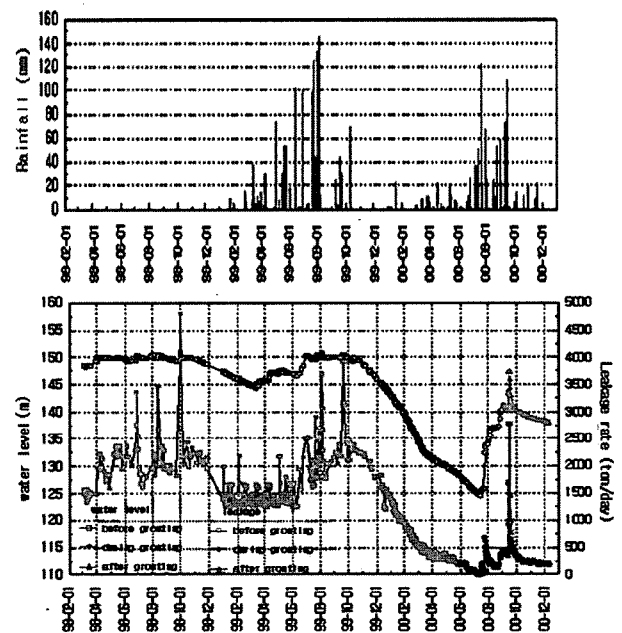
Fig. 7. Changing patterns on water level-leakage-rainfall with time

The dam construction was completed in July 1993. The leakage detection devices were installed in December 1997. The leakage was firstly detected in February, 1998 (Korea Water Resources Corporation, 2000; Lim et al., 2004). The average leakage before the grouting indicated about 3,240 ton/day at maximum reservoir water level. Figure 7 shows reservoir water level, rainfall and leakage change with time. The reservoir water level and leakage increased through heavy rainfall seasons and decreased through light rainfall seasons. But it was revealed that there was no significant increase of leakage after grouting application in June, 2000.

As shown in Figure 7, the leakage substantially increased after the completion of dam construction and during dam operation before the remedial work. Furthermore, it was observed that the leakage significantly increased when the reservoir water level was higher than 145 m. It is possible that rainfall and poor dam materials can cause the leakage increase. However, the detected leakage was not significantly dependent on rainfall events as shown in Figure 10. Figure 10 shows the relationships between leakage and water level which eliminated the record during 5 days after rainfall. The regression line can be expressed as  $y = 10.433 \ln(x) + 69.467$  ( $R^2 = 0.9147$ ). Figure 11 represents the correlations of leakage - water level with low water level and high water level. The values of measured leakage did not show great difference one another and over allowable leakage in the cases of

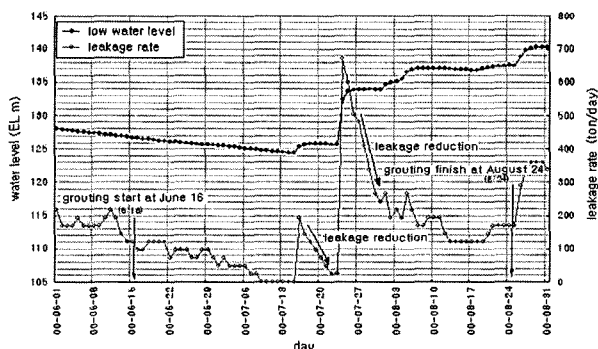
Fig. 8. The reservoir and leakage change during grouting

The leakage through the dam was measured and analyzed in order to evaluate compaction grouting effect during the remedial work. Figure 8 presents the reservoir water level and leakage change during the repairing periods by compacting grouting. The compaction grouting

initiated on June 16, 2000. The leakage was significantly reduced as shown in this figure 8. The leakage increase on July 16 and 23, 2000 resulted from the heavy rainfall of the dam areas. Although the reservoir water level increased, the leakage tended to decrease. Figure 9 demonstrates leakage reduction during the compaction grouting works. The compaction grouting effectively worked against the leakage through the dam. The areas

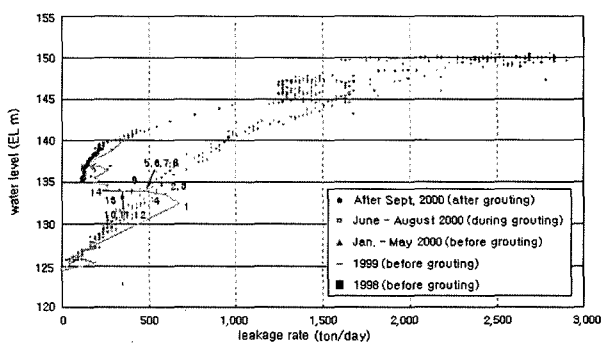
Fig. 9. Leakage reduction during the grouting activity

around Sta. No. 10 and 12 were the weakest regions in this earth fill dam. The leakage decreased to approximately 300 ton/day after the remedial work as well. This leakage of 300 ton/day after the remedial work corresponds to about 10 percents of the maximum leakage of 3,240 ton/day before the remedial work.

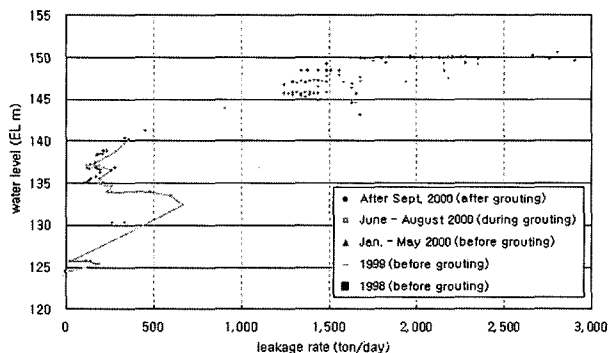
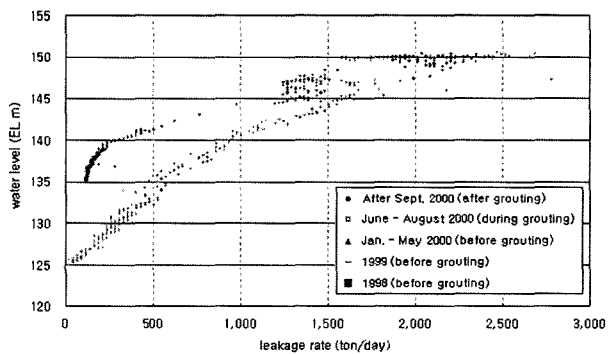
Fig. 11. The relationships between water level and leakage quantity with water level rise and drop

water level rise and water level drop. Thus, the difference of water level does not significantly affect on the rapid increase of leakage rate.

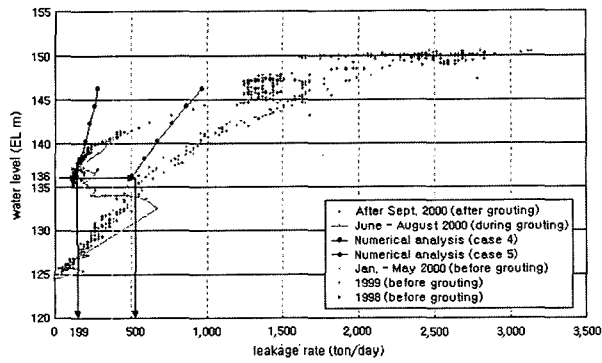
Fig. 12. Comparison of water level and leakage amount (simulated result versus measured result)

Seepage through the dam was simulated using SEEP/W developed by Geo-Slope Co., Canada to investigate whether influx water 3,000 ton/day can seep through the dam or not. As a result of seepage analysis, the estimated seepage value was 807 ton/day at reservoir water level of 138.5 m that was similar to measured leakage at down stream of the dam. The calculated permeability was

$1.1 \times 10^{-4}$  cm/sec which was not appropriate as core material in an earth fill dam. The measured leakage through dam body is greatly higher than the simulated leakage using SEEP/W software by comparing seepage analysis result with measured result during grouting works as shown in Figure 12. Therefore, it is known that the poor dam body alone did not cause the measured leakage. There should be water influx from another pathway.

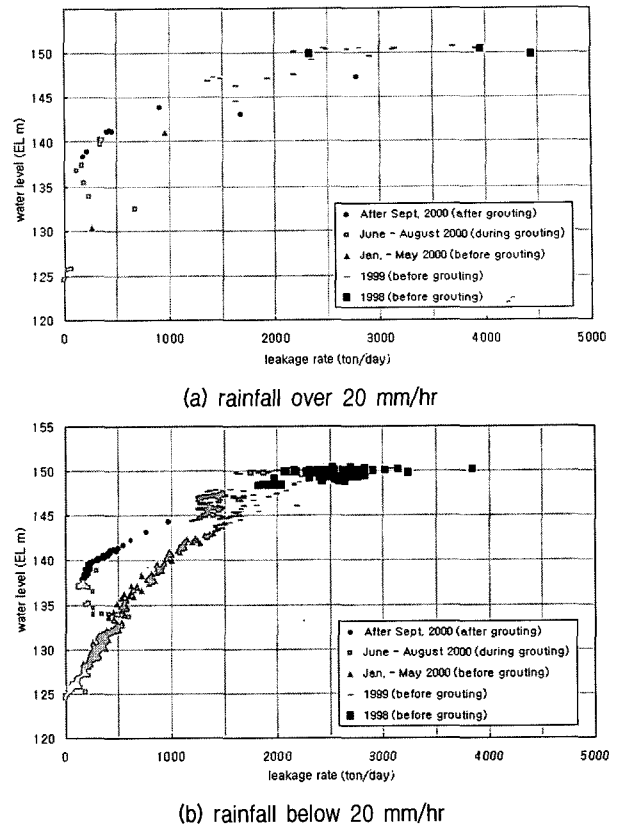
Fig. 13. The relationships between water level and leakage considering rainfall over and below 20 mm/hr

Figure 13 demonstrates the relationships between water level and leakage with rainfall intensity difference of 20 mm over and below. The values measured leakage do not show great difference one another and over the allowable leakage in the case of rainfall over 20 mm and rainfall below 20 mm. Thus, it can be suggested that the difference of rainfall does not have significant effect on the rapid increase of leakage rate.

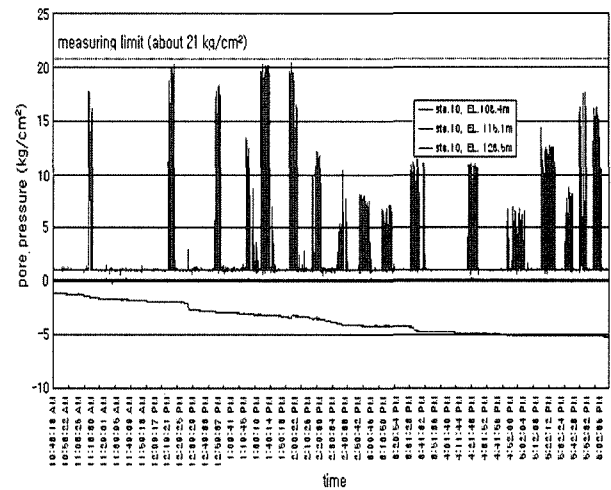
Fig. 16. Pore pressure change of 9-6d point during grout injection (July 4<sup>th</sup> 2000, low water level (125.25 m))

The pore pressure measured at EL. 108.4 m significantly increased due to the grouting pressure. The compacting grouting broadly influenced on the dam and caused an increase in the pore pressure. The pore pressure significantly increased from  $2.4 \text{ kg/cm}^2$  to  $16 \text{ kg/cm}^2$  due

to the influence of grouting pressure. Particularly, the pore pressure increased at borehole 9-6d to 21 kg/cm<sup>2</sup> which is the limit of the pore pressure device. It was considered that the increment of pore pressure could affect the deformation of dam, but this phenomena did not affect the development of dam deformation by measuring data of dam deformation. Thus, the pore pressure measured at high and middle elevation in dam did not increase due to grouting pressure dissipation, but the pore pressure measured at low elevation in dam increased due to grouting pressure confinement.

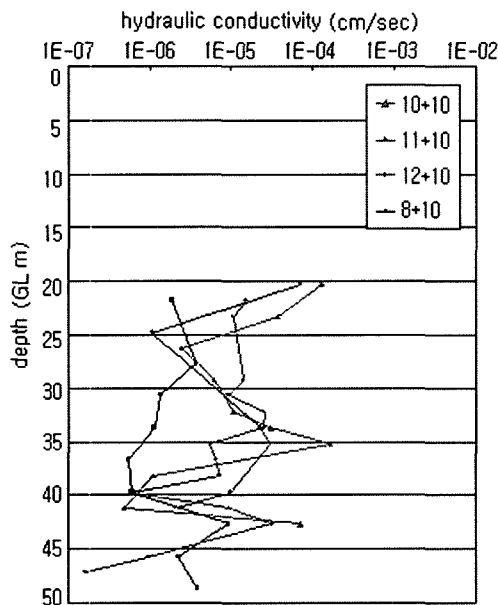
Fig. 18. In-situ permeability of dam core before the grouting activity

According to the in-situ monitoring, a large amount of water influx to the borehole appeared at around 20 and 40 m deep. The high permeability regions appeared at 20 m and 35 m deep according to the predicted per-

meability distribution before the grouting work. As a result of the investigation, seepage would occur in the certain portion of the core. The in-situ water content and plasticity at the point with influx water was higher than the point in which there was not any water influx. The plastic index (PI) was slightly higher than the PI value of 10. Based on the Unified Soil Classification System (USCS), most of the core materials were classified as SC and CL soils. The GC soils were recognized at depth 30 to 40 m. The in-situ permeability tests based on a recovery method were conducted through the water influx areas of the dams (Korea Infrastructure Safety and Technology Corporation, 2005). Figure 18 shows that in-situ permeability of the dam core materials before the compaction grouting. This figure represents the range of in-situ permeability of  $10^{-4} \sim 10^{-6}$  cm/sec and the average in-situ permeability of  $10^{-5}$  cm/sec.

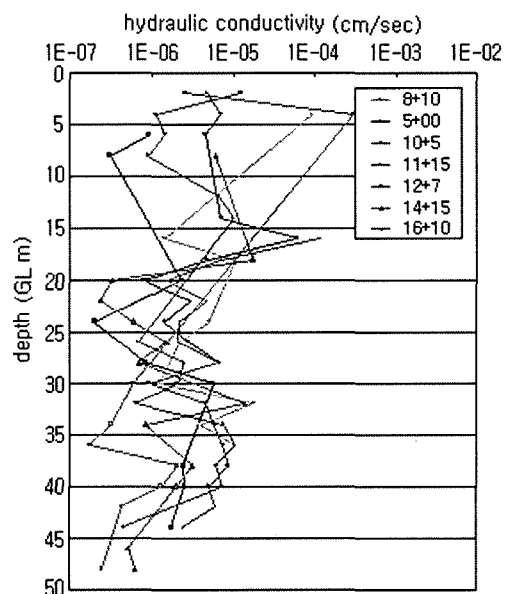
Fig. 19. In-situ permeability of dam core after the grouting activity

Figure 19 shows that in-situ permeability of the dam core materials after the compaction grouting. This figure represents that the range of in-situ permeability is  $10^{-5} \sim 10^{-7}$  cm/sec and the average in-situ permeability is  $10^{-6}$  cm/sec. In comparison with permeability prior to the remedial activity, the measured in-situ permeability after the compaction grouting decreased to 10 orders of magnitude. However, groundwater level significantly increased to 14 m after water influx around 35 m during drilling the borehole of Sta. No. 11+15 in spite of conducting a recovery test. Therefore, it was speculated

that seepage through the high permeable areas within the dam might exist through the dam core.
