Journal of the Korean Society for Nondestructive Testing Vol. 26, No. 6 (2006, 12)

## Detection of Second-Layer Corrosion in Aging Aircraft Fuselage

Nohyu Kim\*, and J. D. Achenbach\*\*

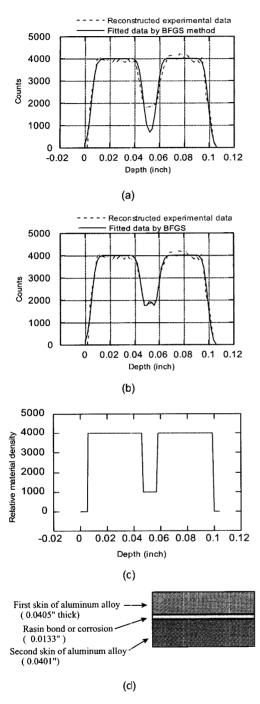
The dotted line in Fig. 5(a) is a reconstructed scan obtained from region A, where only two aluminum sheets appear, but between them exists a low density material which may be a bonding resin or a corrosion product. The solid line in Fig. 5(a) represents the curve-fitting result of a reconstructed image(dotted line) using the BFGS method when an air gap is assumed to exist between the two aluminum skins. The curvefitting is quite good except in the region of low density material between the two aluminum layers. The big difference between the two curves in that region means that the assumption is wrong, i.e. the valley in Fig. 5(a) is not an air gap but something else with low density. In Fig. 5(b) where a low density material is assumed between the two skins, the reconstructed image (dotted line) very well fits over the whole range. Therefore, it may be concluded that the low density material is a resin bond or a corrosion product trapped between the skins, or both of them. Through deconvolution using the BFGS method, the thickness of each layer has been calculated. The results are displayed in Fig. 5(c) and 5(d). Fig. 6 is another scan taken at the

Fig. 5 Reconstruction and deconvolution of scan data in region A: (a) reconstructed data and curve-fitted data by BFGS method when the second layer is assumed to be an air gap; (b) reconstructed data and curve-fitted data by BFGS method when the second layer is assumed as a low density material; (c) restored data; (d) thickness of layers

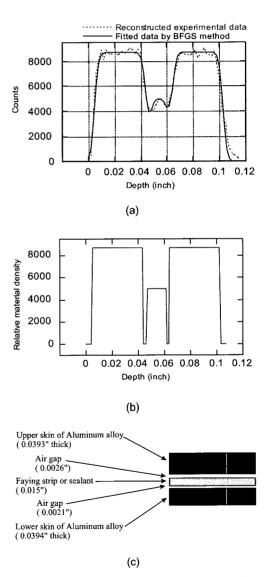
region A with a faying strip or sealant between the two aluminum skins. In Fig. 6(b) and 6(c), there are clear disbonds between the aluminum skin and the faying layer which strongly imply the development of corrosion inside the gap. The back surface of the lower aluminum skin seems to be painted because the slope of the dotted curve at the back surface in Fig. 6(a) is a little bit lower than that of the curve-fitted line (solid).

Fig. 6 Restoration and deconvolution of X-ray scan data from a lap-joint in region A: (a) reconstructed data and curve-fitted data by BFGS method; (b) deconvolved data; (c) thickness of layers

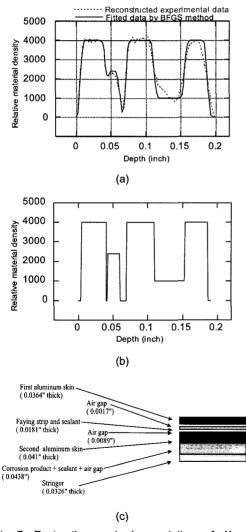
The scans in Fig. 7 and 8 were conducted in the region B where three layers were detected. A faying strip and a sealant between the first and the second skin in Fig. 7 is totally detached from both skins leaving a wide air gap which probably indicates the presence of corrosion. The rear surface of the second skin is very irregular which is caused by severe exfoliative corrosion of the surface. It appears in Fig. 7(a) as a very low density material. The third layer is a stringer that seems to be covered with a thick layer of paint

on the back surface because the slope of the rear surface is lower than the curve-fitted slope(solid line). The front side of the stringer has also a low slope, which means that it is either corroded or painted. It measured only 0.0326" in thickness. Examination within the plane showed that the stringer was indeed this thick at points near where the scan was taken. The last scan from region B is shown in Fig. 8, where apparently two air gaps exist between the layers. The thicknesses of the layers are displayed in Fig. 8(c).

Fig. 7 Restoration and deconvolution of X-ray scan data from a corroded lap-joint in region B: (a) reconstructed data and curve-fitted data by BFGS method; (b) deconvolved data; (c) thickness of layers

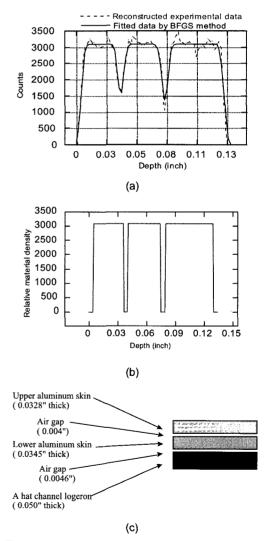
Fig. 8 Restoration and deconvolution of X-ray scan data from a relatively sound lap-joint in region B: (a) reconstructed data and curve fitted data by BFGS method; (b) deconvolved data; (c) thickness of layers
