A Study on Interaction Behaviors of Soil-PET Mat installed on Dredged Soils

연약한 준설향토상 매립시 포설된 PET 매트와 지반거동에 관한 연구

Lee, Man-Soo¹ 이 만 수
Jee, Sung-Hyun² 지 성 현
Yang, Tae-Seon³ 양 태 선

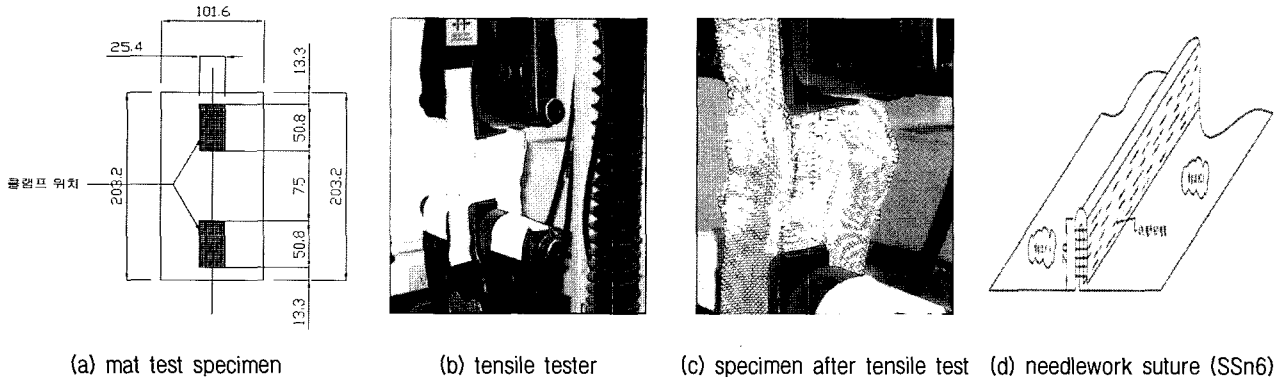
Fig. 12. PET mat tensile test (15t) and 'J'-type field needlework suture

Polyester mat (tensile strength 15 ton) used in pilot trial was tested by KS K 0210, 0530, 0743, whose tensile strength is 470.6 kgf (cross machine direction, tensile strain 20%). Fig. 12 (a) shows specimen of Grab method

and dimension of clamp. Fig. 12 (b) shows tensile test shapes, and Fig. 12 (b) shows ruptured features of specimen when strain was concentrated on clamp after tensile test finishes. PET mats were set up in a banking direction with overlapped needlework suture (J-SSn6) in field.

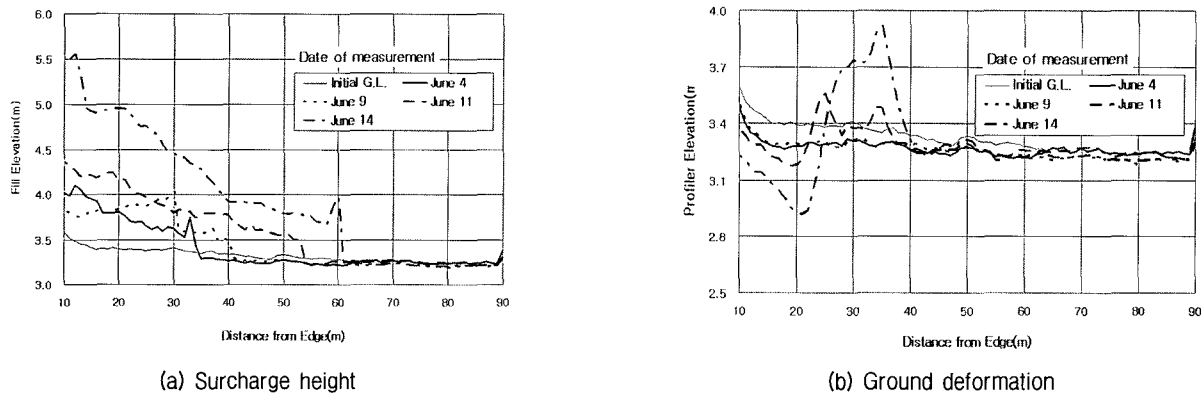
Fig. 13. Surcharge height and ground deformation measured by profile gauge (Line 1)

Figs. 13 (a) and (b) show behaviors of embankment thickness and lower ground layer measured by profile

gauge from surcharge start to June 14. While banking progressed uniformly by designed thickness at initial time of embankment, the management of equipment did not match the supply the of banking materials after banking duration of 10 days. Finally height at start point of embankment increased by 2 m. On June 14, banking

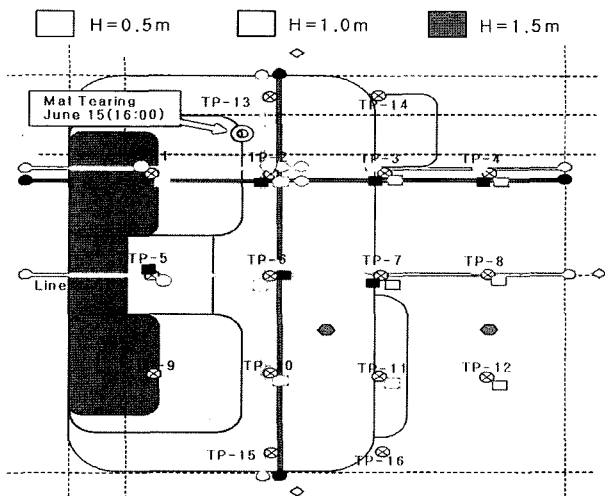
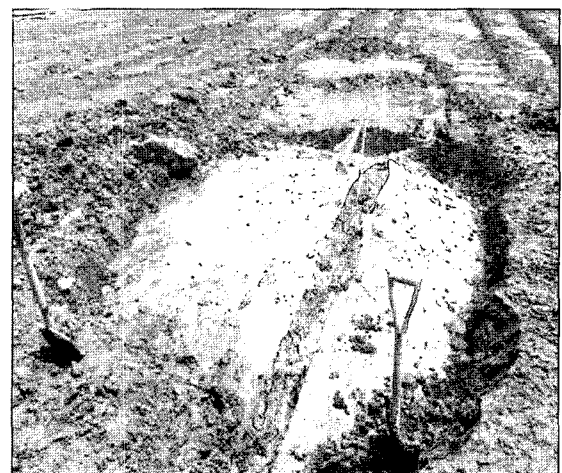
has rapidly performed to 20 m at that point. Large heaving took place after one day at TP-2. It is judged that considering ground height, mat was ruptured for heaving. So, construction was stopped to remove and investigate embankment soil. From the center heaved, the seamed part of mat has torn and got wider by about 15 cm, then

(a) Location of shear rupture (b) Photograph of torn PET mat
Fig. 14. Torn mat while construction after ground heaving (2004 June 15 (surcharge duration=9days))

reclaimed clay was displayed (Fig. 14).

Fig. 15 shows comparisons of surcharge height and ground deformation measured by profile gauge while banking was progressed for 7days from June 9. About 1 m thick banking at start point of embankment on June 11 caused irregular settlement and heaving at the front of 50 cm banking. It is judged that on June 14, dumping was progressed thicker than design height of about 22 m thick inducing ground deformation of about 1 m heaved at the sector of 50 cm banking thickness. Finally on June 15 shear failure happened. On June 15, nearly damaged mat was excavated, and banked again with the width of 1 m after PET mat was installed with overlapping.

Main causes of polyester mats, which were torn at suture parts, come from field overlapped needlework suture that did not confirm suture strength. Indoor overlapped needlework suture in Fig. 23 would be used. When it comes to the same polyester mat used in pilot trial, applied load is 504.9 ksf larger than tensile strength.

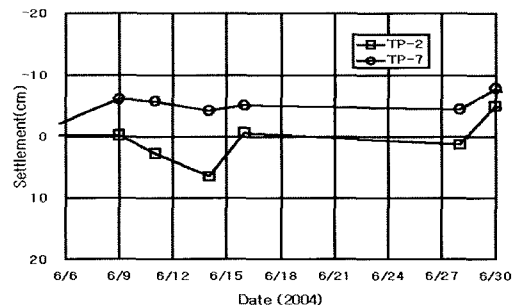
Fig. 17. Results of settlement plate

groundwater level at each location kept constant even for 2days (from June 14 to June 15) when rupture happened. Fig. 17 shows results of surface settlement plate at 2 locations: the one is at TP-2 where failure happened, another is TP-7 where rupture did not happen. At TP-2, heaving of about 10 cm was monitored just on the day shear failure took place, but, at TP-7 it did not happen, settlement kept constant.

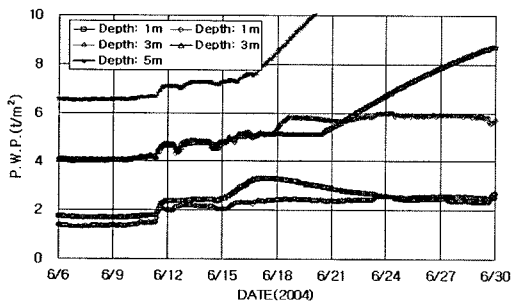
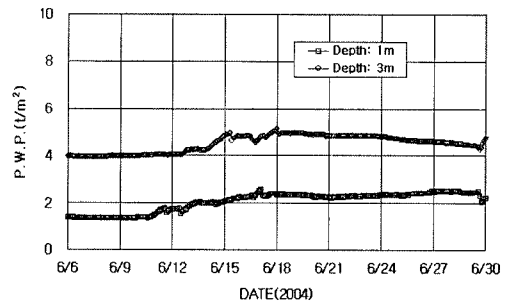
Fig. 18. Changes of pore pressure at 1 m, 3 m, 5 m depth of TP-2 and TP-7 location

Fig. 18 shows results of pore pressure measured from underground depth of 1 m, 3 m, 5 m at TP-2 and TP-7. While observing changes of pore pressure from June 14 to June 15, rupture may happen. At TP-2, pore pressure value increased very insecurely. Pore pressure at the depth of 5 m at TP-2 increased sharply. It is judged that the unsettled increase of pore pressure from June 14 to June

15 was converted to be stable and decreased slowly after June 16 embankment was recontrolled. Even at TP-7, the pressure finally kept to be 0.5 t/m^2 which is induced from surcharge.

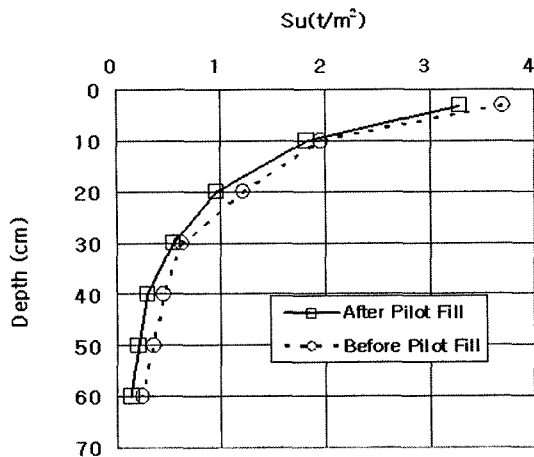
Fig. 22. Shear strength of dry desiccated surface layer after banking completion

Fig. 22 describes the relationship between undrained shear strength and depth of dry desiccated surface layer after banking completion. When undrained shear strength of dry desiccated surface layer decreases after banking, it is judged by effects of disturbance that as embankments progressed, water content of dry desiccated surface layer,
