Field Application of an Ultrasonic Testing for Reconstructing CT Images of Wooden Columns^{*1}

Sang-Joon Lee^{*2†}, Chun-Young Park^{*2}, Kwang-Mo Kim^{*3}, and Jun-Jae Lee^{*2}

ABSTRACT

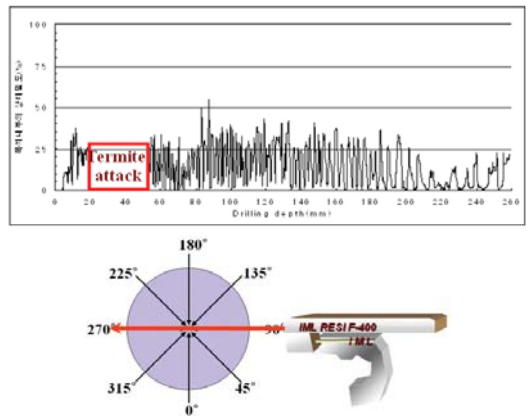
Fig. 3. Example of line distribution from the drilling resistance test.

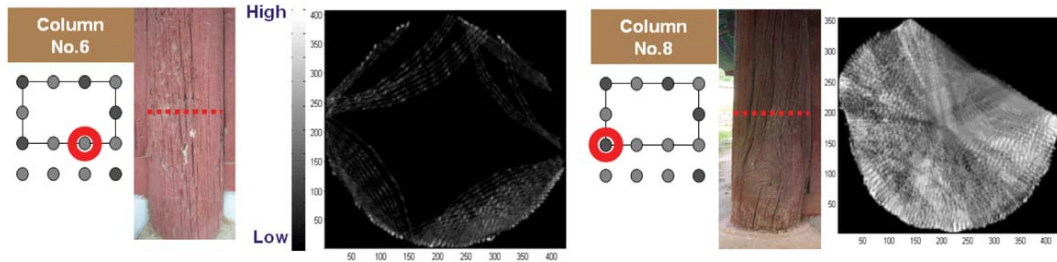
Fig. 4. Ultrasonic CT images of columns No. 6 and No. 8.

In the case of column No. 6, the determined ultrasonic TOF data was only 13% of the total data, while the out of range data was 66% and the inaccessible path data was 21%. The out of range data of 66% was the highest value observed. This high value is thought to be caused by the surface condition and an inner empty hole due to previous rough conservation work. The reconstructed CT image reflects this (Fig. 4), only with a small area of the visible outside and a severely distorted image. From the tested angles, the number of the measured TOF data tends to decrease as the angle increases; thus, in many cases, only the outside of the member was visualized, as for column No. 6. The CT image shows very severe damage of this column however, it is not possible to confirm the real inner status.

In contrast, a relatively reliable image was reconstructed for column No. 8. In the case of this column, the inaccessible path data was 56%, which is due to the additional facility in the building. This value is the highest one observed in this study, while the out of range data was only 3%. In spite of a large portion of buried parts, which makes the acquisition of data difficult, a reliable image was reconstructed us-

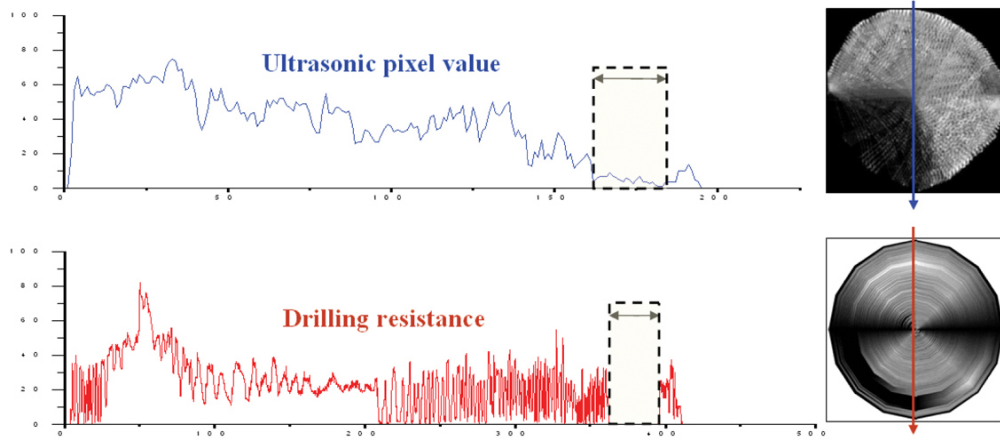
Technically, the most reliable data for evaluating the internal state of a tested column is thought to be the line distribution of the drilling resistance test, which is because the drill directly scans the density of wood. Even the annual ring due to the existence of earlywood and latewood can be identified (Fig. 5). In addition, an empty hole, where the resistance value drops to zero, was also identified. This defect was considered to be the termite attack, as termite attacks cause empty holes around the annual ring.

Based on the line distribution of the ultrasonic value, this defect was over-estimated and the pixel values did not perfectly drop to zero. Ultrasound cannot easily penetrate cavities; originally, this result was considered to be a reflection of the nature of ultrasound.

Fig. 5. Comparison of the ultrasonic and drilling resistance results (column No. 12).

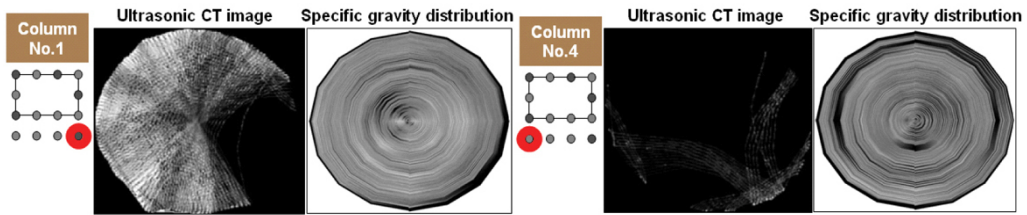
Fig. 6. Comparison of ultrasonic CT image and specific gravity distribution (Column No. 1, 4).

ured TOF data of column No. 1 was 51%, which is relatively high. The specific gravity distribution of column No. 1 (Fig. 6) derived from the drilling resistance test showed slight surface deterioration. However, this defect was over-estimated in the ultrasonic CT image, because the ultrasound is largely affected by the surface condition of the tested member. About one fourth of the area was identified as a defect.

Internal damage was well-reflected in the ultrasonic CT images, exemplified by column No. 4. A large area of deterioration around the annual ring was identified in the drilling resistance test, resulting most likely from a termite attack. The ultrasonic CT image also identified this defect, showing the column to be severely dam-

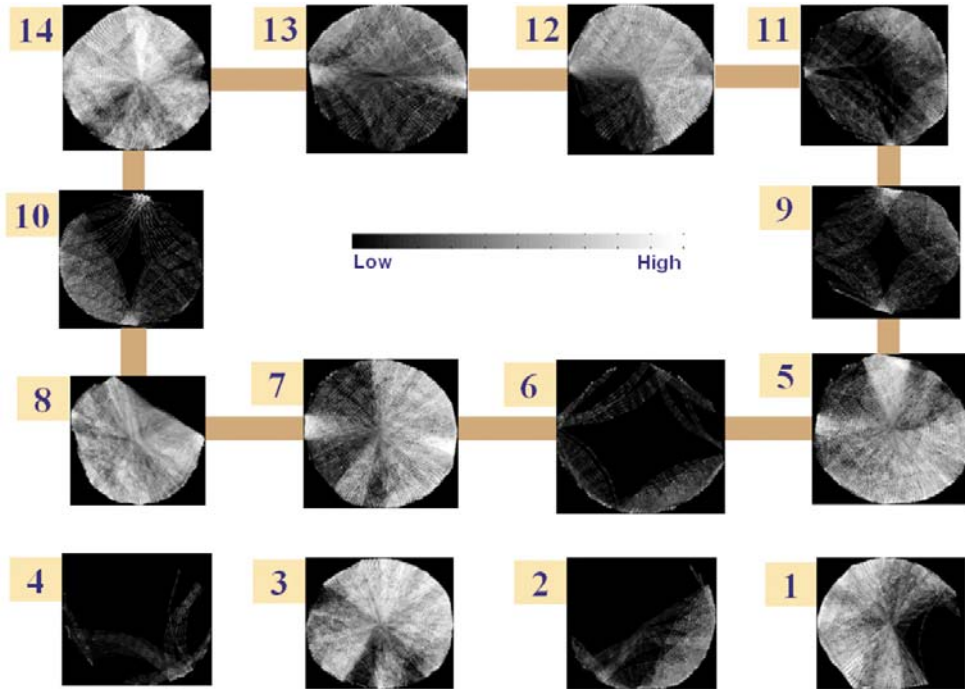
Fig. 7 shows the results of the ultrasonic tests derived from the above-mentioned methodology. Severe damage including inner and surface damages of columns made it difficult to analyze the actual internal states specially for columns 2, 4, 6, 9, 10, and 11. Most of these columns were severely damaged by termite attacks and the effects of weathering.

Fig. 7. Ultrasonic CT images of all columns tested in the shrine.
