## Investigation and Analysis of the Occurrence of Rail Head Checks

Ying JIN\*, Fusayoshi AOKI\*\*, Makoto ISHIDA\*, and Akira Namura\*

### Abstract

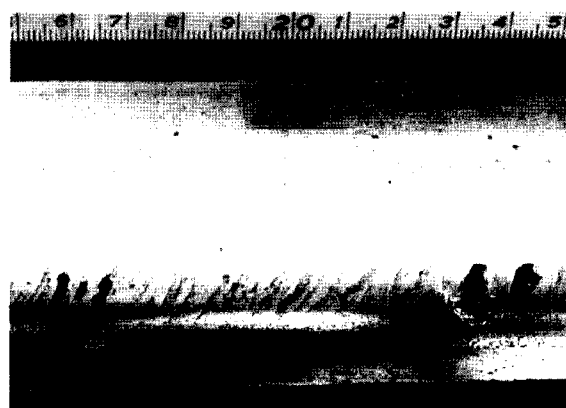
Head check is one of rolling contact fatigue (RCF) defects and consists of many small cracks located at the gauge corner of high rails of curved track. Those cracks occur continuously along the longitudinal direction of rails and grow against the running direction of rails. The head checks generally occur in mild circular curves and transition curves that are set at both ends of sharp circular curves. In Japanese railway, some cracks of head checks often grow up to the generation of rail spall as shown in Fig. 1, which may cause rolling noise and lead to rail break though only on rare occasions [1]. A number of serious accidents caused by RCF damage have happened abroad [2], accompanied with serious human and economic loss. Recently, the damage of head checks is remarkable according as railway vehicle runs with a higher velocity and its body trends to become lighter, then a lot of maintenance such as grinding and renewals of rails have been executed to refrain rolling noise and to avoid rail break [3-5]. It is well known that the cracks of RCF

Fig. 1 Rail Head Checks on Outer Rail

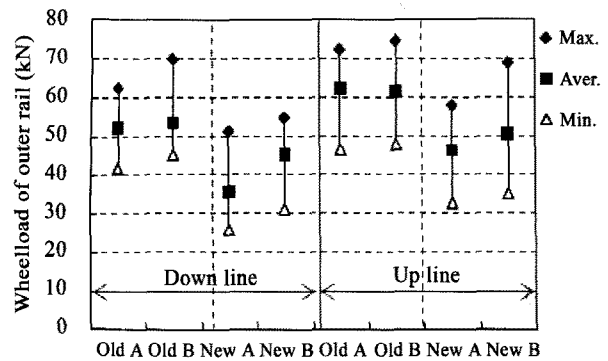
Fig. 2 shows the results of wheel loads measured at the dynamic test point. The maximum and minimum values of

**Fig. 2** Measured Results of Wheel Load

the wheel load were in the ranges of 50~75 kN and 25~50 kN respectively. Compared with the static wheel load shown in Table 1, it is apparent that the dynamic wheel loads are significantly larger than the static ones on the track. The results also exhibit that the dynamic load on the track of the up line is higher than that of the down line for the same type vehicle, and that the old type vehicles have larger dynamic wheel loads than the new type vehicles.

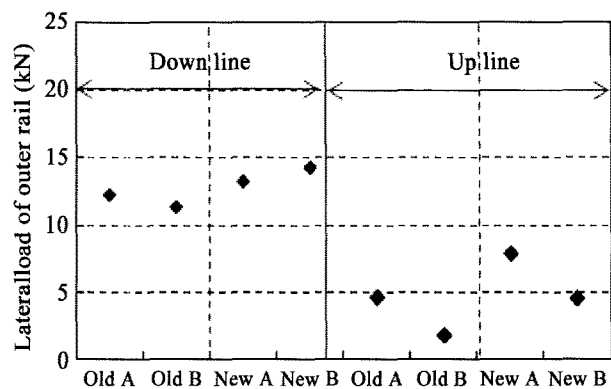
**Fig. 3** Measured Results of Maximum Lateral Force

Fig. 3 shows the measured results of maximum lateral forces. The maximum lateral forces were in the range of 10~15 kN on the track of the down line, and 2~7 kN on the track of the up line. These results represent that the track having head checks has larger lateral forces than the track without head checks. It is noticeable that the lateral forces caused by new type cars are larger than that caused by old type cars, although the new type cars tend to cause lighter dynamic wheel load in comparison with the old type cars.

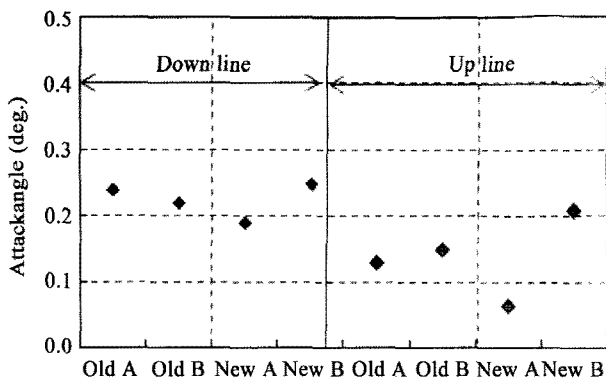
Fig. 4 indicates the maximum values of the angle of attack. The angles of attack at outer rail of up line having no head checks were in the range of 0.08~0.2 degree, while they were in the range of 0.2~0.25 at the outer rail of down line having head checks. This result means that the angle of attack is larger at the site of occurrence of head checks than at the site without occurrence of head

Fig. 4 Measured Results of Maximum Angle of Attack

check. The effect of different car types on the angle of attack is not clear from the measured results.

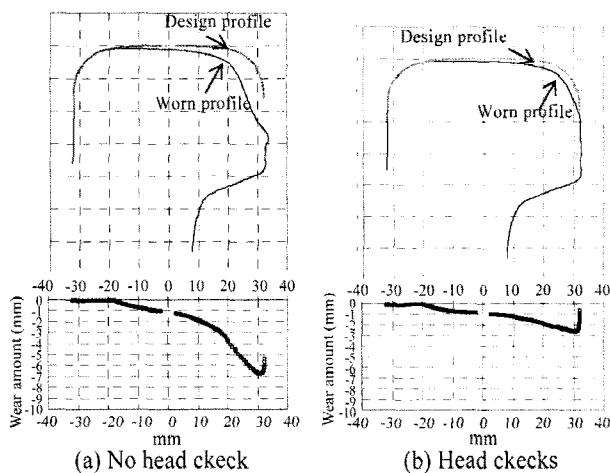
Fig. 5 Relationship of Head Checks and Wear Amount

Fig. 5 shows examples of worn profiles and wear amounts on the outer rail. The rail with a severe wear shown in Fig. 5(a) had no head check observed. However, Fig. 5(b) shows a moderated worn profile, where the cracks of head checks were observed.

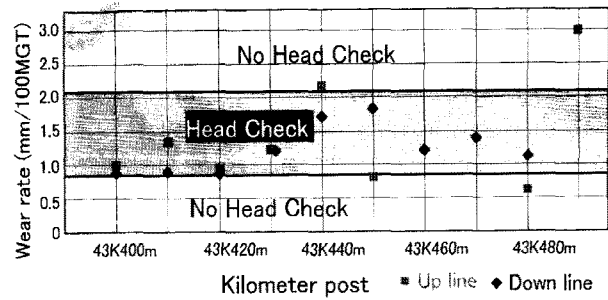
Fig. 6 Relationships of Head Checks and Wear Rate

Fig. 6 shows the relationship between rail gauge face wear rate (the ratio of wear amount and accumulated passing tonnage) and occurrence of head checks in the test sections of 100 meters. As shown in Fig. 6, a severe wear rate can restrain the formation of head checks, and an extremely low wear rate restrains the occurrence of head checks. It is evident that the

cracks of head checks occur easily in the range of wear rate of 0.9~1.8 mm/100 MGT, but there occur no cracks of head checks when the wear rate is lower or higher than the value aforementioned. This result suggests that the head checks only occur in some specific range of wear rate due to the interacting competition phenomena of wear progress and crack growth caused by wheel-rail interacting forces. Although the volume of measured data is not so much, a quantitative relationship between wear rate and growth of head check has been given for the heat-treated outer rail of the curved track with the radius of 800 m. Certainly, more surveys should be performed in other railway lines or for other rail materials

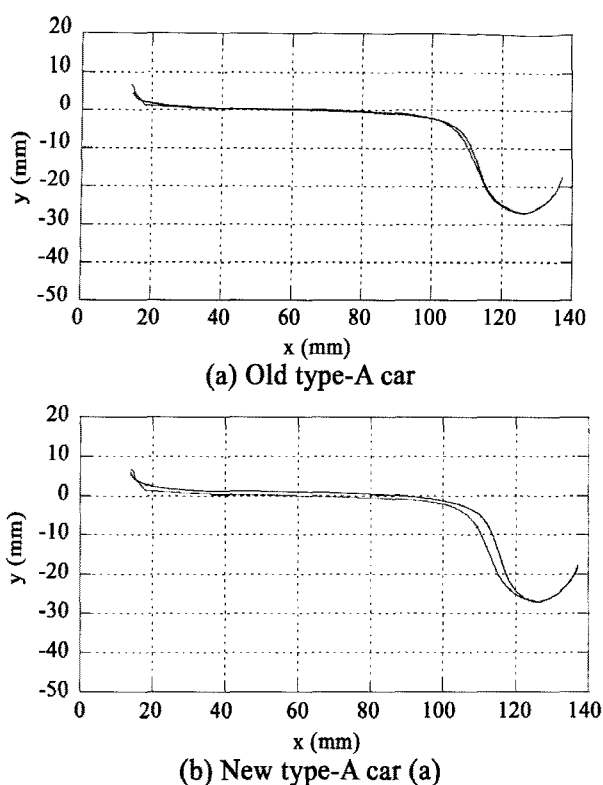
The worn profiles of wheels were measured for various vehicles passing the test sections. Fig. 7 shows two typical profiles of the worn wheels of new type-A car and old type-A car, after the running mileages of 0.18 million kilometres and 0.12 million kilometres respectively. In Fig. 7, the worn wheel of new type-A car indicates the flange wear of 2 mm after the running mileages of 0.18 million kilometres, but the worn wheel of old type-A car shows

Fig. 7 Wheel Worn Profiles of Various Vehicles

almost no obvious shape change compared to the design profile of the wheel. This may be because new type cars have larger lateral force than old type cars according to the measured results of dynamic testing. In addition, the worn profiles of eight wheels of new type-A cars of a given train were measured and compared with those of eight wheels the old type-A cars of another train to confirm the above. As the result, there is a common trend that the worn profiles of wheels of new type cars have much larger shape change than those of old type cars.

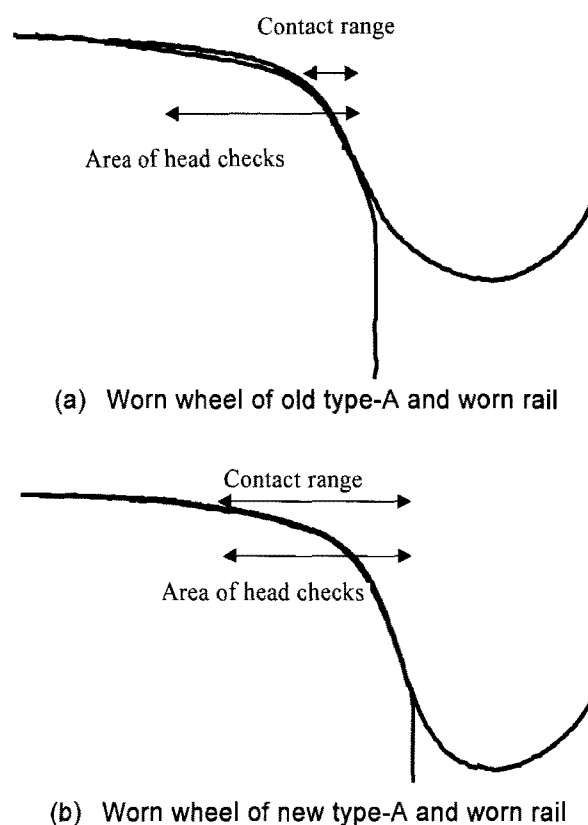
To study the effect of worn wheel profile on head checks of rails, the contact geometries of actual wheel and rail were analyzed. Fig. 8 shows two typical contacts between each of two different worn wheels and a worn rail. The profiles of two worn wheels are after the running mileages of 0.12 million kilometres and 0.18 million kilometres respectively, and the worn rail represents the profile measured at dynamic test point of the down line, where the head checks already exist. Fig. 8(a) shows a two-point contact of wheel-rail at the rail head and the rail gauge corner because of a gap between the worn rail and the worn wheel of old type car. However the worn wheel of new type car shown in Fig. 8(b) has a fitting contact (hereafter called conformal contact) with the worn rail. The profile of worn wheel of the new type car is fully in

Fig. 8 Contact Geometry Between Worn Wheel and Worn Rail (Worn Rail: Gauge Face Wear of 2.8 mm)

conformity to the profile of worn rail and head checks occur at the wheel-rail contact area, thus it is apparent that the wheel flange wear of new type-A car is thought to contribute to the formation and the growth of head checks, more than that of old type-A car.

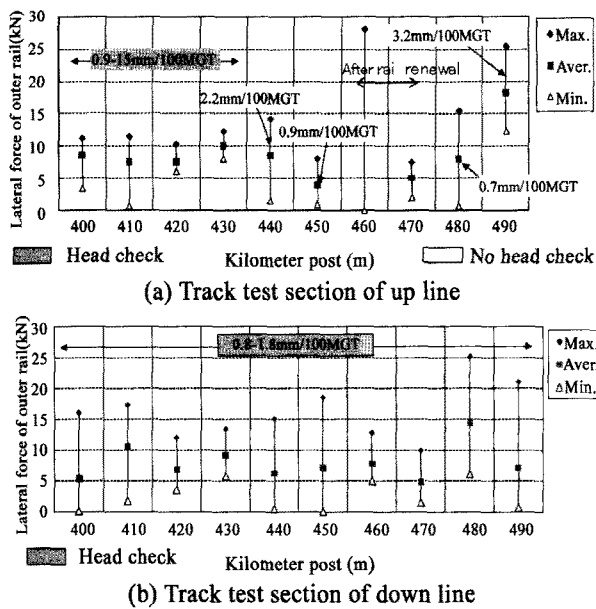
Fig. 9 shows the measured results of the lateral force by track inspection car, in the test section of 100-meter from 43 km 400 m to 43 km 500 m near the dynamic test site. It should be noticed that at the location of the mileage of 43 km 500 m a crossing is installed, where the track alignment is poor. In Fig. 9, the results of wear rate and occurrence of head checks were also indicated, corresponding to the related lateral force. The maximum values of lateral force were 10~25 kN, and their average values were 5~15 kN at the locations of head check occurrence in both the up line and the down line. It is seen that the lateral force on the track of the down line is larger than that of the up line at the locations of head checks occurrence. On the track of the up line, the significant variations of the maximum lateral force of 7~28 kN were observed accompanied with the wear rate of the wide range of 0.7~3.2 mm/100 MGT, at the locations with head checks and without

Fig. 9 Varied Lateral Forces from the Track Inspection Car, Corresponding to Head Check and Wear Rate

head checks. The maximum lateral force at the site of 43 km 490 m was 25 kN, leading to a severe wear of 3.0 mm/100 MGT and no occurrence of head check. In addition, on the track of the down line, the maximum lat-

eral forces were in the range of 10~25 kN, their variations were slightly small compared to those on the track of the up line. As a result, the wear rates on the track of the down line were in 0.8~1.8 mm/100 MGT, and the head checks occurred at all locations. The results verify that the head checks easily occur on the tracks with the moderate lateral force and no severe rail wear.

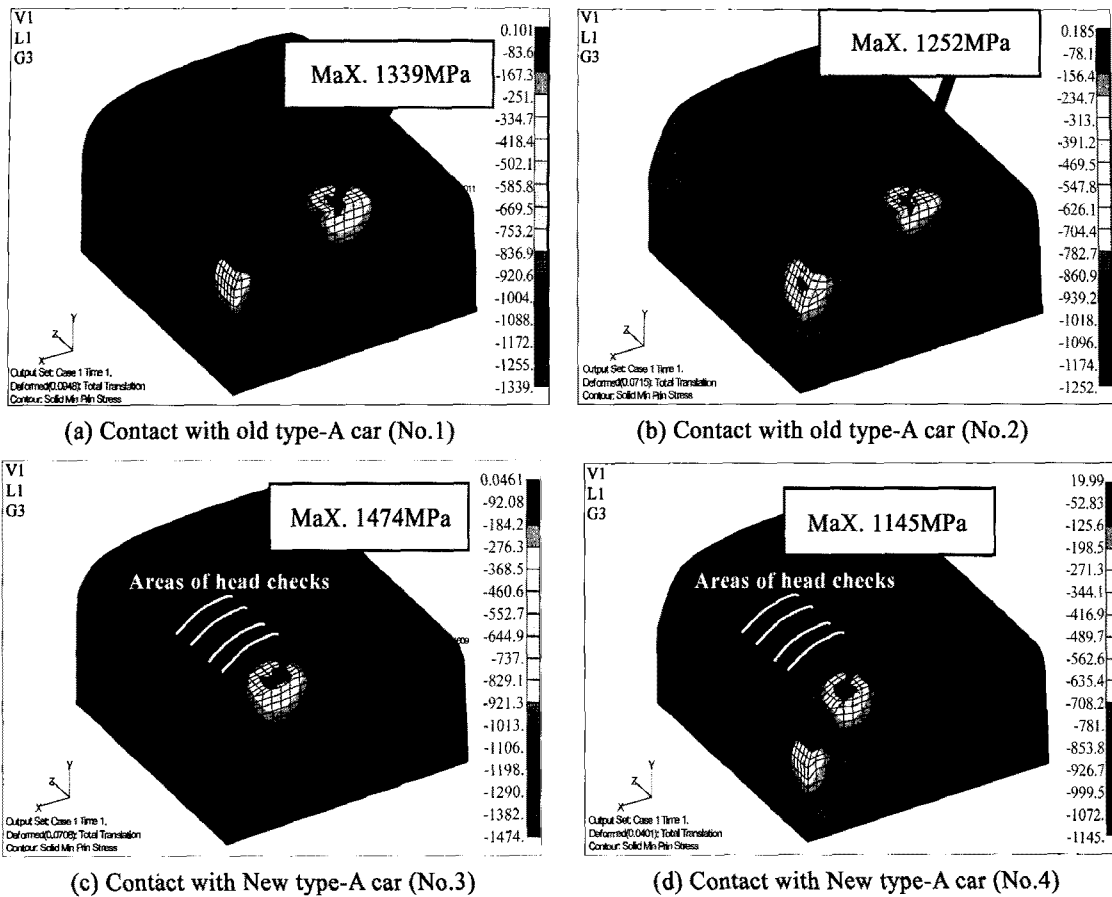
Fig. 11 shows typical stress distributions caused by the applied wheel load and lateral force, in which the contact geometry is formed by a combination of worn rail and worn wheel. In Figs. 11 (a) and (b), the contacts between the worn rail and the worn wheel of old type car are obvious by at two points, and the maximum contact stresses tend to be generated at contact points on the rail crown. However, the contacts between the worn rail and the worn wheel of new type car shown in Figs. 11 (c) and (d) greatly differ from those in case of old type car, because of the conformal contact between worn wheels and worn rails. The conformal contact area is positioned near the gauge corner, 15~18 mm apart from the rail crown. The conformal contact area almost coincides with the cracked area of railhead. It is evident that the wheel flange wear of new type-A car strongly affects on the occurrence and growth of head checks.

Fig. 11 Maximum Principal Stress on the Worn Rail of Head Check

interface. Some wear progress should be beneficial, since the length of cracks of head checks may be shortened by wear progress, or very short cracks may be removed completely by wear; thus the risk of cracks growing to the dangerous lengths and causing rail breaks is significantly reduced. In order to restrain the occurrence and growth of head checks, some value of wear rate should be suggested, which responds to the wear rate over 2.1 mm/100 MGT for the heat treated outer rail in curved track of radius of 800 m. From the viewpoints of reducing the cracks of head checks, railhead needs to be re-profiled periodically by grinding. Rail grinding is effective for getting rid of the fatigue layer of material surface and for eliminating the close conformity of the wheel-rail profiles, leading to great reduction the risk of head checks [6]. Consequently, it will be necessary to repeat the grinding at regular intervals to prevent the worn rail profiles from forming a conformal contact with worn flange profiles. In addition, the wheel turning is generally performed when the running mileages of vehicle reach 0.20 million kilometres, which is the practice of Japanese railway. However, it would be necessary to shorten the period of wheel turning for the worn wheel of new type car, in order to avoid the

conformal contact between worn wheel flange and worn rail.
