# A Case Study on the Assessment of Damaged Cause for the Damaged Reinforced Concrete Pier

**Abstract :** In this thesis, appearance inspection, compressive strength of concrete test, arrangement of bar inspection, survey, and bearing stress analysis were performed on a damaged coping of reinforced concrete pier to investigate the damage cause. According to the performed a series of inspections, it was found that the coping of pier was damaged during PSC (Pre-stressed Concrete) beam construction. In this thesis, the repair method for damaged pier was studied. The repair procedure used in this thesis was follows : chipping for damaged part, clean by high-pressure, installation of wire mesh, coating of surface hardening, construction of section restoration material, copula grinding, and prevent coating for far-infrared radiation.

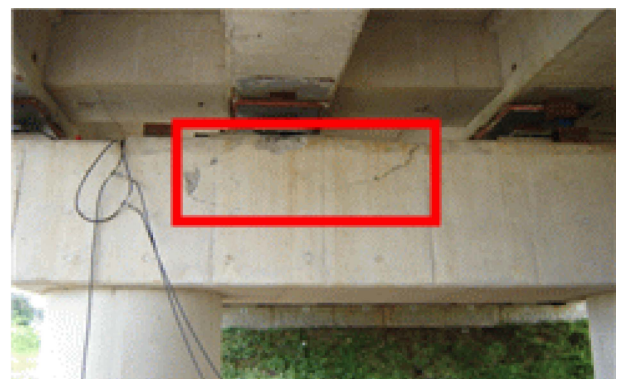
As damage investigation results, local damage with width of 2.0 m, height of 1.5 m, and thickness of 10 cm was observed on the upper face of coping of pier P1. The local damage was extended to support concrete of shoe.

It was observed that the depth of damage was similar with covering depth and the corrosion of reinforcing bar did not happen. The whole views of damaged pier P1

**Fig. 1.** Front view of damaged concrete pier.

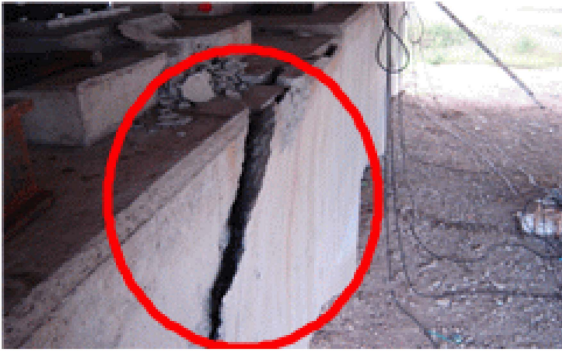
Fig. 2. Detail panorama of damaged concrete pier.

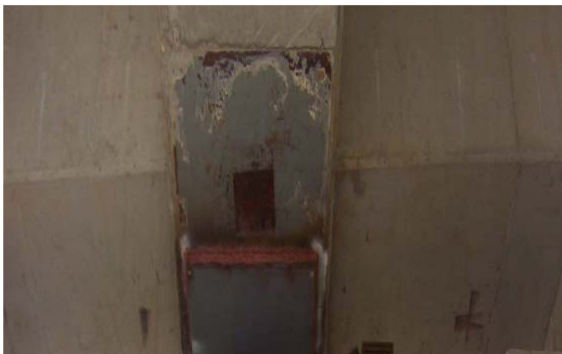
Fig. 3. Detail view of damaged concrete pier after cutting.

1. Chipping for damaged concrete
2. Clean by high-pressure
3. Installation of wire mesh
4. Coating by antibacterial, surface strengthen and systemic, water-soluble primer (SLC-1000)
5. Construction of section restoration material : anti-bacterial, water-soluble epoxy mortar (SLC-4000)
6. Copula grinding
7. Prevention coating for far-infrared radiation emission and antifouling, surface reinforced materials

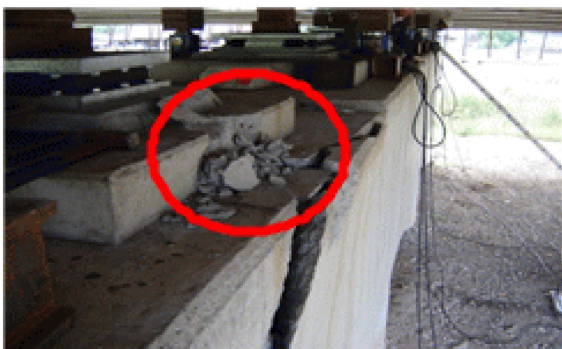
elastomeric bearings. As the inspection result for upper part of pier P1, it was observed that support concrete of shoe was exfoliated from upper part of coping. The damage of elastomeric bearings and sole plates did not observe. The whole views of damaged concrete of shoe in pier P1 was shown in Fig. 4.

Fig. 4. Damaged concrete of shoe support.

So, Safety factor is below 1.0 and cause of damage or defect is likely to be offered. Descending process of the current damage of the PSC beam is a large stress is generated locally. This exceeds the allowable bearing stress was believed to be due to the bearing stress.

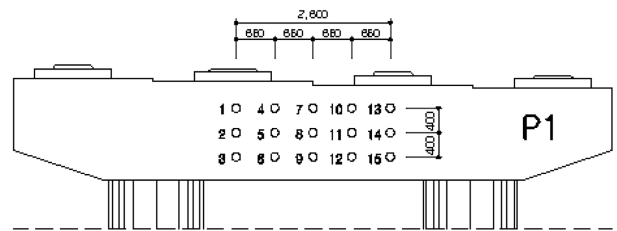
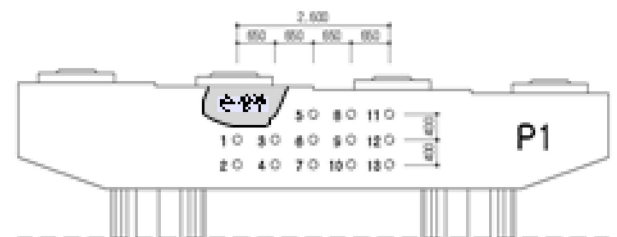
Fig. 5. Measurement location of NDT at direction to abutment 1.

Fig. 6. Measurement location of NDT at direction to pier 2.

As testing result, the compressive strength of pier P1 was about 11~21% higher than specified strength of concrete of 24 MPa. Therefore, lack of the compressive strength was not mainly cause for damage at coping of concrete pier.

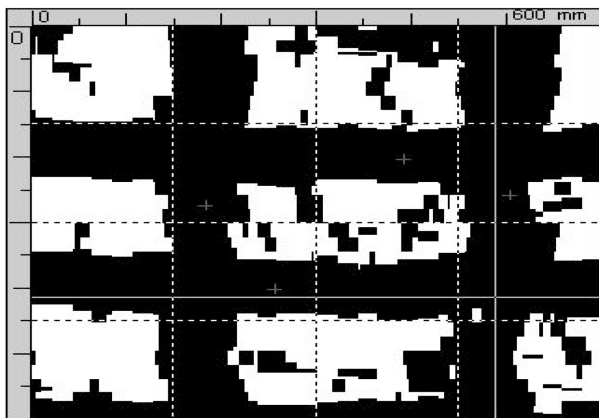
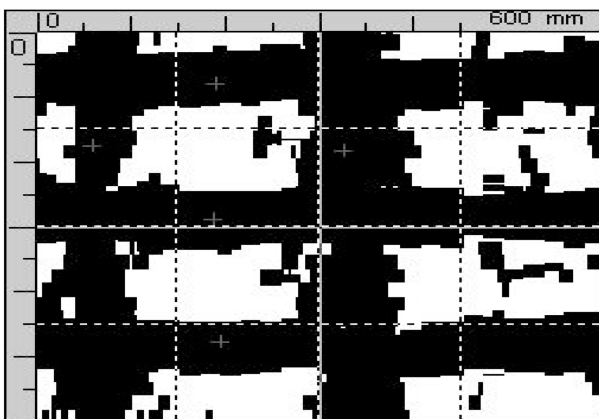
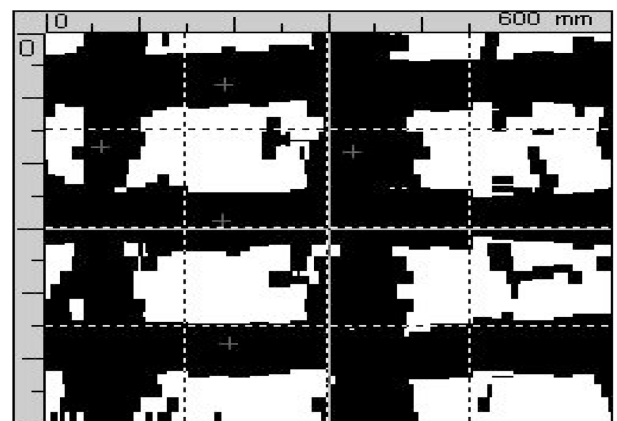
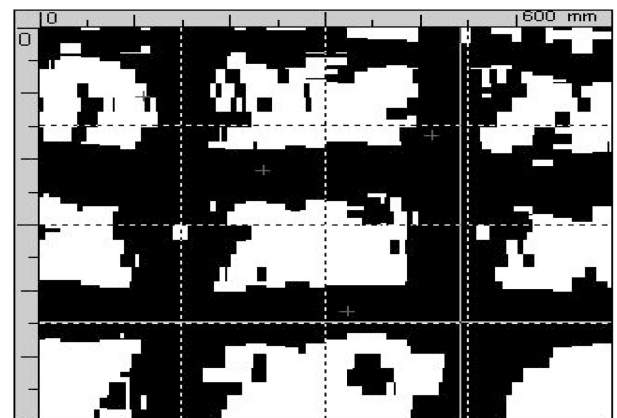
**Fig. 7.** Results of bar arrangement inspection at direction to abutment 1 in the northbound lane.

**Fig. 8.** Results of bar arrangement inspection at direction to pier 2 in the northbound lane.

Table 3 Results of the bar arrangement inspection, bar spacing and thickness of concrete cover was measured to be constructed to meet design standards [3,4].

**Fig. 9.** Results of bar arrangement inspection at direction to abutment 1 in the southbound lane.

**Fig. 10.** Results of bar arrangement inspection at direction to pier 2 in the southbound lane.

Therefore, arrangement of reinforced bar is not affected damage to the coping

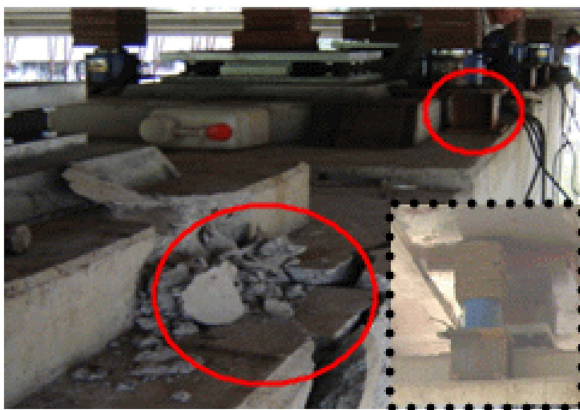
This is also a small construction errors (Hydraulic control, and communication between the worker and the worker Skillful characteristic, etc.) by the applied stress and hence a very high bearing is likely to cause local damage is expected. Fig. 11 shows the construction of

**Fig. 11.** Panorama of PSC girder installation method.

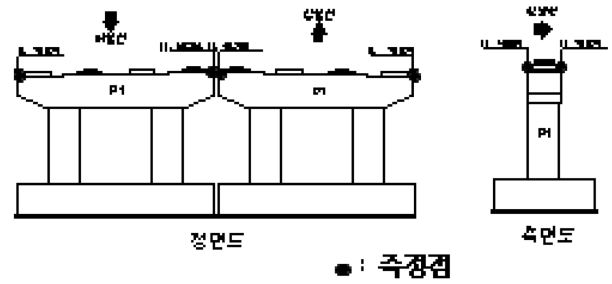
Fig. 12. Survey inspection points.

As a result of measurement investigation, Phase difference between vertical and horizontal level of damage to bridges was about 2 mm. Given the measurement error or construction error can be evaluated with very small level.

Damaged bridge piers based on damage assessment of the displacement is negligible.

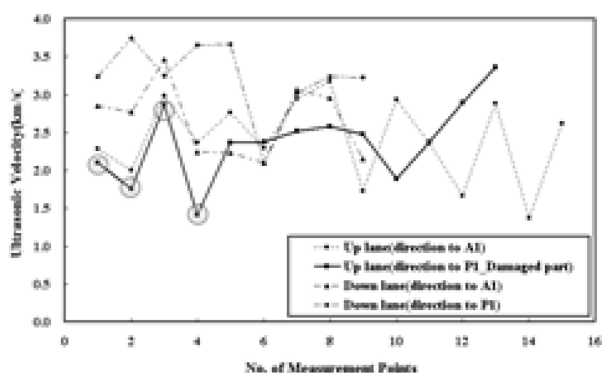
Descending process of the current damage of the PSC beam is a large stress is generated locally. This exceeds the allowable bearing stress was believed to be due to the bearing stress. It is estimated the main damage cause when deflection or eccentric load act the edge of bearing concrete. The damaged concrete is restrict to concrete exfoliation.

Fig. 14. Test results of ultrasonic velocity.
