# 러시아 상트 페테르부르크 여름궁전 스웨덴 석조화병의 조사 결과

## Inspection Results of the Swedish Stone Vase in the St. Petersburg Summer Garden, Russia

Andrej Bulakh | Evgeny Nesterov<sup>1</sup> | Choi Seok-Won\* | Dmitry Vlasov

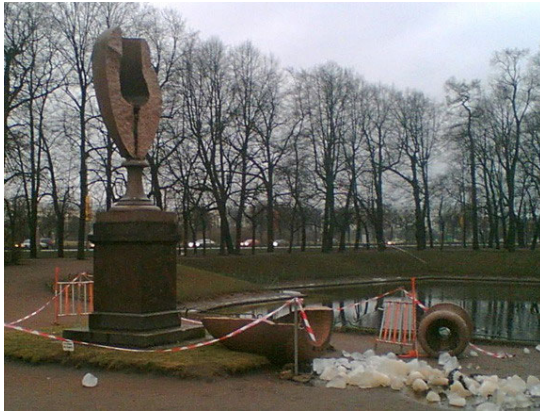
The fall downwards had made 16 degrees. Natural inspections showed that the split of the vase had continued unevenly. The older crack, in our opinion, had been in the part of the vase body facing the Carp's Pond. Here it is appropriate to recollect an episode of the preparation of the gift to the Russian emperor Nikolay I from the Swedish king, the fact is quoted by Bulakh (2006, 2007) by the materials of the Elfdahlen Museum of Porphyry. Two vases were made but one of them cracked when it was being carried out of the factory.

**Figure 1.** Studied broken stone vase.

pressure still there in Elfdahlen. The vase was not sent to St. Petersburg. Obviously, the body of the vase that reached the place at the Carp's pond also had a developing invisible thin zone of weakening - the future crack. It had lived in the vase body. The crack gradually extended deep into the vase due to biological, physical and chemical factors. At the moment of the break in January, 2008 it did not reach its internal space only by 1.5 to 2 cm, thus the crack remained invisible from the outside, first, because of its insignificant thickness (about one or several tenths of a millimeter), and second, because of its dirty external surface.

The executed research has shown that the vase, most likely initially had had internal heterogeneities and faults in its integrity. In due course they had worked because of absence of regular inspection and care of the vase condition. Interconnected physical and chemical (first of all, atmospheric pollution and climatic conditions) and biological factors (aggressive microbial environment) encouraged the change of properties of the stone material (by cracks and in the superficial layer). The vase body broke up on an equal surface. It is absolutely fresh except for a small part which corresponds to the old crack. The stone surface microstructure is roughly granular, a favorable work for glue. For greater durability the two parts of the vase can be fastened by pins. It is desirable not to touch the leg, plinth, pedestal, socle and passing through them the old metal core covered by rust. To return to a pedestal vertical position is possible by means of lifting jack devices, then it is necessary to strengthen the base with elementary engineering-technical means.

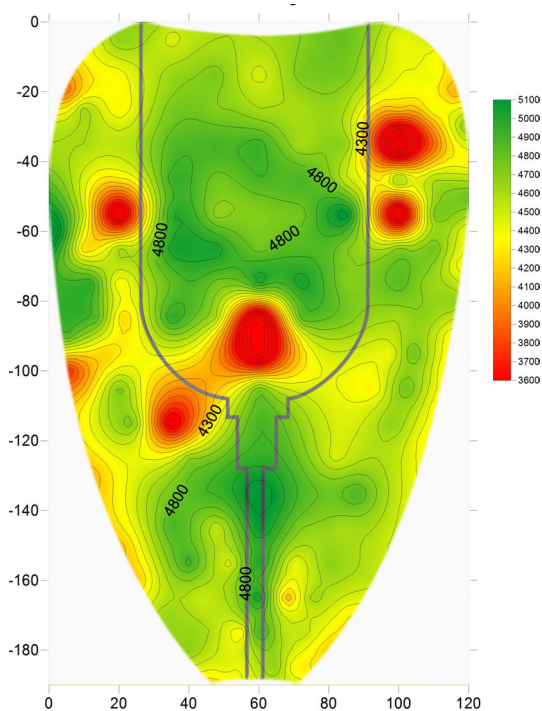
Ultrasonic sounding with the purpose of revealing of inside cracks of the granite body of the vase was carried out with two methods: by means of separate ultrasonic converters and by means of separate ultrasonic converters. It allowed revealing a number of heterogeneities that led to the vase ruin. The average speed of ultrasound was kept within the limits of 4,600 to 5,000 m/s corresponding to solidity of usual granite. Graphic representation of the results is given in the form of isolines and in colour (Figure 2). More than 350 measurements were carried out and taken account of. Lowering of ultrasound speed below 3,500 m/s can testify about internal heterogeneities in the body of the vase. In the remaining part of the vase body one such section was discovered (Figure 3), in the fallen part - five were revealed.

**Figure 2.** The fallen part of the vase body. The results of ultrasonic sounding of the stone

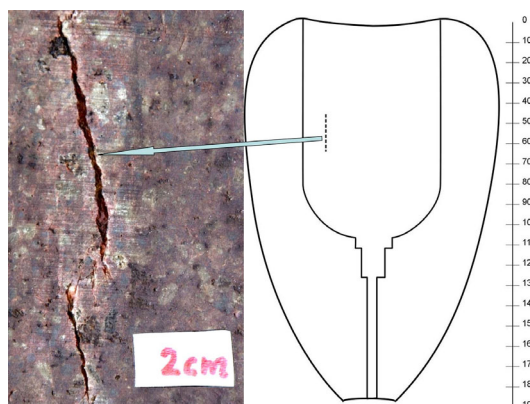
**Figure 3.** The remaining part of the vase body. A crack
