DETECTION OF ODSCC IN SG TUBES DEPENDING ON THE SIZE OF THE CRACK AND ON THE PRESENCE OF SLUDGE DEPOSITS

HANSUB CHUNG*, HONG-DEOK KIM, YONG-SEOK KANG, JAE-GON LEE, and MINWOO NAM
Korea Hydro Nuclear Power - Central Research Institute
70 1312-gil Yuseong-Daero Yuseong-Gu Daejeon, 305-343, Korea
*Corresponding author. E-mail : 007chung@khnp.co.kr

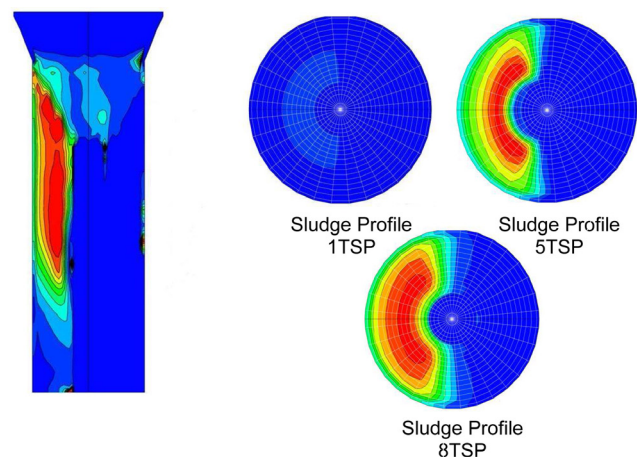
Fig. 2. Distribution of THACC Deposit Parameter Inside the SG as Calculated using the ATHOS Code

environment formed by concentration of impurities inside the occluded region causes ODSCC. It is a hideout mechanism that impurities are concentrated inside the occluded region by localized boiling under heat flux from the inside to the outside of SG tubes [2, 3]. The ODSCC was found to occur mostly in the heavy sludge deposit zone of the SG. The heavy sludge deposit zone was near the center of the hot leg half circle in the elevations between the 5~9th TSPs, as defined by a thermal-hydraulic analysis using the ATHOS code [4]. The Thermal Hydraulic Aided Colloidal Concentration deposit parameter is defined as $\rho v / (1-x)$, where ρ is the two phase fluid density, v is the fluid velocity, and x is the steam quality. The higher the THACC deposit parameter, the heavier the sludge deposit. Figure 2 shows the distribution of the THACC deposit parameter as analyzed by the thermal hydraulic calculation. The thickness of the sludge deposit can be estimated by analyzing the bobbin coil probe eddy current inspection signal, since the magnetic permeability is increased by the sludge deposit [5]. Careful analysis of the plant bobbin coil inspection signals indicated that the trend in Figure 2 was valid.

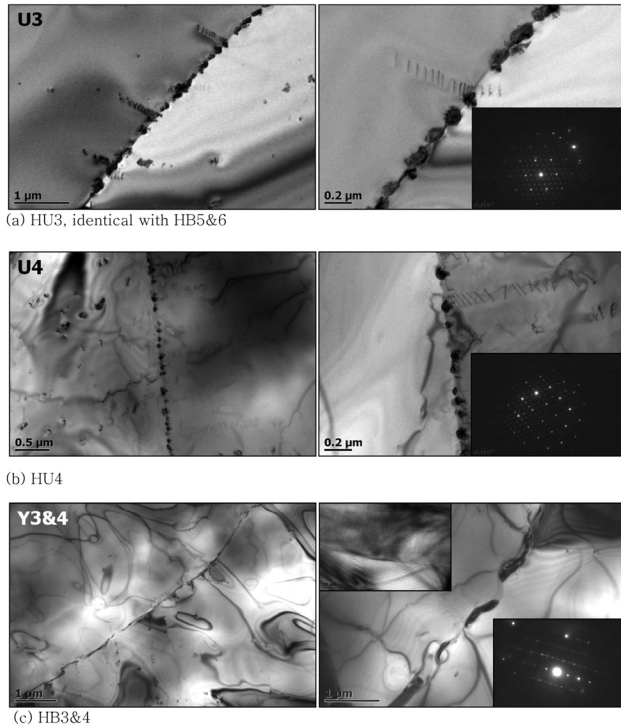
Fig. 3. TEM Images in the Grain Boundary and Diffraction Patterns of Carbides; (a) HU3, (b) HU4, (c) HB3&4 [1]

the six Korean units are shown in Figure 3. The tubes of HU4 were the most susceptible, and those of HB3&4 were the least susceptible. The manufacturing residual stresses of the tubes in the six units are shown in Table 1. The residual stress was measured by the split tube method [7] and X-ray diffraction [8]. It is noted that the manufacturing residual stress played a critical role in the development of ODSCC, since the residual stress was higher than the operational stress caused by the pressure and temperature differential, as the operational stress is estimated below 100MPa. It is understood that the manufacturing residual stress is generated during the straightening rolling and

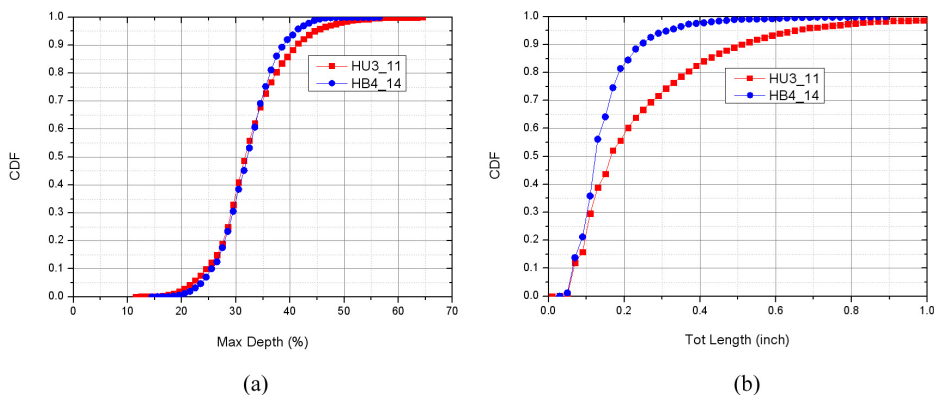
Fig. 4. Cumulative Distribution Fraction of Maximum Depth and Total Length of Cracks for EOC 14 in HB4 and EOC 11 in HU3; (a) Maximum (peak) Depth (b) Total Length

Figure 4 shows the cumulative distribution fraction of the peak depth and length of cracks detected at the 14th EOC inspection of HB4 and at the 11th EOC inspection of HU3. It is noted that the cracks are substantially smaller in HB4. 93% of the total cracks are shallower than 40% peak depth, and 83% of the total cracks are shorter than 5mm.

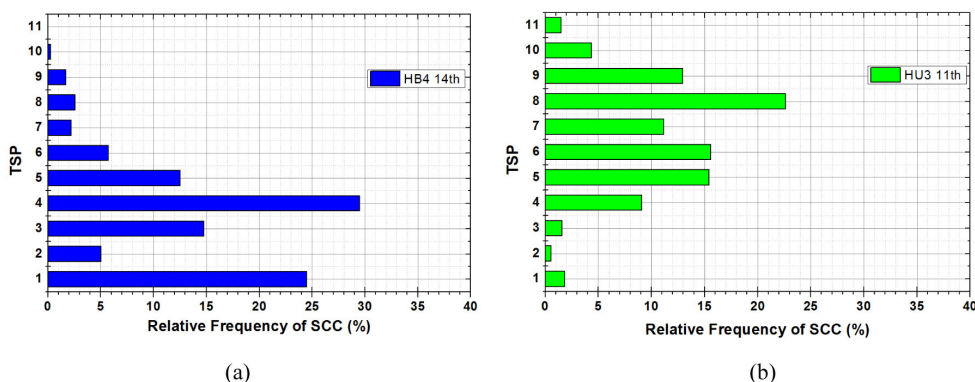
Fig. 5. Distribution of ODSCC Depending on Vertical Locations of TSPs: (a) 14th EOC in HB4, (b) 11th EOC in HU3

It was found that most ODSCC indications were detected in the elevations below the 5th TSP in HB4, as shown in Figure 5. This trend is clearly different from HU3&4, where most cracks were detected in the elevations between the 5th and 9th TSPs, where the sludge deposited most heavily.

It was already described that most cracks were detected below the 5th TSP in HB4, while most cracks in HU3&4 were detected in the heavy sludge deposit region, near the center of the hot leg semicircle in the elevation between the 5th and 9th TSPs. HU3&4 and HB3~6 are of identical design and the analyses of the bobbin coil eddy current inspection signals confirmed that all the units have an identical distribution profile of sludge deposition.

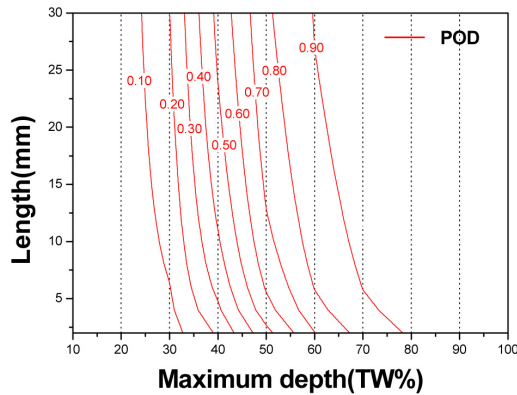
Fig. 6. POD Curves Depending on Peak Depth and Length of Axial ODSCC, MRPC Inspection [13]

POD is an element of practical importance for the engineering assessment of structural and leakage integrity of SG tubes, since undetected cracks may grow to a size which threatens the structural and leakage integrity. There have been engineering estimations of pre and post-SGCC POD of bobbin coil eddy current inspection for detecting ODSCC of CE steam generators [12]. POD is often expressed as a function depending on the peak depth of the crack. The heavy dependence of the POD on the sludge deposit and other factors affecting the quality of the inspection signal renders POD highly plant specific. Review of a few pre and post-SGCC PODs indicates that SGCC enhances POD substantially, and that the extent of the enhancement is marked mostly in the range of peak depth between 20~50% through-wall [10]. Most cracks shallower than 20% tube wall are not detected irrespective of SGCC. Figure 6 shows POD curves of MRPC eddy current inspection for axial ODSCC [13, 14]. Information on the dependence of POD on the length of the crack is limited. Figure 6 was constructed based on databases developed by a Korean round robin inspection program using tubes from a retired steam generator [14]. Most cracks used for figure 6 were on the free span of the tubes covered with sludge deposit. It is seen from figure 6 that POD depends not only on the peak depth but also

substantially on the length of the cracks, when, in particular, cracks are very short. It is readily understood that most of the short and shallow cracks in HB4 were not detected by the pre-SGCC inspection. The shallowness of the cracks may be explained by the slower crack growth rate of the less susceptible microstructure. The shortness of the cracks may be explained by the lower density of crack initiation so that there was less coalescence of short cracks into longer cracks.
