Blocking of Fuel Filter in Aircraft by an Accelerator Blooming

Ik-Sik Kim[†], Young-Ha Hwang, Kyung-Suk Sohn, Jung-Hun Lee, and Byung-Hoon Sohn^{*}

Aero Technology Research Institute, The Republic of Korea Air Force, P.O. Box 304-150,
352 Ayang-ro, Dong-gu, Daegu, Korea

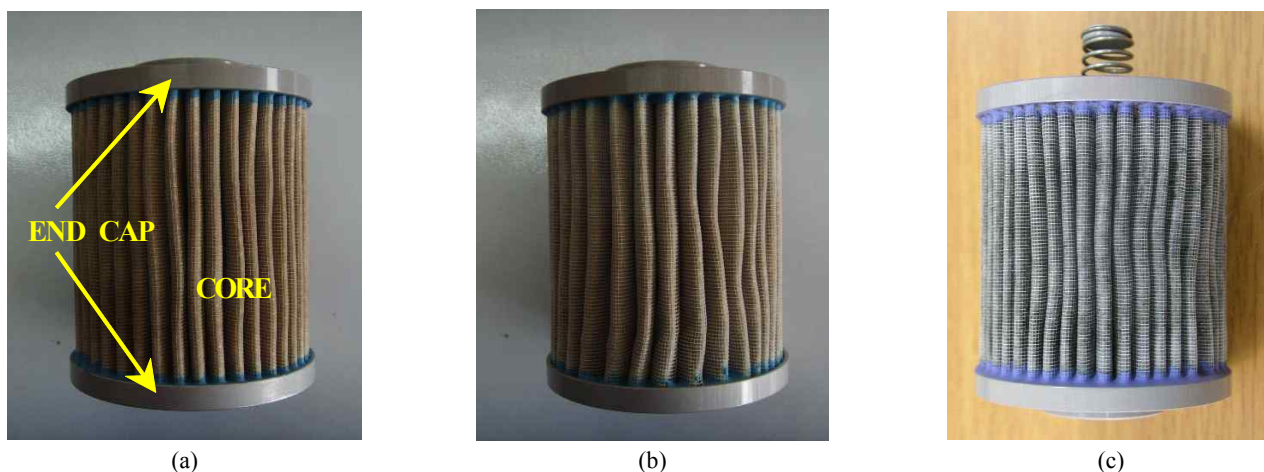
Two failed fuel filters [(a) and (b)] and the unfailed fuel filter (c) are shown in Figure 2. Two failed fuel filters are blocked by an unknown material even before than criteria of exchange period. The failed fuel filter (a) is much more severe than the failed fuel filter (b), meaning further contamination of filter. The more severely failed fuel filter (a) is somewhat denser brownish color than the less severely fuel filter (b). The unfailed filter (c) is introduced to compare with two failed filters in the same conditions.

Figure 2. Fuel filters (a) in the more severely failed, (b) in the less severely failed, and (c) in the unfailed.

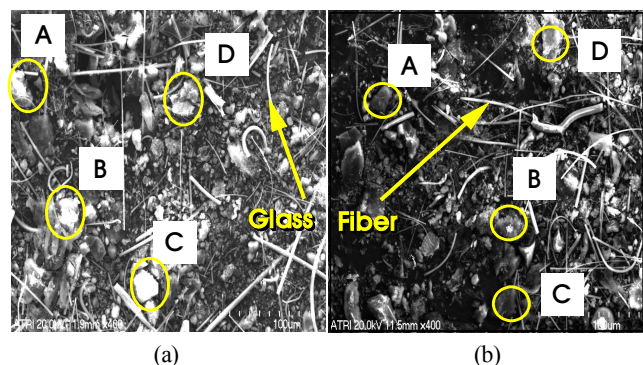
Figure 5. SEM photographs of blackish particles for (a) the more severely failed fuel filter and (b) the less severely failed fuel filter.

As shown in Figures 6(a) and (b), chemical elements about blackish particles (A, B, C, and D) indicated in Figure 5(a) and (b) are analyzed with EDS. Chemical components for blackish particles in two failed fuel filters are identified to S, Si, Al, Ca, Mg, and K. The results showed that the peak intensity for chemical elements was the highest in sulfur, meaning the largest amount of all other elements. As represented in Figure 5(a) and (b), long linear fragments are considered as glass fiber. Glass fiber is generally used as material of fuel or oil filter in aircraft. Glass fiber mainly includes chemical elements such as Si, Na, Al, Ca, K, and Mg. It is inferred that the fragments of glass fiber come from main filter during extraction process as the result of ultrasonication. Therefore, as shown in Figure 6(a) and (b), chemical elements such as Si, Al, Ca, Mg, and K except S for all blackish particles are considered as those of glass fibers. All blackish particles from outside of two failed fuel filters are identified to sulfur.

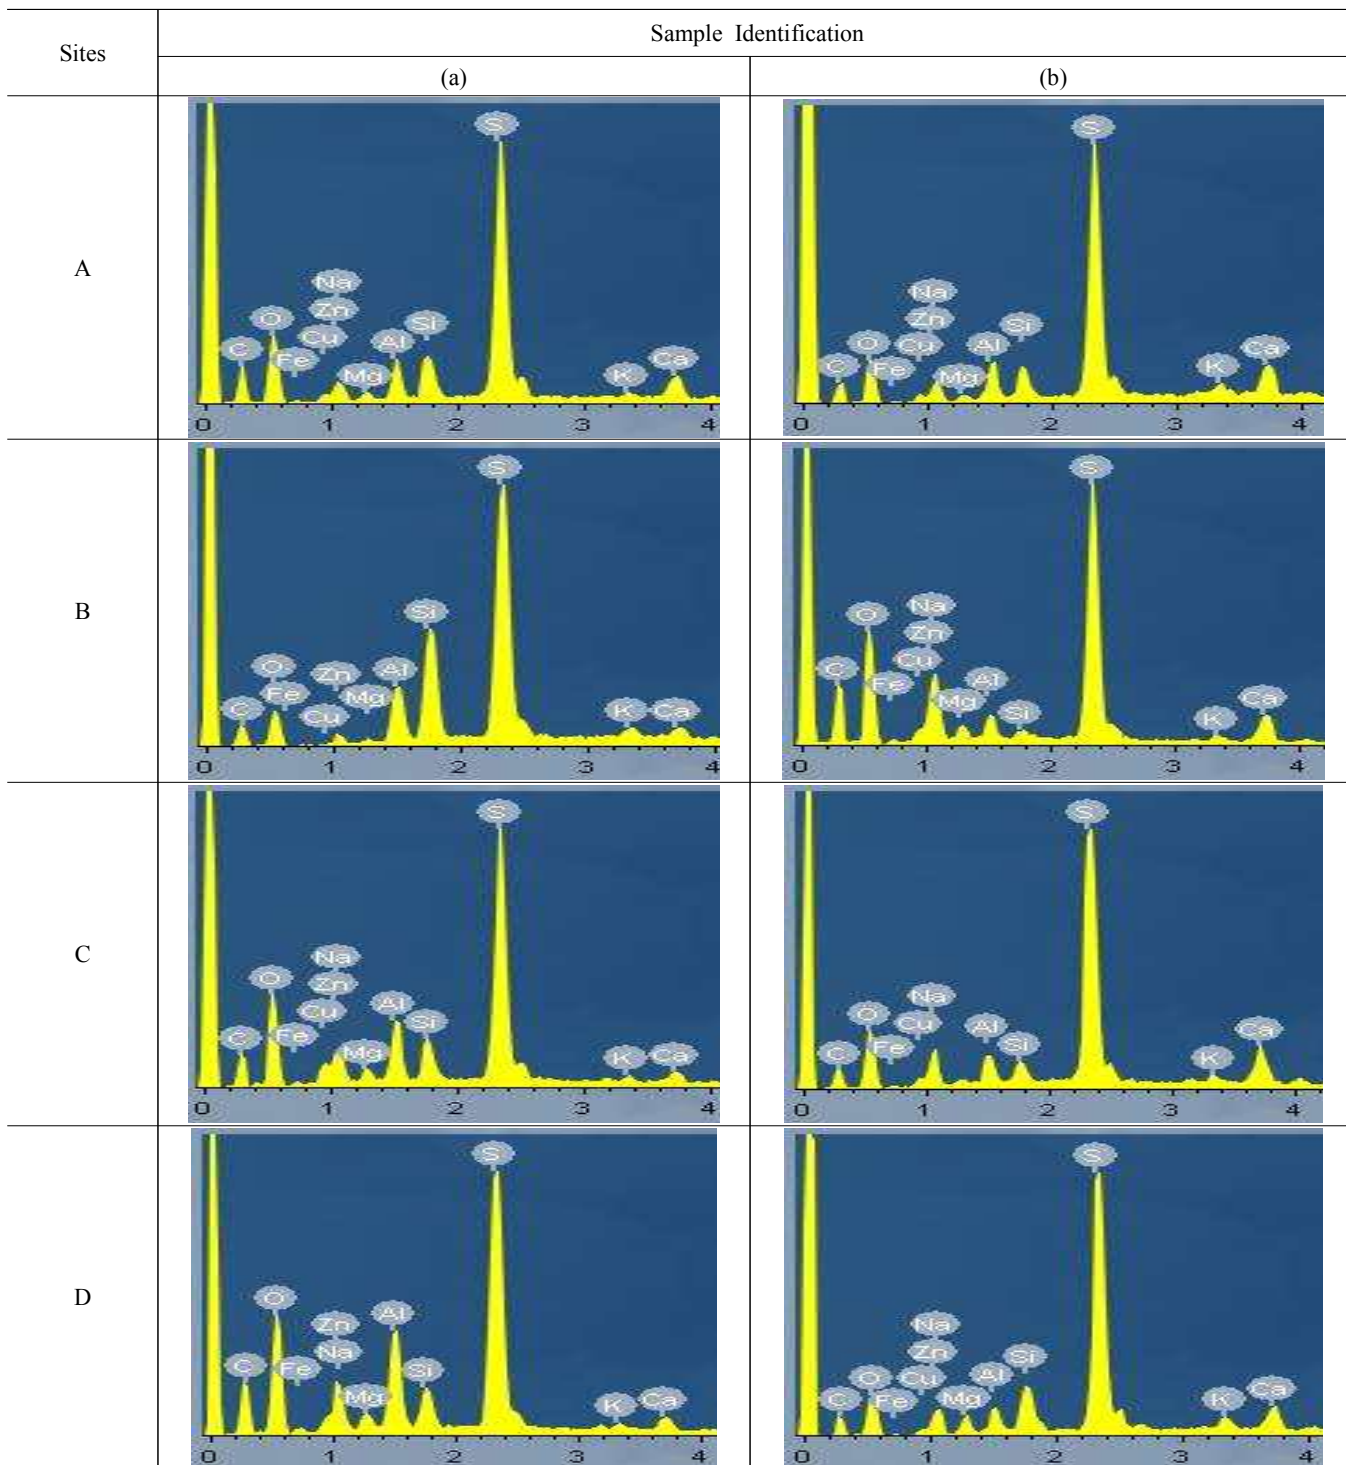
In summary, a yellow-brownish liquid and blackish particles extracted from outside of two failed fuel filters were identified to sulfur and an ester oil, respectively. However, it was considered that both of them do not affect directly on blocking fuel filter because of relatively very small quantity.

Figure 6. EDS spectra of blackish particles (A, B, C, and D) indicated in Figure 5 in (a) the more severely failed fuel filter and (b) the less severely failed fuel filter.

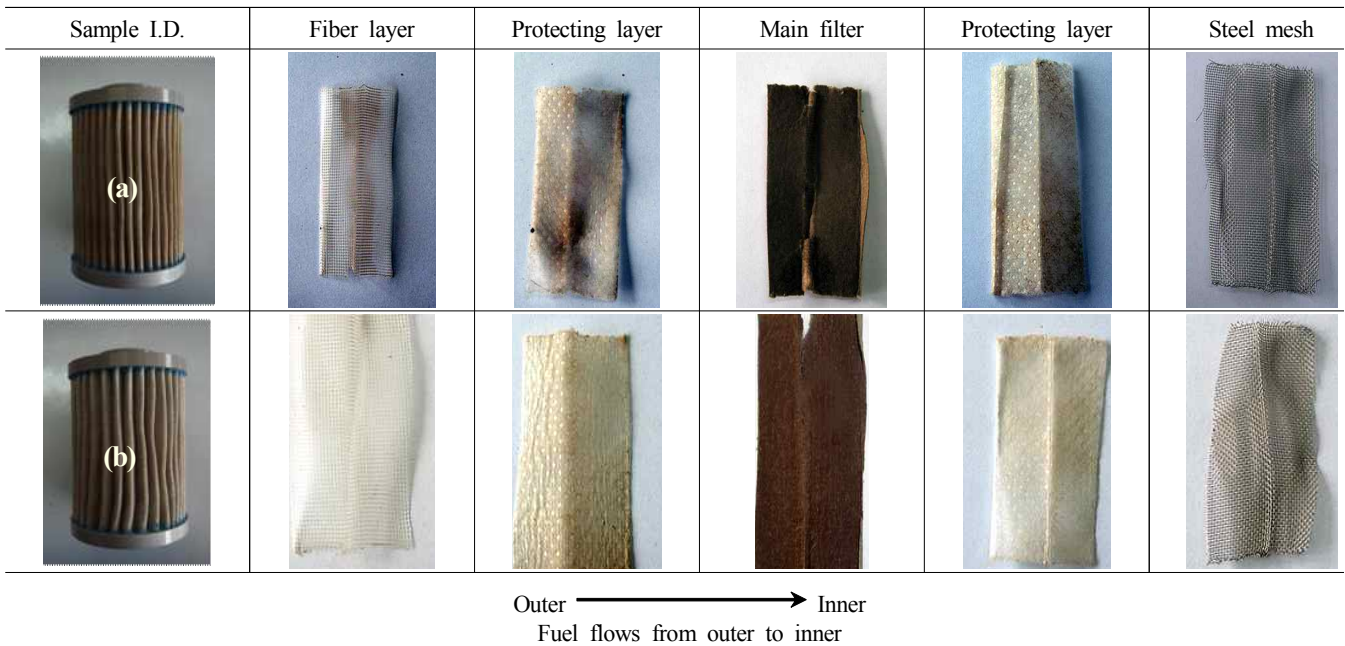
As stated previously, the fuel filter was composed of two parts, two end caps and core. Two end caps were supporting fuel filter on both sides. A core of the fuel filter was disassembled. Its core has 5 layers which are comprised of fiber filter, two protecting layers, main filter, and steel filter as given in Figure 7. There was fiber layer at the most outside. Fuel to fuel filter flows from outer layer to inner layer, in order of fiber filter, a protecting layer, main filter, a protecting layer, and finally steel filter. Two protecting layers protect the main filter. The main filter plays a significant role in filtering impurities smaller than $10 \mu\text{m}$ from fuel. Compared with the unfailed main filter, two failed main filters was stained

Figure 7. Disassembled fuel filters for (a) the more severely failed and (b) the less severely failed.

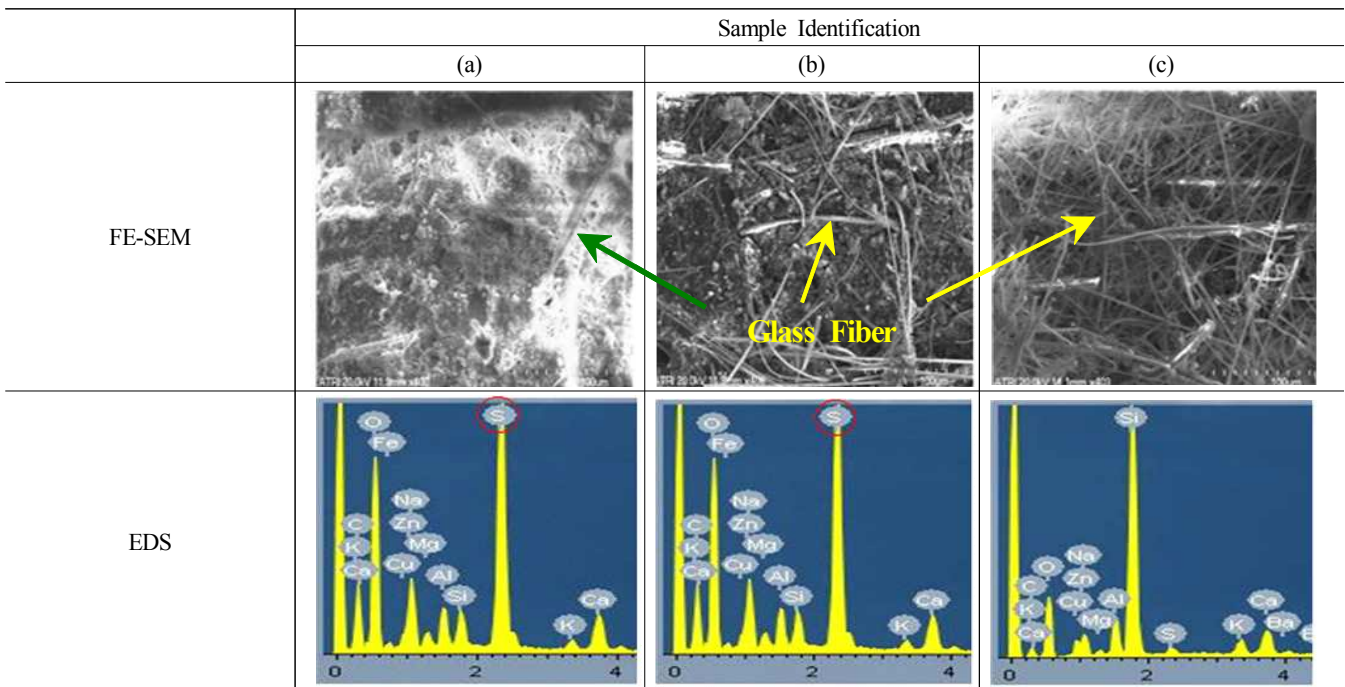
verely failed, and the unfailed, respectively. The remnants of photograph (a) show even more fine particles than those of photograph (b), coinciding with the result of earlier blocking of fuel filter. The main filter is completely covered with these

Figure 8. FE-SEM photographs and EDS spectra for the remnants of main filters in (a) the more severely failed, (b) the less severely failed, and (c) the unfailed.

fine particles, showing no fine lines. The main filter in FE-SEM photograph (b) is partly covered with these fine particles, showing some fine lines

Most of fine particles for two failed main filters belong to smaller than 10 μm in size. Compared with the particles from

outside of fuel filter, those of the main filter is even more fine. Maybe fine particles of main filter are considered as the main cause of blocking fuel filter. Figure 8(c) represents the remnants of the main filter for the unfailed do not exist, showing only many fine lines.

Figure 8 also shows EDS spectra for the remnants of the main filters in two failed main filters [(a) and (b)] and the unfailed fuel filter (c), respectively. As shown in Figure 8(c), the main filter of the unfailed is neat, showing only fine lines without any particles. A lot of fine lines were considered as glass fiber since it was commonly used as material of main filter in aircraft. Glass fiber was made up of chemical elements such as Mg, Si, Al, Ca, K, and Na. Chemical elements of the unfailed main filter corresponds to those of glass fiber. As shown in EDS spectra of Figures 8(a) and (b), it was found that chemical elements except sulfur for two failed main filters was corresponding with those of glass fibers. Therefore, chemical component of dark brownish impurities for two failed main filters was identified to sulfur.

In summary, the main filters of two failed fuel filters, which were more severe or less severe were filled with a number of fine particles. These fine particles were identified to sulfur. Therefore, sulfur in main filter was thought as the main cause of blocking fuel filter.

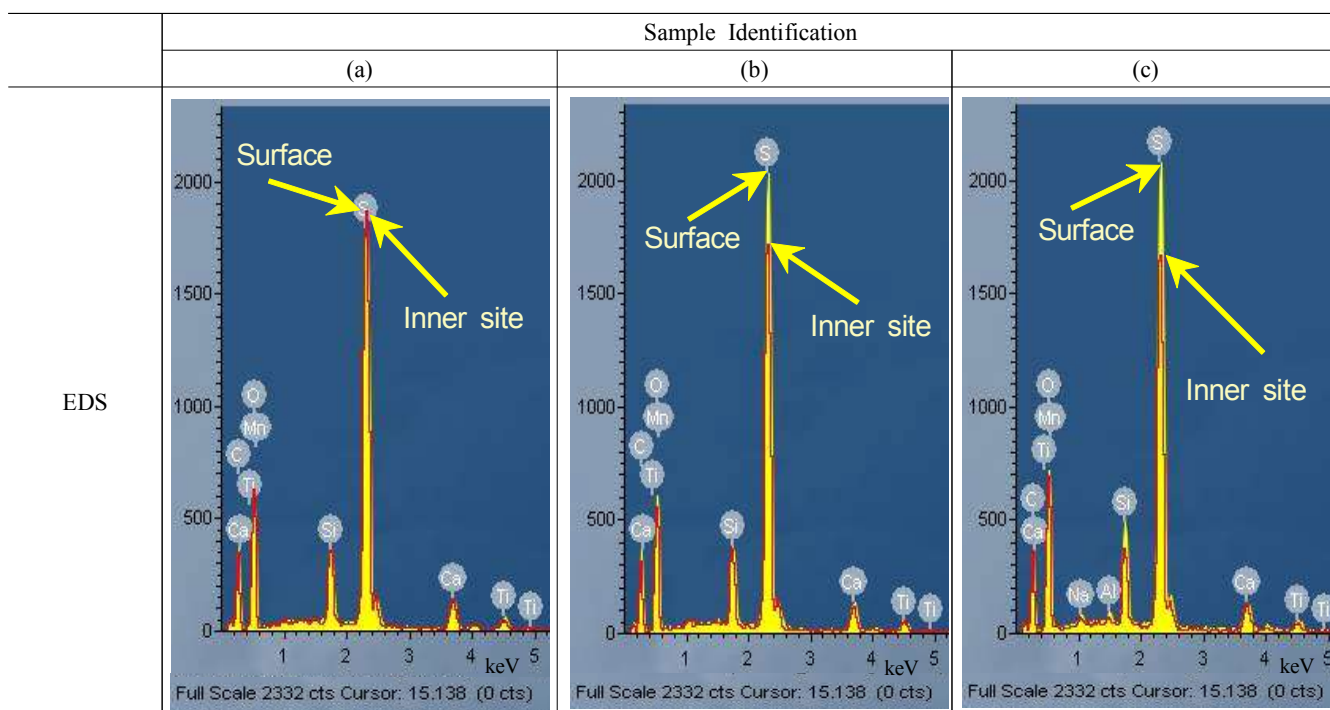
Figure 10. EDS spectra of sulfur at both the inner site and surface after aging according to the mixing ratios of (a) 100/10, (b) 100/20, and (c) 100/40 in Part B/Part A, respectively.

Figures 10(a), (b), and (c) represent EDS spectra showing differences of the peak height of sulfur at both inner site and surface after aging according to the mixing ratios of 100/10, 100/20, and 100/40 in Part B/Part A, respectively. Table 3 represents the relative abundance of migration of sulfur to surface calculated from the peak height, on the basis of peak

height (100) at the inner site after aging for each compound. The results showed that migration of sulfur to surface was increased with the increment of loading of Part A and the relative abundance of migration was increased with the order of 100/10, 100/20, and 100/40 in Part B/Part A, respectively.

In the case of mixing ratio of 100/10 in Part B/Part A, an EDS spectrum showed that there was no difference of sulfur concentration between inner site and surface after aging, meaning no migration of sulfur to surface. Polysulfide polymers with the terminal thiol end groups were cured by the oxidation

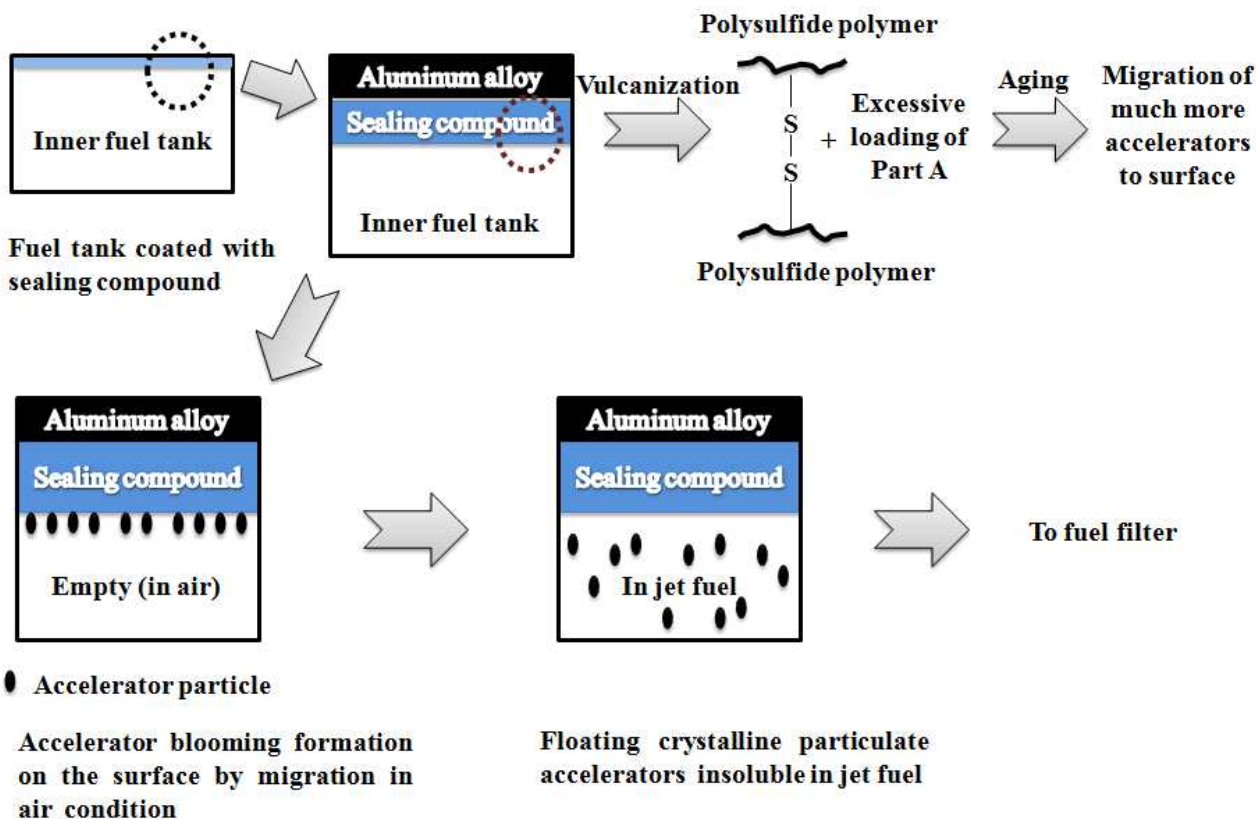
Figure 11. A mechanism for the formation of the blocking material by an accelerator blooming in fuel tank.

Figure 11 indicates a mechanism for the formation of the blocking material by an accelerator blooming in fuel tank. As mentioned previously, blooming material as an accelerator can be produced by both the excessive loading of Part A and aging. As the vulcanizate cools after vulcanization, accelerator particles will crystallize and grow within the bulk of sealing compound. As the crystals grow within the bulk of the rubber, regions of strain will be set up around the crystal. These regions increase as the crystals grow until no further crystallization can occur. However, at the surface of the sealing compound, there will be much less strain and crystals will continue to grow, resulting in a lower soluble concentration of compound close to the surface. This, in turn, will lead to migration of the soluble compound from the bulk of the sealing compound in an attempt to remove the solute concentration gradient. Crystals in the bulk will redissolve to restore the bulk solubility concentration which will maintain the gradient. Migration will continue until all the bulk crystals have dissolved and there are a mass of crystals on the surface. It is known that the migration rate of antioxidants is increased by rising temperature.¹⁶

If fuel tank is empty instead of filling up fuel, migration to surface of accelerator will be more accelerated, together with the increasement of temperature. In case of filling up fuel, migration of accelerator may be even more decreased because of preventing fuel from coming out. During manufacturing, the fuel tank was empty. So migration to surface of accelerator within sealing compound in air condition was continuously increased, together with a cumulative effect by rise in temperature. Eventually much more accelerators were bloomed on the surface. Crystalline accelerators on the surface were insoluble in non-polar JP-4 fuel because of their polarity. For flying if fuel tank is filled with JP-4 fuel, a lot of crystalline accelerators on the surface will be detached and floated

in JP-4 fuel. These floated fine accelerator particles could not be filtered by the main filter of fuel filter. Therefore, blocking of fuel filter resulted in an accelerator released by an accelerator blooming in air condition.
