Characterization of Burned Architectural Woods by Fire Using SEM-EDXS and Computerized Tomography¹

The nation's first national treasure, Sungnyemun, which was badly damaged by fire on February 10th 2008, had 10% and 90% physical damage on the first floor and second floor of a gate tower, respectively.

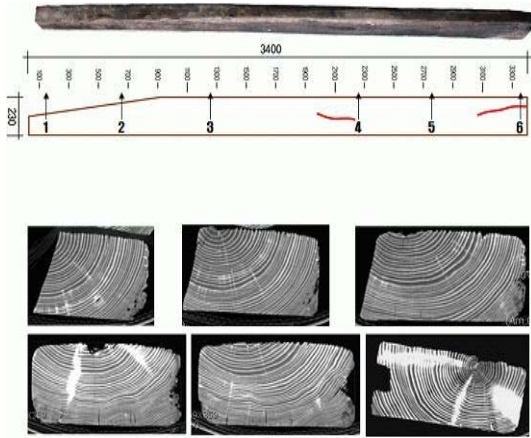
Fig. 2. Lintel's schematic and CT images.

Prediction investigation into residual performance of damaged materials by fire has been previously undertaken by computerized tomography (Davis and Wells 1992; Lee 2010). CT images indicated that the white area reflected high density and a deep color or black area represented low density or a space. Among the materials used, a lintel material, which had the least damage by fire in the outside cells and secondary damage (like a nail, static, loss) except carbonization, was found to exhibit a little internal decay but was shown not to form a carbonization layer. On the other hand for fan-rib rafters carbon-

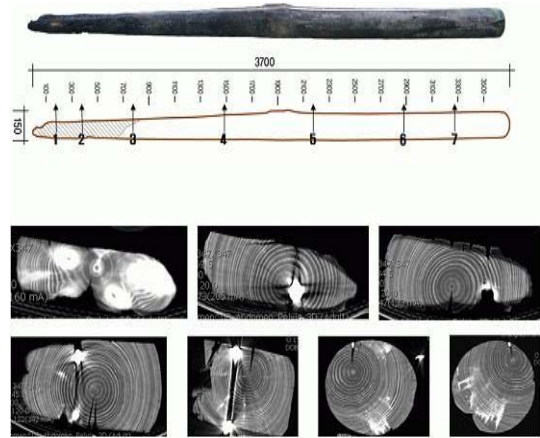
Fig. 3. A fan-rib rafter 2's schematic and CT images.

ization was the most serious and the secondary damage caused by a nail was also discovered. In addition, CT images showed that the carbonization layer formed was about 2-4 mm. in depth. In the iron-ware, (like a nail), because of high density compared with wood, diffuse reflection had taken a place as seen in the fan-rib rafters' CT image in the Figs. 2 and 3. For static or decay density was lower than wood and was represented by black color. In wood density of knots was higher than for woody parts and appeared as a bright white color but unlike a nail, light scattering did not occur. Furthermore, the carbonization layer which was relatively lower than tissue produced a medium color between tissue and a space.

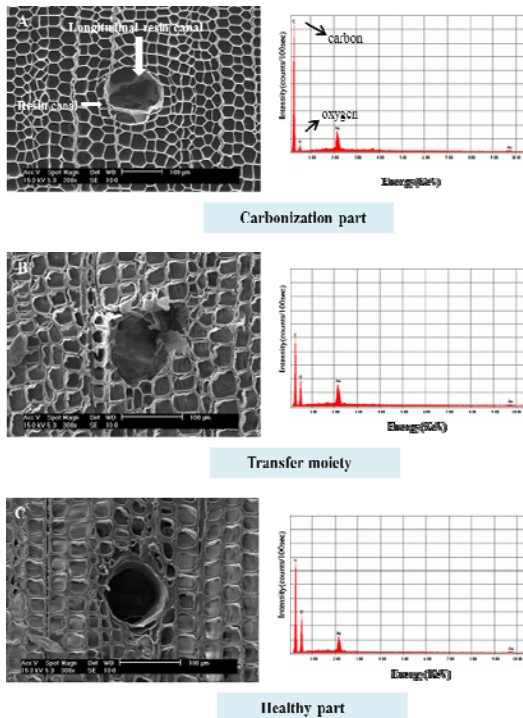
Fig. 5. SEM images of fan-rib rafter 2's each part cross section and SEM-EDXS's results (A: Carbonization part, B: Transfer part, C: Healthy part).

Figs. 5-8 show exemplary results of each material observed by SEM. Each material appeared similar in almost all of the same phases. In terms of the transverse phase, tracheid wall thickness in the burned part was much thinner than in the transfer moiety and the healthy part. The reason is that in the process of carbonization, it was assumed that among wood's main components, cellulose, hemicelluloses

- It had longitudinal resin canal cross section showing a growth ring boundary (Cross section showing a growth ring boundary).

and lignin were decomposed and evaporated, then contracted by a high temperature. However, although destruction and loss of tracheid wall occurred in the carbonized part of some materials, it was considered that it occurred during the process of making samples rather than in the process of carbonization.

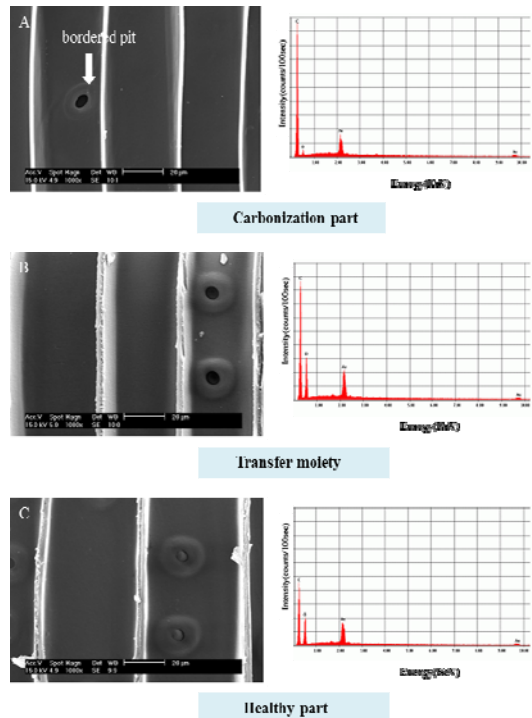
Fig. 6. SEM images of Fan-rib rafter 1's each part radial section and SEM-EDXS's results (late wood tracheid) (A: Carbonization part, B: Transfer part, C: Healthy part).

In the Figs. 6, 7 as for radial sections and tangential sections, unique and wood structure change was not found, but pit walls of tracheids, epithelial cell and bordered pits in the carbonized part were lost much more than in the transfer moiety and healthy part. It was assumed that very thin pit walls were destroyed by a high temperature in the process of

- Late wood tracheid and bordered pit's radial section was significantly found.

carbonization. However, there was little anatomical difference of wood in the transfer moiety and healthy part.

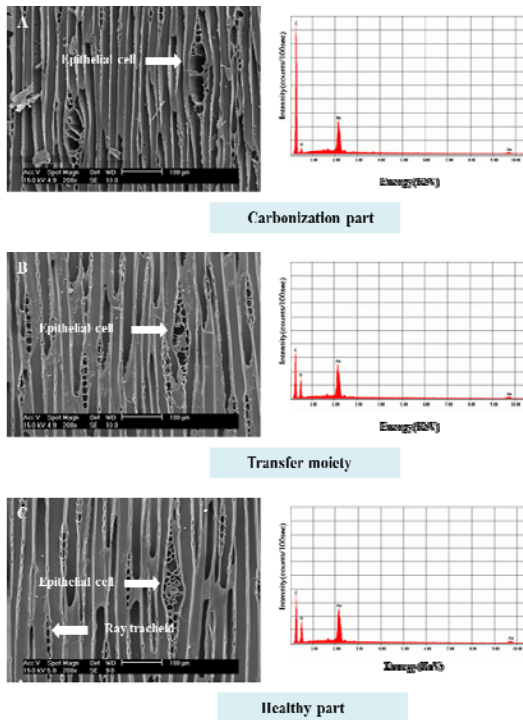
Fig. 7. SEM images of each part tangential section of tie beam and SEM-EDXS's results (A: Carbonization part, B: Transfer part, C: Healthy part).

In the Fig. 7, conifer cell components epithelial cells surrounding tracheids, longitudinal · transverse resin canals and ray tracheids were observed. Additionally fusiform rays including transverse resin canals and uniseriate rays were observed.

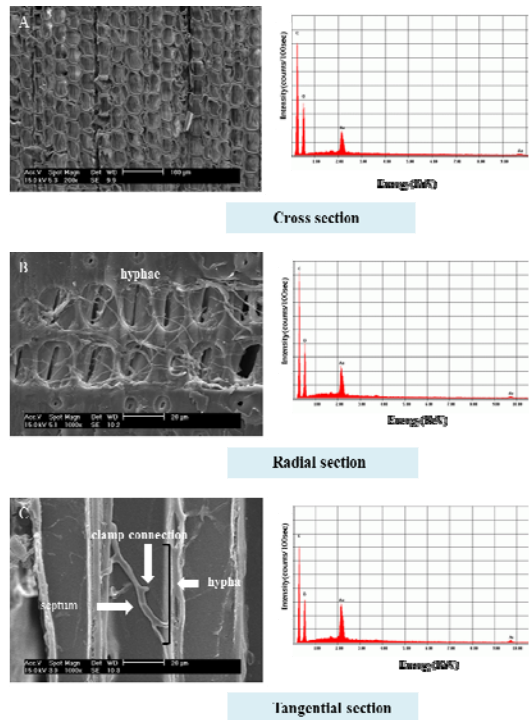
Fig. 8. SEM images of lintel's decay part and SEM-EDXS results.

On the other hand Fig. 8 showing the decay part results from SEM that hyphae occur in the radial section, cracks and static in the cell wall had occurred. However the cell wall of radial structures in the tangential section exhibited considerable

deterioration. The hyphae possess characteristics of basidiomycete (rotting fungi) such as clamp connection and septum and the wood structure seemed healthy without decay.
