선체 부식 및 손상 부재를 고려한 침몰선박의 구조 안전성 평가에 관한 연구 - 제7 해성호를 중심으로 -

Structural Safety Assessment of a Sunken Ship Considering Hull Corrosion and Damaged Members - Focus on the Sunken Ship ‘No. 7 HaeSung’ -

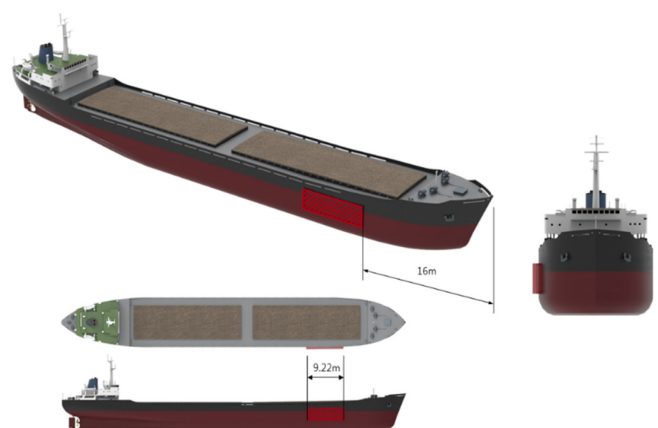
Fig. 2. The Expected Damage of NO.7 HaeSung's Hull Structure.

observations, the image data, or related regulations regarding the ship at the time of the accident. Any information about the site and size of the damage can be used to estimate the position and size of the damage recorded in the data. However, when information about the damage size is missing, then as per regulations, the smallest damage has to be assumed. The designated standard of the damage size to the ship is presented in MARPOL/IBC Code, in which the ship can stand against the damage considering the range of flooding (IMO[2007]). No. 7 HaeSung sank due to a marine accident, but there was no information in the written findings or related materials, except the position of the damage. Moreover, the initial damage at the time of the accident could not be estimated by multi-beam echo sounder 3D image investigation, due to the failure of the hull structure. The cargo hold of No. 7 HaeSung was damaged during a collision on route No. 1. The angle of the collision was 75 degrees from the freeboard of the opposite line. After the collision, the hull first collapsed from the freeboard, and sank within 2 minutes of the impact. Table 2 shows the estimated size of the damage to No. 7 HaeSung, based on the regulation of the damage size.

In case of, it can be considered that No.7 HaeSung has sunk because the damage was more than the range values of Table 2. Table 2 shows basic information on sunken ships, and Fig. 2 shows the estimated damage of the hull structure at the time of the accident.

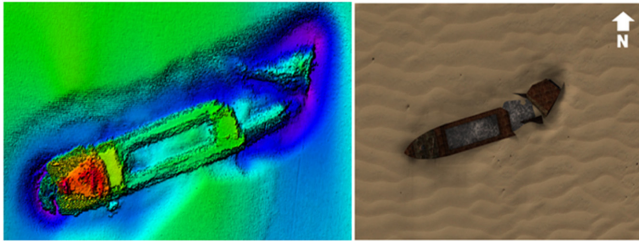
Fig. 3. The Position of the Sunken Ship, 'NO.7 HaeSung'.

As seen in Figure 3, No. 7 HaeSung had the freeboard that was bottomed with the condition toward the northeast and had a collapsed hull. In the vertical position, the freeboard turned upward towards the bow at a degree of 2~6, and was about 0~2 degrees in the horizontal slope. The front body of the cargo hold, No. 1 was inclined to the north at the degree of 20, due to the structural failure.

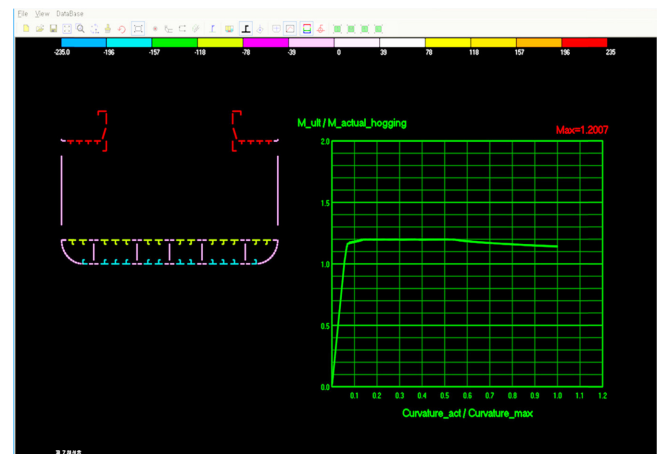
Fig. 7. The Final Strength of NO.7 HaeSung'.

Figure 7 is the screen that reevaluates the ultimate strength after applying the degree of corrosion to the hull structure. The value of ηM is assumed as 0.63 in the current status, in which there appears to be a low possibility of the failure in the hull

structure. However, there seems to be a high possibility that the hull structure will collapse because of the growth for the degree of corrosion over the time afterward.
