Large Steel Tank Fails and Rockets to Height of 30 meters – Rupture Disc Installed Incorrectly

Frank H. Hedlund*, Robert S. Selig, Eva K. Kragh

COWI, Kongens Lyngby, Denmark

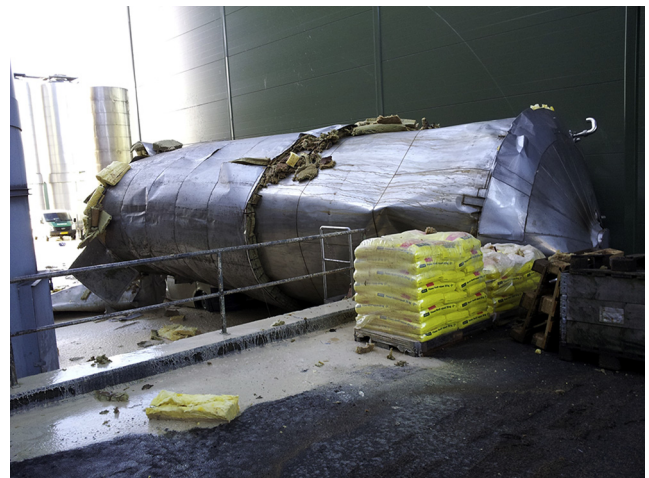
Fig. 2. The van is visible under the tank. The tank contents washed up on the elevated platform. (Photo courtesy of the company.)

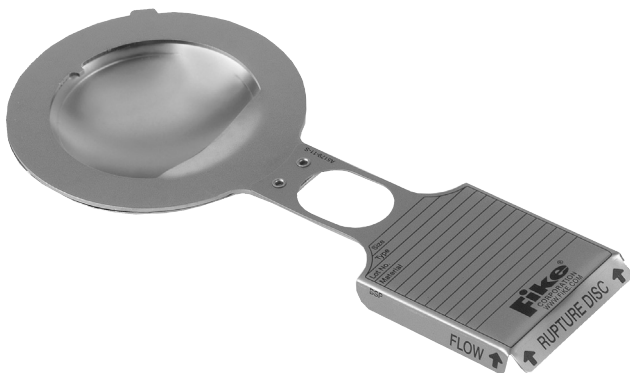
The rupture disc was intact. It was a reverse buckling type device that had been installed upside down (i.e., with the dome facing away from the tank). The vendor stated that the rupture disc likely

To guide correct installation, the arrow printed on the rating plate indicates the direction of the pressure relief (Fig. 5). However, the dome itself can point either way, depending on the type of design, and gives no reliable indication of the correct direction of installation.

Fig. 5. The reverse buckling type rupture disc (the dome points towards the fluid under pressure) is similar to the one installed on the incident storage tank. Proper flow direction of pressure release is marked on the nameplate. (Photo courtesy of Fike Corporation.)
