# Ten-Year Performance of Shell-Treated Wooden Deck<sup>1</sup>

The performance of a wooden deck made of refractory materials that have difficulties in achieving target penetrations as stipulated in the specification and quality standards for treated wood in Korea, was assessed via a case study in this research. A wooden deck built in Jinju in 2009 was selected for this study because of its fabrication method using pressure and treated refractory materials. The penetration and retention analysis did not satisfy the domestic standard for treated wood. Inspection of the deck in 2019 revealed that the deck had been attacked by decay fungi. Cap rails showed much deeper and wider checking on their surface compared with the top and base rails, resulting in a severe fungal attack. The decking boards exhibited severe fungal decay primarily in the end parts. However, the rails and balusters without checks and posts were virtually free of fungal attack irrespective of the preservative penetration measures. Copper content in the soil 5 cm away from the deck was less than 150 mg/kg, implying that copper movement in the soil was very limited. These results suggest that the inhibition of surfac

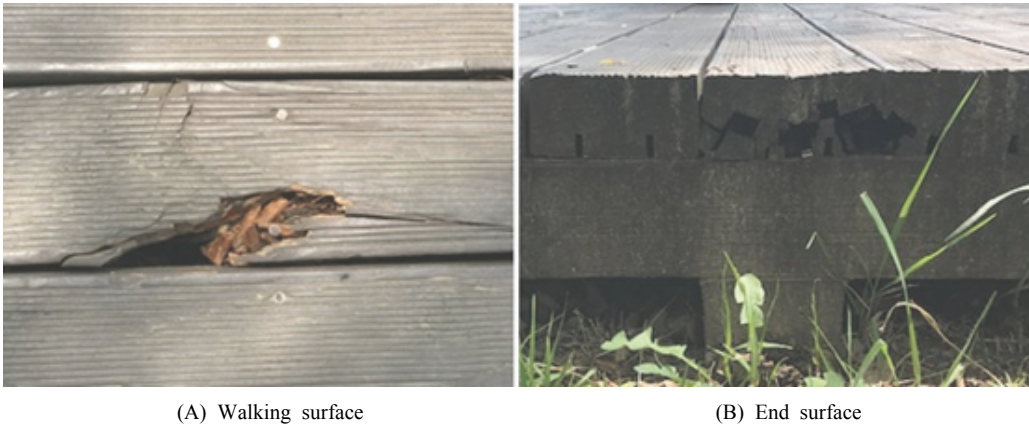
The decking board showed extreme graying from UV exposure, warping, checking, splitting, and decaying.

The deck boards seemed to be treated with oil stain once. However, the end surfaces of many deck boards were not treated sufficiently with wood preservatives, which resulted in severe decay (Fig. 2). The decay ratings of the decking in Table 3 are the values of the decking unreplaced.

**Fig. 2.** Decking boards showing severe decay.

new wood, must be treated by brush or spray application with wood preservatives. Domestically this is often overlooked, resulting in the severe decay.

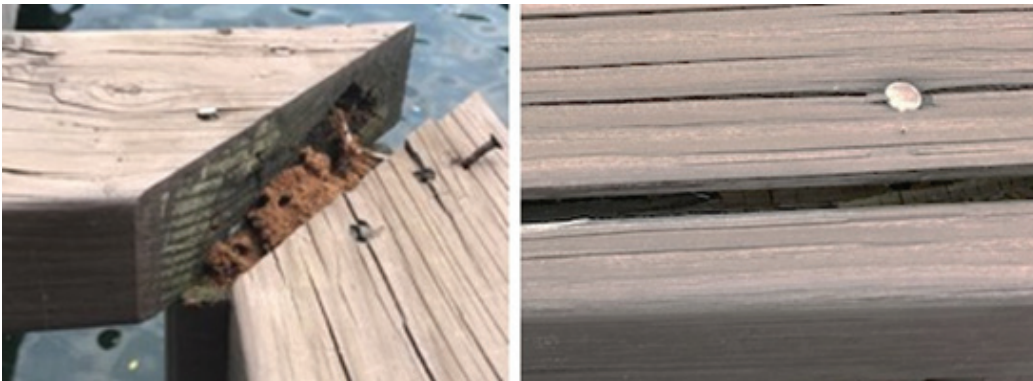
The inspection of the deck rails showed that the cap rails were under severe checking, splitting, and decay (Fig. 3). However, other treated members such as posts, top rails, base rails, and balusters had only limited decay in a few members and were not in danger of falling.

Severe decay in the cap rails can be explained by the poor penetration and retention, the occurrence of deep checking or splitting, and the exposure of untreated end surface (Fig. 3). The end surface, if cut to expose

**Fig. 3.** The decayed parts of the cap rails.

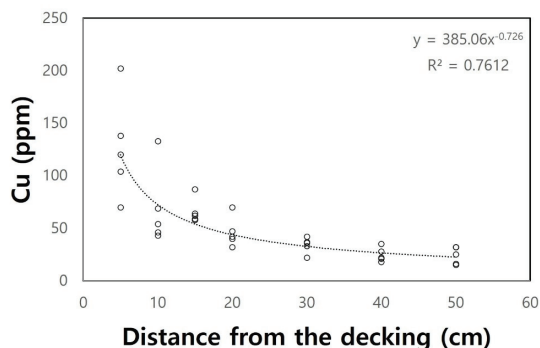
**Fig. 4.** The amount of copper depleted the treated wood in soil.

The evaluation of the degree of copper depleted in the soil showed that the Cu concentration was in the range between 15 ppm and 200 ppm (Fig. 4).

Copper concentrations varied from 50 ppm to 200 ppm in the soil 5 cm away from the deck. The copper concentration rapidly dropped to about 50 ppm at 30 cm. Several studies about the mobility of copper in soil showed similar results (Ra, 2015; Townsend, 2003). It seems that there is little concern about the environmental pollution considering that the domestic standard for copper is 150 ppm in the residential area.
