Cause Analysis and Improvement of Signal Interference in Byteflight Data Bus

¹Korea Aerospace Industries, LTD.

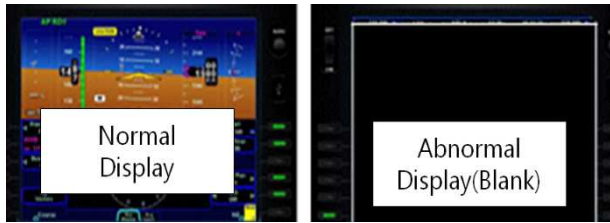
Fig. 2 Abnormal display.

We examined specific fault occurrences, as shown in Table 1 and Fig. 2, to accurately investigate failure of the integrated avionics system. We observed intermittent occurrences of blank or flickering display in the integrated display unit, loss of communication, and GPS faults.

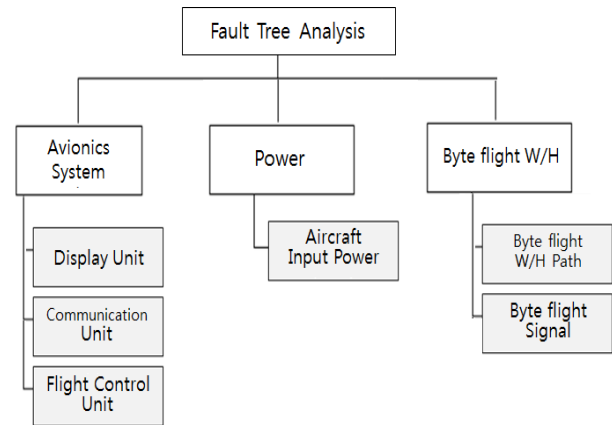
Fig. 3 Fault tree analysis for abnormal phenomenon.

By performing fault tree analysis (FTA), as shown in Fig. 3, we examined the effects of main factors that cause Byteflight data communication errors such as avionic units that use Byteflight signals (integrated display unit, communication unit, and flight control unit), instability of input voltage, and wire harness (W/H) path of Byteflight data bus connected between avionics units.

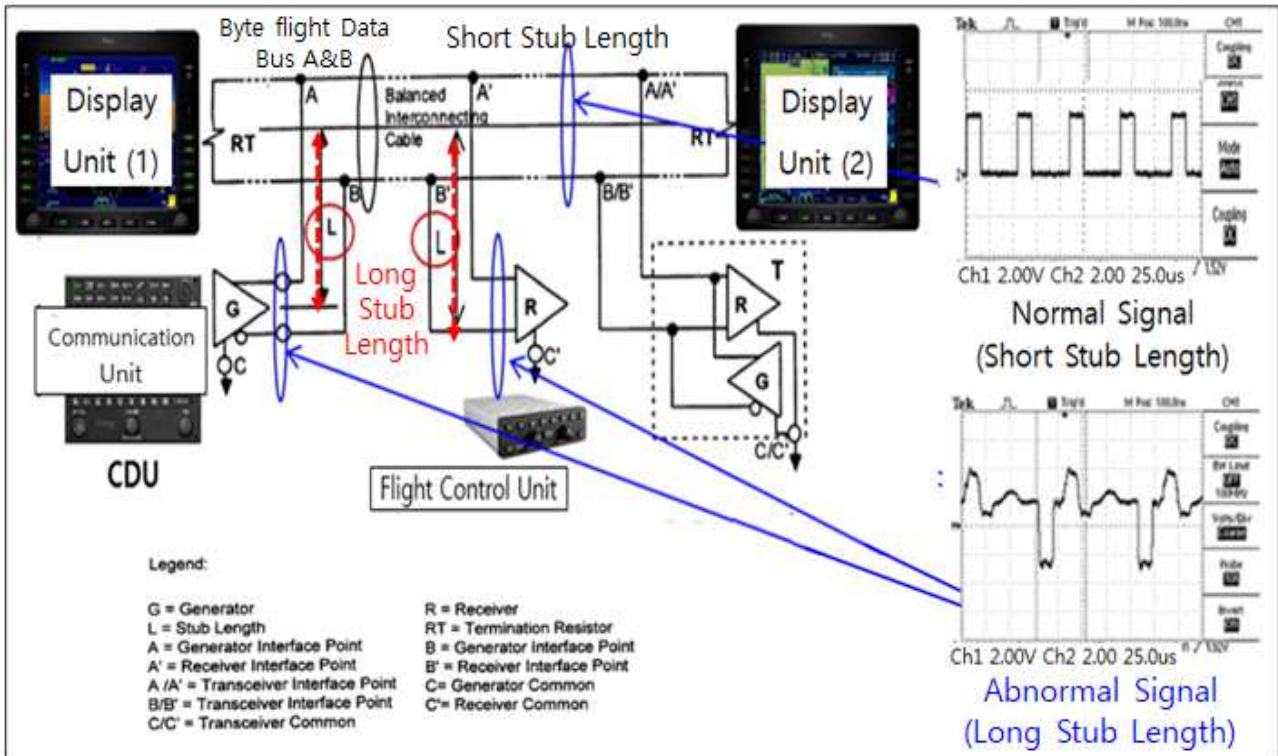
Fig. 7 Analysis of the TIA/EIA-485-A.

Furthermore, as shown in Fig. 7, we confirmed the content related to RS-485, which is the basis of Byteflight data communication in the standard specifications (TIA/EIA -485-A). As per the standard specifications, the connection should be made with the shortest possible stub length (L) such that a signal can be normally recognized from the main cable. Furthermore, in signals of a short stub length, linear and normal

signals are measured. However, in a long stub length, non-linear signals are measured. Hence, Byteflight data communication errors can occur due to interferences and distortions of signal waveforms [4]. Specifically, a parallel-line structure exhibits a characteristic impedance as shown in Eq. (1) and Fig. 8 [9]. Therefore, a variety of characteristic impedance ranging from 100 Ω to 300 Ω can occur. This leads to impedance mismatch based on the gap, length, and conditions of the red and blue lead lines at the stub point in the signal cable [10-11].

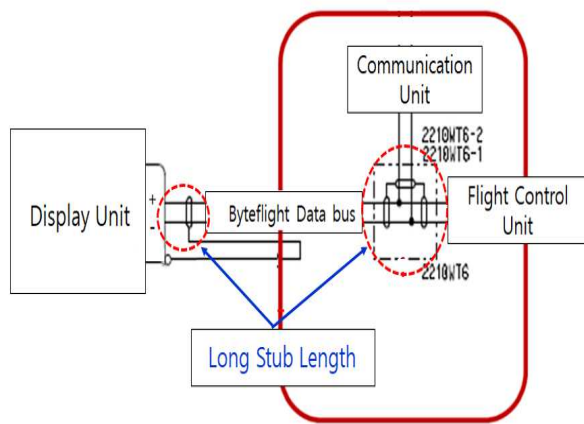
Fig. 9 Measurement result of Byteflight data bus stub.

Based on the examination results, the Byteflight data bus W/H is connected to various avionics system units of the integrated avionics system, and a variety of large amount of data is transmitted/received between the avionics units in real-time via each stub point. Hence, an open shield structure with a moderately long length is observed at the harness stub point of the avionics system units. Given the mismatch at each stub point of the W/H, signal interference and impedance mismatch can occur in transmitted/received data. Therefore, we measured actual impedance signals by using a time domain reflectometry (TDR) device. This device verifies impedance signals by measuring the reflected waves that are returned after providing step pulses to the stub point. In the measurement results, impedance mismatch signals are intermittently observed at the stub point as shown in Fig. 10. Therefore, we examined the method of minimizing the open shield part by applying the same short length at the stub points of the Byteflight data bus W/H.

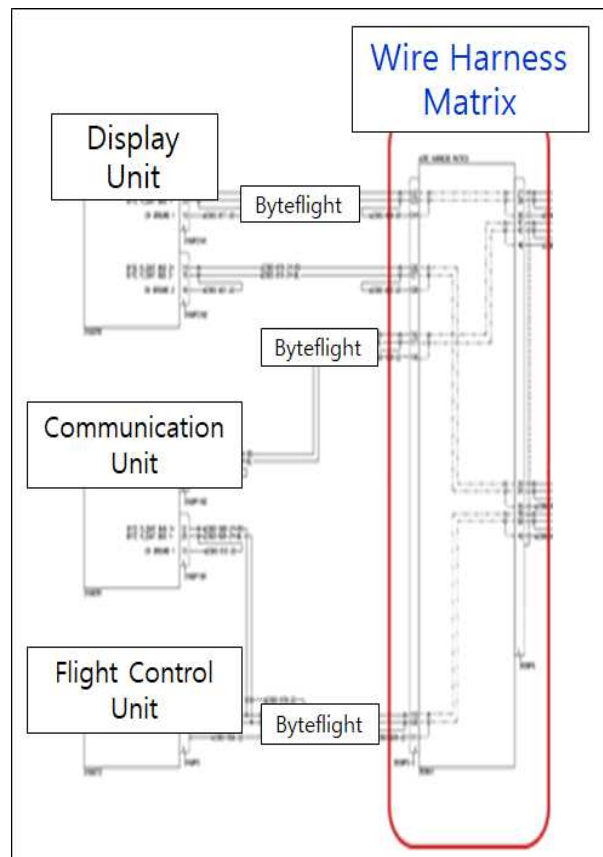
Fig. 11 Avionics unit and W/H matrix disconnection.

In addition to signal interference between the output unit and reception unit and inadequate length of the connected line, impedance mismatch can occur due to stub points between the W/H path. Therefore, we examined the Byteflight W/H path and length between the avionics units. As shown in Fig. 11, given various types of transmitted/received signals between the avionics units, the Byteflight W/H is designed to branch with a W/H matrix as opposed to directly connected between the avionics units such that each signal can be provided to each device. This design method involves applying separate W/H paths by adding W/H matrix to improve the maintainability based on ease of removing/mounting wires when Byteflight wires are deteriorated or damaged [12]. However, as stub points are added due to the W/H matrix of the Byteflight data bus cable paths, signal interference and distortion occur because of the impedance mismatch characteristics. This implies that improvements are required. Furthermore, given that the stub points connected to the W/H matrix exhibit an open shield structure, internal/external interference signals can lead to screen flickering. Therefore, it was necessary to examine the effect via signal measurement.

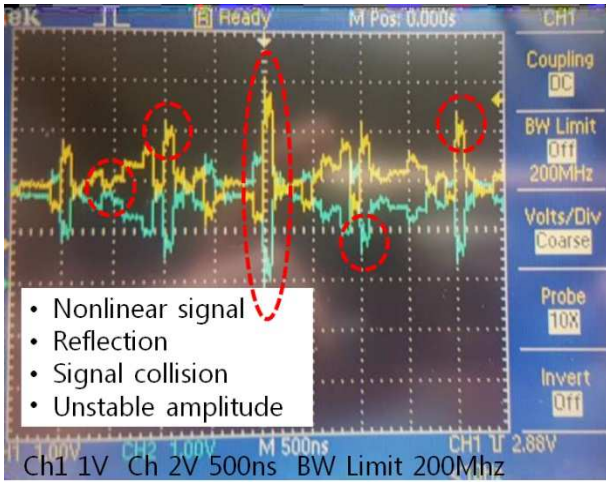
Fig. 12 Measurement results of Byteflight impedance mismatch signal.

We examined signals at the stub points of the Byteflight data bus with the open shield, a long length condition, and W/H path matrix. As shown in Fig. 12, weak signal strengths, unstable amplitudes, reflections, quality degradation, signal collisions, and high impedances were measured because of signal loss and impedance mismatch.

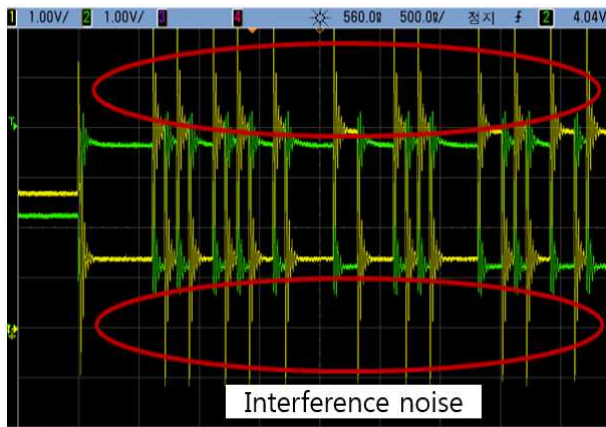
Fig. 13 Measurement results of Byteflight interference signal.

Furthermore, when linear and normal signals are measured, as shown in Fig. 13, interference signals are continually measured at the end of the signals. This implies that improvements are required.

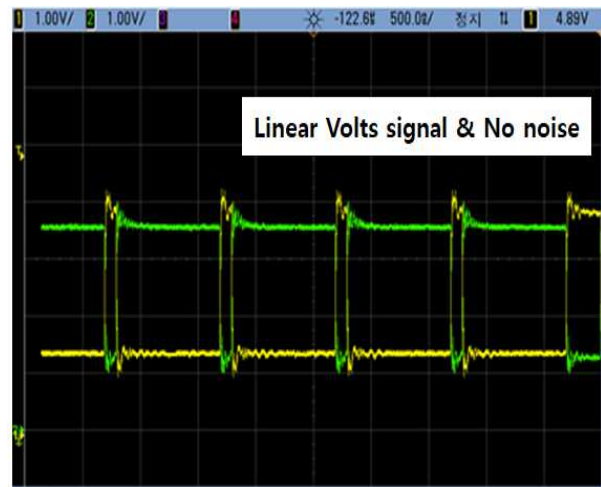
Fig. 17 Measurement result of Byteflight data bus signal after improvement.

We applied short stub lengths for the Byteflight data buses in the aircraft where abnormalities of the avionics system occurred. Then, after performing improvements with the method of directly connecting the W/H paths, we measured Byteflight signals. As shown in Fig. 17, waveforms of linear Byteflight voltage signals without interference and noise and with impedances of strong and weak signal strengths were continuously measured.

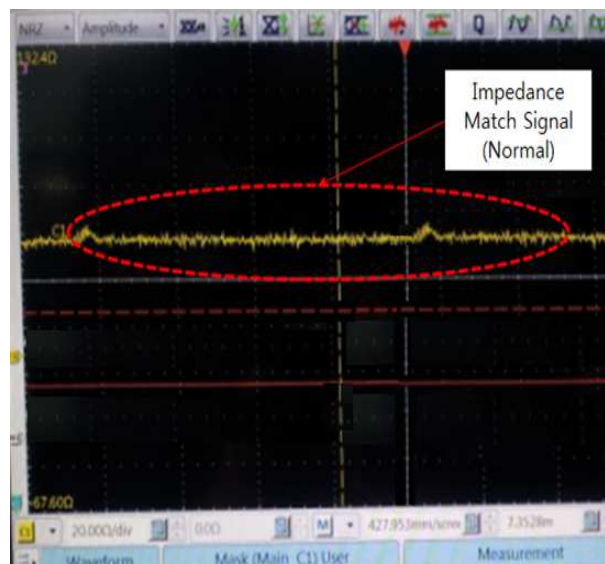
Fig. 18 Measurement results of impedance match.

Additionally, we used the TDR device to measure the impedance signals, and as shown in Fig. 18. Furthermore, normal impedance signals were continuously measured.
