Letters to the Editor

The Author Response: A Case Study on Engineering Failure Analysis of Link Chain

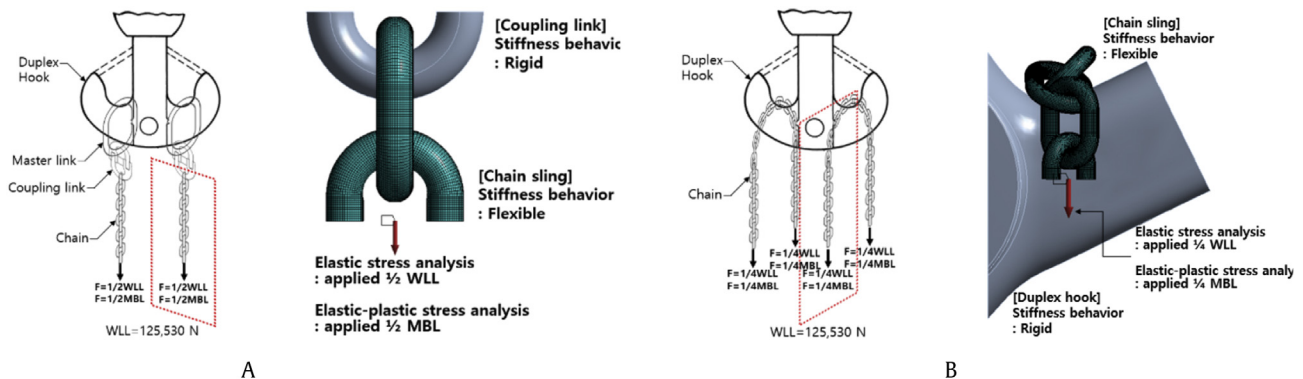
Fig. 1. Boundary and loading conditions of elastic stress analysis in each installation condition. (A) Correct installation condition. (B) Incorrect installation condition.

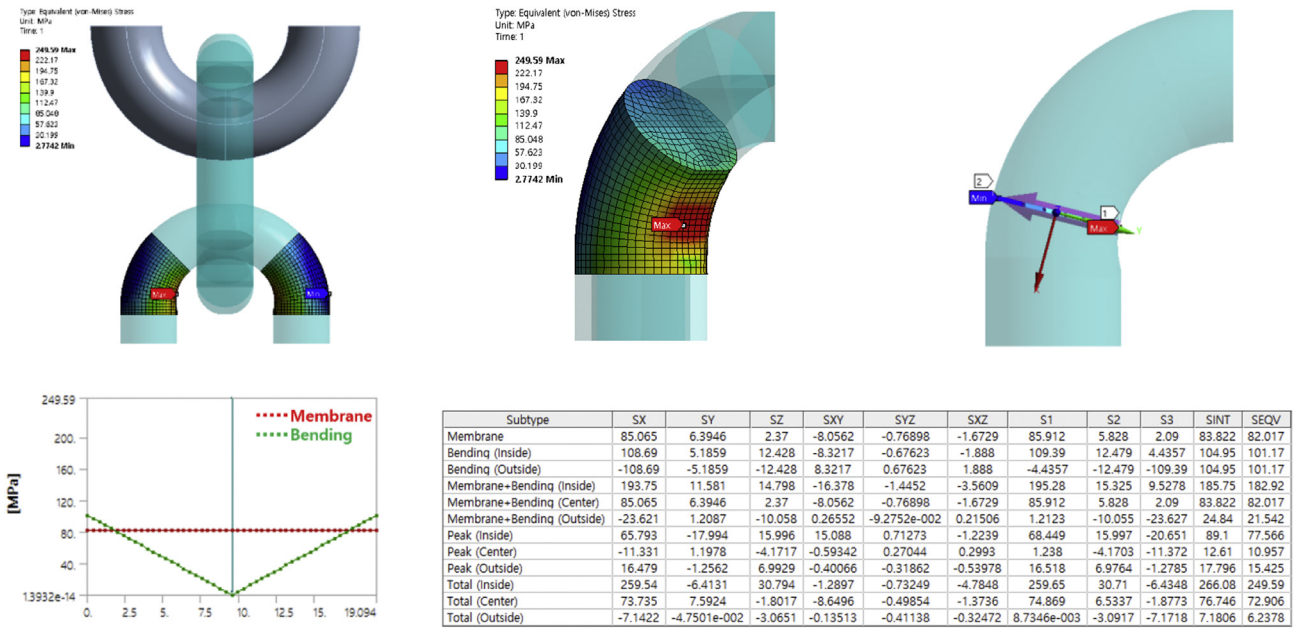
1. Response revised on FEA category in this paper: This article is written for supplementation of stress analysis parts (relatively idealised and straightforward structure, simplifying the loads and material property assumptions, etc.) for crane chain in the existing paper [1]. In material properties, an elastic material model for stress analysis, which was conducted in an existing paper, was used to re-evaluate plastic collapse due to the Working Load Limit (WLL) in each installation condition. The analysis results show that high stress (total stress) at the junction of the barrel and that of curvature of the crane chain are similar in the area where the crane chain was broken. Compared with the correct installation conditions, when high stress is applied, the incorrect installation condition evinced a breakage. For determining the membrane and bending stress components, the total stress distribution was obtained from elastic stress analysis, and linearised on stress component integrated along the cross-section of Stress Classification Lines (SCLs) through

the crane chain's wall thickness. It is shown that the results of this analysis support the results of the fractographic analysis presented in the original paper.

Fig. 2. Results of elastic stress analysis of correct installation condition.

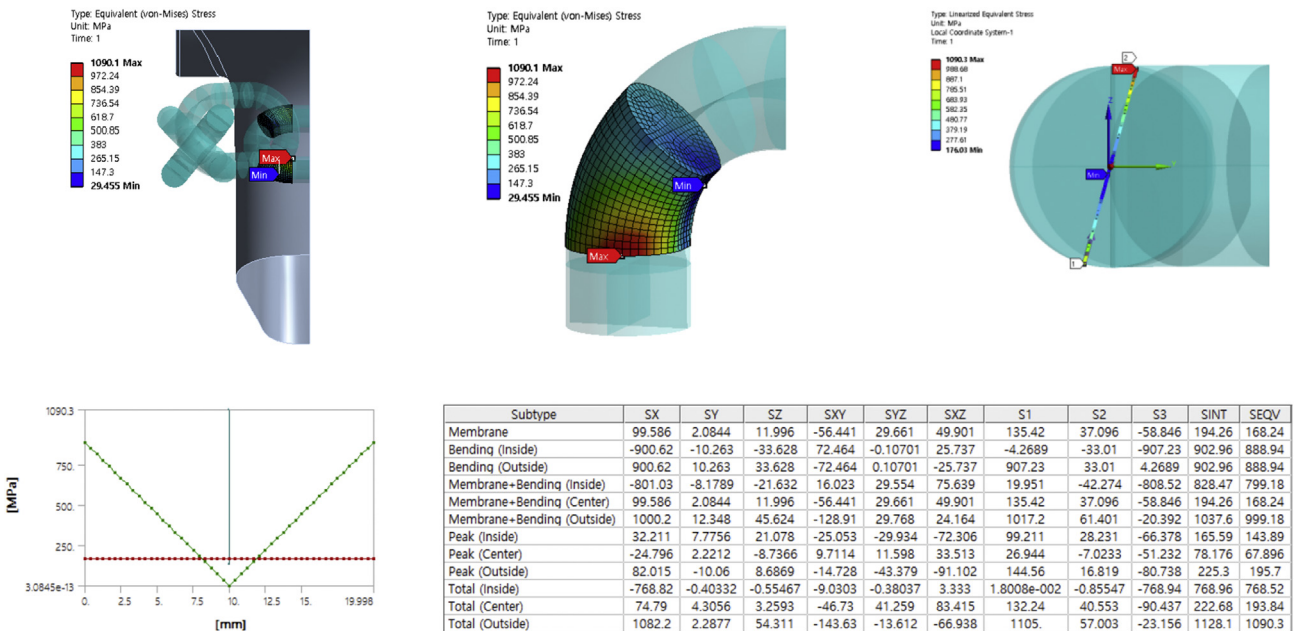
2. Additional explanation of the fractographic analysis: According to your comments on the paper, you claim that “the crack likely initiated around the chain inner surface, where the presence of high tensile stress under tension load or small stresses under bending load while a ‘crushed damage’ area was found there.” However, the crushed damage observed in the chain's inner surface cannot be formed by uniaxial tension load because the inner surface of the chain at this position was not contacted with other chains on the condition that the crane chain was installed correctly, as shown in Fig. 7 [1] A in the paper. Accordingly, we concluded that the crushed damage was possibly formed by an improperly installed crane chain inducing abnormal interlocking of the chains (Fig. 3).

Fig. 3. Results of elastic stress analysis of incorrect installation condition.
