Elimination of Screen-Flickering Phenomenon in Multi-Function Display During Flight of Fixed-Wing Aircraft

Jung-Hyuk Kwon¹, Ik-Hyun Kwon¹, Jun-Ho Beak¹, Geun-Hyung Jang¹ and Wang-Sang Lee^{2,†}

¹Korea Aerospace Industries, LTD.

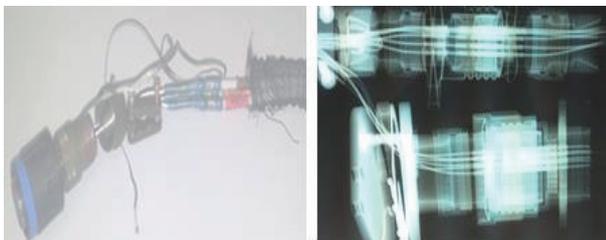
Fig. 5 Results of disassembly and examination of video cables.

First, the video cables in the aircraft suffering from screen flickering were disassembled, and the fabrication quality and workability of the cables were examined. It was determined that appropriate working methods had been used, as was the case for other sub-systems. Moreover, as shown in Fig. 5 and Table 3, no internal/external damage to the cables was found.

Category	Details
Workability	<ul style="list-style-type: none"> Contact, cable: Used specification Cable work: Clear Clamping, tapping: Clear Connector mating: Clear
Damage	<ul style="list-style-type: none"> No internal/external damage (X-ray result: Normal)

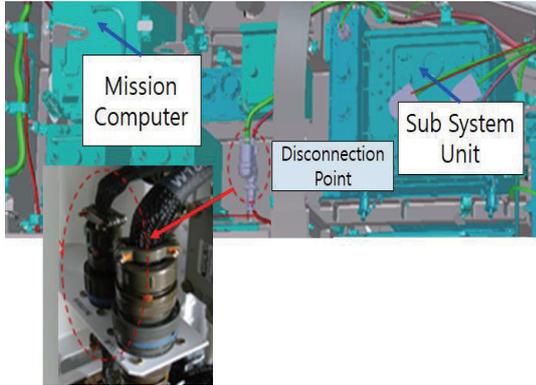
Fig. 7 Video signal path between the sub system and the mission computer.

to the mission computer, it was confirmed that the cables were not connected directly, but a disconnection point had been added, as shown in Fig. 7. The design included a separate wire harness path with a disconnection to improve the serviceability by ensuring ease of installation/removal during the long-term operation of the aircraft. This is a normal design method because there is no separate restriction on the application or number of disconnection points for the wire harness, including the video cables, in the standard specifications regarding wiring in aerospace vehicles (MIL-W-5088L) [7]. However, if the impedance characteristics are affected by the addition of a disconnection point to the video signal cables, signal loss and distortion may occur. Furthermore, if the external shield is open at the disconnection point, noise may enter the cable, causing screen flickering. Therefore, a detailed examination was needed.

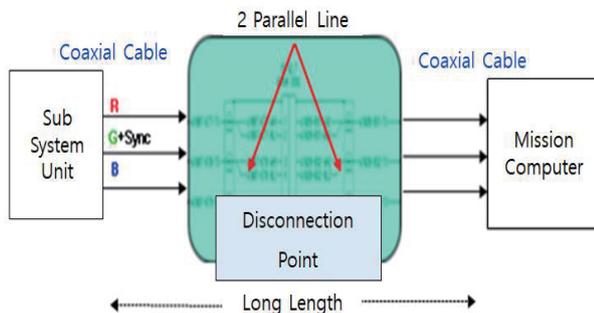
Fig. 8 Disconnection point in the video signal path.

Upon examining the disconnection point of the video signal cables, it was found that the point had a structure of two parallel lines, as shown in Fig. 8.

However, the disconnection point has a parallel wire structure and a characteristic impedance that are different from those of the coaxial cables, as shown in Eq. (3) and Fig. (10) [10]. As a result, the characteristic impedance may vary from 100 Ω to 300 Ω depending on the separation between the white and black lead wires at the disconnection point. Because the characteristic impedance does not match that of the coaxial cable (75 Ω), impedance mismatching may occur [11].

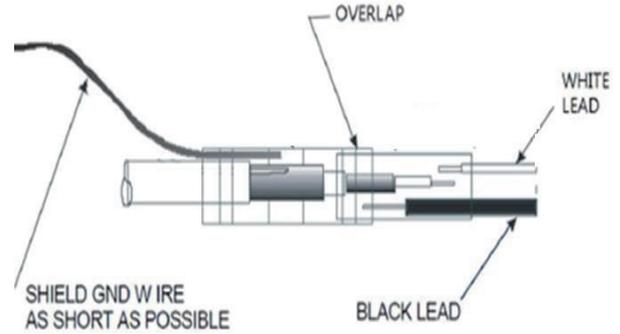
Fig. 9 Two parallel lines of lead configuration.

These parallel transmission lines comprise a white lead and black lead in the solder sleeve, as shown in Fig. 9 [8].

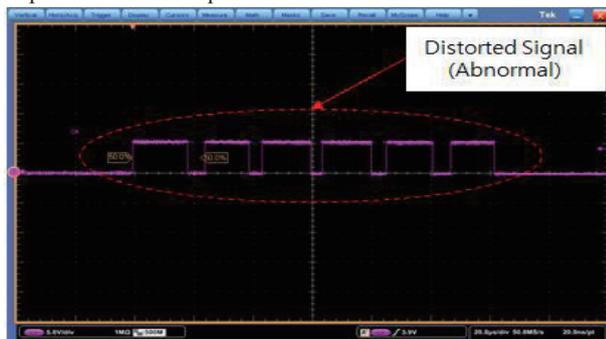
Fig. 12 Measurement result for disconnection point.

Pulses at certain intervals were expected to be generated in the output signals. However, based on the measurement results, distorted and disconnected signals were observed intermittently, as shown in Fig. 12; this indicates that an improvement was required.

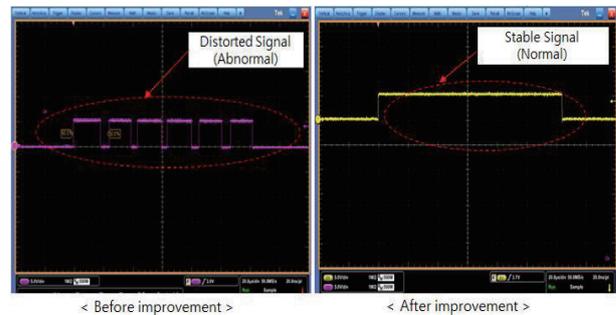
Fig. 17 Signal measurement result.

In addition, we measured the characteristics of the final signals provided by the mission computer to the MFD by using the method shown in Fig. 11. As a result, normal signals without distortion of disconnection were continuously measured in the output signals, as shown in Fig. 17, confirming the improvement in the output.

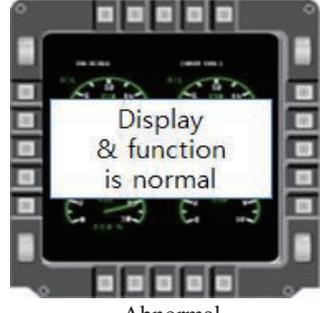
<p>Abnormal</p>
