# Cause Analysis for a Lining Damage in Sea Water System Piping Installed in a Korean Industrial Plant

K. M. Hwang<sup>1,†</sup> and S. K. Park<sup>2</sup>

<sup>1</sup>KEPCO E&C, 269 Hyeoksin-ro, Gimcheon-si, Gyeongsangbuk-do, 39660

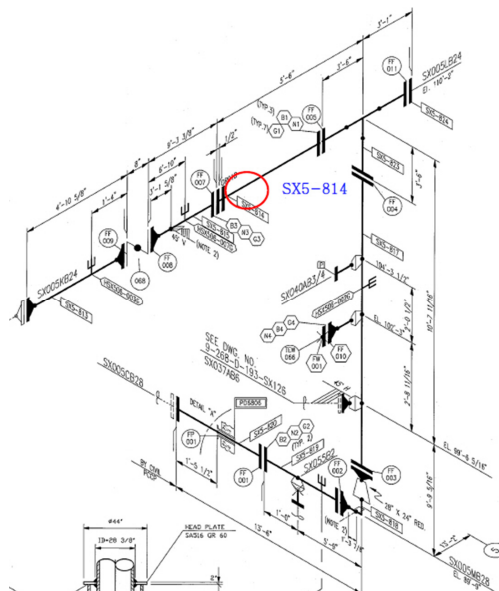
Fig. 3 Isometric drawing of the damaged pipe.

tribution of void fractions in vertical sections of piping in contour and void fraction profile. It was assessed that cavitation occurred as it was assumed to be dissipated after air bubbles were generated near the pipe wall up to an area of approximately  $0.5D$  at the rear of the orifice. This corresponds to the pipe damage areas shown in Fig. 2 and Fig. 3.

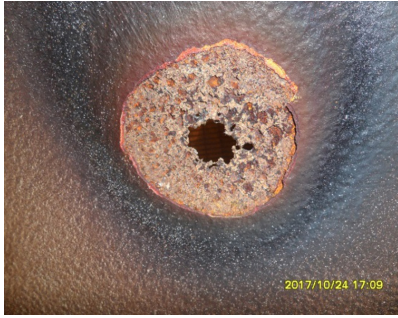
Fig. 4 Damaged inside surface.

the lining of the damaged pipe is peeled and the base metal is eroded, indicating that cavitation is the cause of the damage.

Visual inspection results show that the cause of the pipe damage in the component cooling seawater system is cavitation due to differential pressure at the front and rear of the orifice. As such, the cavitation evaluation was performed by engineering method. The cavitation evaluation was performed by the Tullis theory described in EPRI Report [4]. Cavitation and flashing are not evaluated as quantitative values, but rather as a method of evaluating the conditions under which the pipe is located by separating the occurrence conditions step by step. The intensity of the generation of the phasic cavitation can be calculated from the following equations (1) through (4) [5].

To prevent or mitigate such damage, it is necessary to find ways to prevent rapid pressure reduction by securing horizontal part length at the rear of the orifice, reducing cavitation through change of orifice hole size or type, and optimizing operation range with no cavitation.

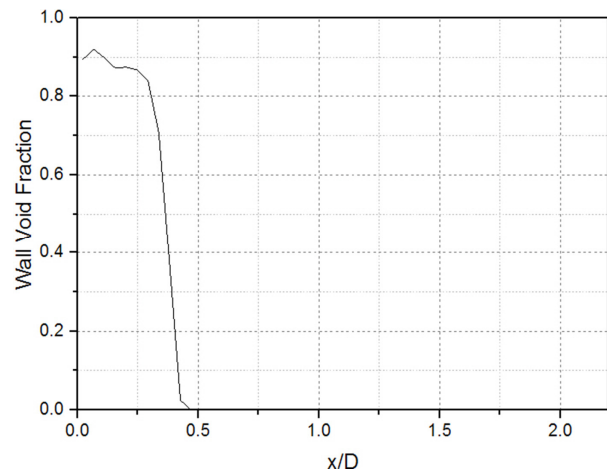
Fig. 10 Void fraction profile in vertical section

The cause of piping damage was analysed by engineering evaluation and CFD analysis for the damage of the lining occurred in the rear piping of the orifice installed at the rear of the heat exchanger of the component cooling seawater system of a particular nuclear power plant in Korea. In the engineering evaluation using the Tullis theory, it was evaluated as an incipient damage, and CFD analysis also interpreted cavitation as a result of the rapid disappearance of bubbles over a  $0.5D$  distance after bubbles were generated at the immediate rear of the orifice. In the case of seawater piping, if the internally lined polymer material can absorb water shock by cavitation, there is no damage to the piping. However, a polyester-based Archcoat lining material installed inside the piping was found to be failed to withstand the impact from cavitation due to its high hardness and hardening of materials due

to its long-term use. This corresponds to the flaking damage in Fig. 1.
