Failure Analysis of Circulating Water Pump Shaft in Power Plant

Jaehong Lee, Nam-gun Jung

Abstract

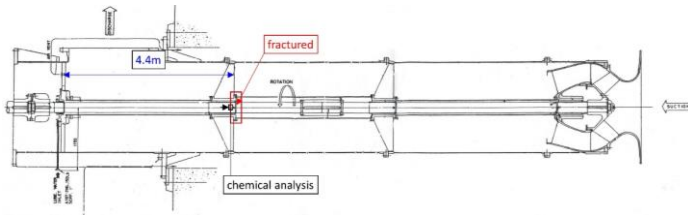
The circulating water pump had broken down in the 560 MW power plant after 24 years in-service. A 10-meter-length shaft of vertical pump was fractured at the location where 5 mm-depth split ring groove exists 4.4 meters down from the top shown in Fig. 1. The shaft was made of 316L stainless steel and has a diameter of 220 mm in the design.

Fig. 1. A drawing of the failed circulating water pump. The fracture position in the shaft was indicated by red the arrow. The sectioning sample, which was examined in chemical analysis and microstructure and hardness in the next chapter, was indicated by the black square and its direction by the black arrow.

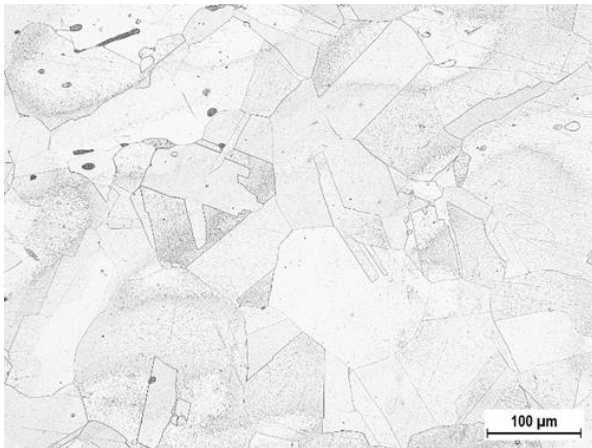
Fig. 3. Optical micrograph of the shaft. It shows no harmful microstructure such as heavy sensitization in low magnification.

an optical microscope. The sample 20mm away from the fracture same as in chemical analysis was used. The surface of the specimen was etched by Vilella's reagent after being grinded by silicon carbide papers up to P800-grit and polished in sequential by 6 μm to 1 μm diamond as a slurry on cloths. Fig. 3 shows microstructure of the shaft made of austenitic stainless steel. Heavy sensitization effect such as wide and dark lines at the grain boundaries which can be easily shown even in low magnification micrograph was not found.

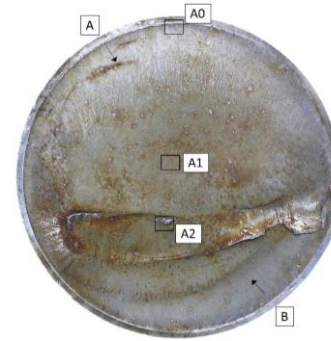
Fig. 4. Macro-fractography of the failed shaft. (a) The fracture surface of the failed shaft. Crack propagation direction was indicated by the arrow. (b) A schematic diagram of the fracture surface. Crack initiation site was named as 'A', 'B'. Fatigue zone and Instantaneous zone with expected fatigue propagation history were displayed in the figure.

on the surface. The surface was chemically cleaned prior to fractographic inspection by organic and alkali solvents for elimination of debris, oil and rust to make the fracture surface features discernible such as ridges for striation. For applied load histories being well-preserved on the surface, no acidic cleaning solution was used [4]. First, it was treated by organic solvent cleaning and soft brush. Next, ultrasonic cleaning was performed in the ultrasonic bath with the alkaline detergent, ULTRAMET Sonic Cleaning Solution, provided by Buehler. A detailed photograph of the top left side in Fig. 4(a) is shown in Fig. 5. The ratchet and ratchet-like marks are revealed along the top left circumference of the shaft. It implies they were origin of the crack and high stress concentration or high stress had been applied to top-left region on the fracture surface. Multiple arrest marks colored in brown by oxidation also intensify the thesis. There is a similar zone where ratchet-marks exists along the local circumstance of the shaft at the bottom and bottom-right on the surface in Fig. 4(a) but much milder than the top-left.

From the region a little below the top, there are numerous shiny ridges which travel downwards which implies unstable state of crack generation [5]. Afterwards, the surface becomes flatter while on the left side of the surface the clear shiny ridges exist. The flat surface changes dramatically to the hill-and-hole zone called the instantaneous zone (IZ) at the lower center of the surface which is usually generated due to the overload.

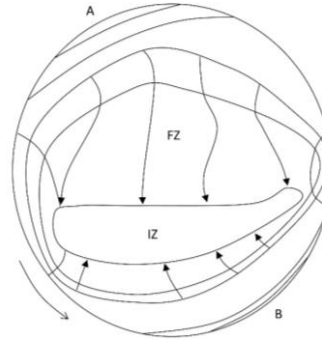
(b)

Fig. 4(b) shows a simplified schematic diagram of the fatigue fracture pattern of the failed shaft. Stress which had been applied to the shaft was low generally until final fracture occurred considering that small area of the IZ in Fig. 4(b). The oval shaped IZ can be considered as the result of a combination of the reversed bending

In summary, at the initial stage, reversed bending moment with moderate to high stress and severe stress concentration had applied to the shaft. Afterwards, the crack had propagated subject to a combination of reversed bending and rotating bending with the intensity of low stress and high stress concentration.

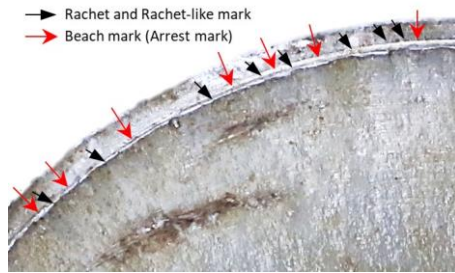
Fig. 5. Detailed fractography of the failed shaft. Oval beach marks, which is barely visible in the photograph, at the multiple points are indicated by the arrow. Ratchet marks at the groove are also shown in the figure.

and the rotating bending moment. Furthermore, its roundness is so small that the reversed bending was much more dominant than the rotating bending to the cracking. Ratchet marks at the top as shown in Fig. 5(a) can make us confirm that there had been severe stress concentration, high stress or both on the shaft at the initial stage. The wide progression marks at the initial stage makes sense with the accordance to Fig. 7. At the propagation stage, stress had applied more intensely to the upper part than the lower part given the fact that progression marks at the upper fatigue zone are wider than the lower one.

High stress concentration at the location the diameter changes can be reduced by changing the roundness of the corner. Mechanical

- 1) Shape improvement of split ring groove for less stress concentration was recommended;
- 2) Shaft alignment and runout examinations should be managed thoroughly;
- 3) Considerate vibration monitoring should be maintained after an overhaul.

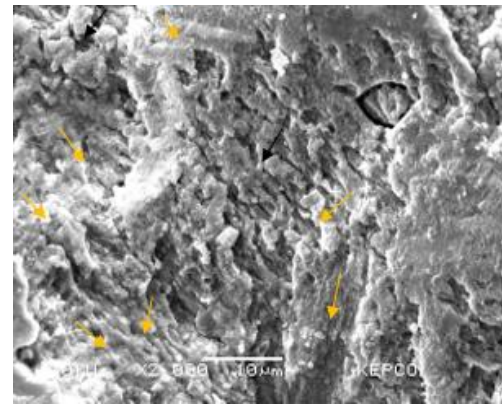
Using scanning electron microscope, the micro-fractography of 'A0', 'A1' and 'A2' in Fig. 4(a) was obtained. Fig. 6(a) shows the possible striations beneath the oxidized fracture surface in 'A0'. The fracture surface in this region was damaged attributed to post failure rubbing. In the region 'A1', striations are clearly visible which propagates to the bottom shown in Fig. 6(b). At instantaneous zone 'A2', there are numerous dimples which indicate ductile fractures shown in Fig. 6(c).

Fig. 6. Micro-fractography from scanning electron microscope (a) 'A0' in Fig. 3. Possible striations underneath the corroded surface indicated by the arrow. (b) 'A1' in Fig. 3. Patterns of striations revealed clearly. (c) 'A2' in Fig.3. Dimple patterns which exist on the surface.
