폐플라스틱 열분해 유화 공정의 화재·폭발 위험성 및 안전관리 방안

Fire and Explosion Hazards and Safety Management Measures of Waste Plastic-to-Pyrolysis Oil Conversion Process

Dong-Hyun Seo^{1)*} · Yi-Rac Choi¹⁾ · Jin-Ho Lim²⁾ · Ou-Sup Han³⁾

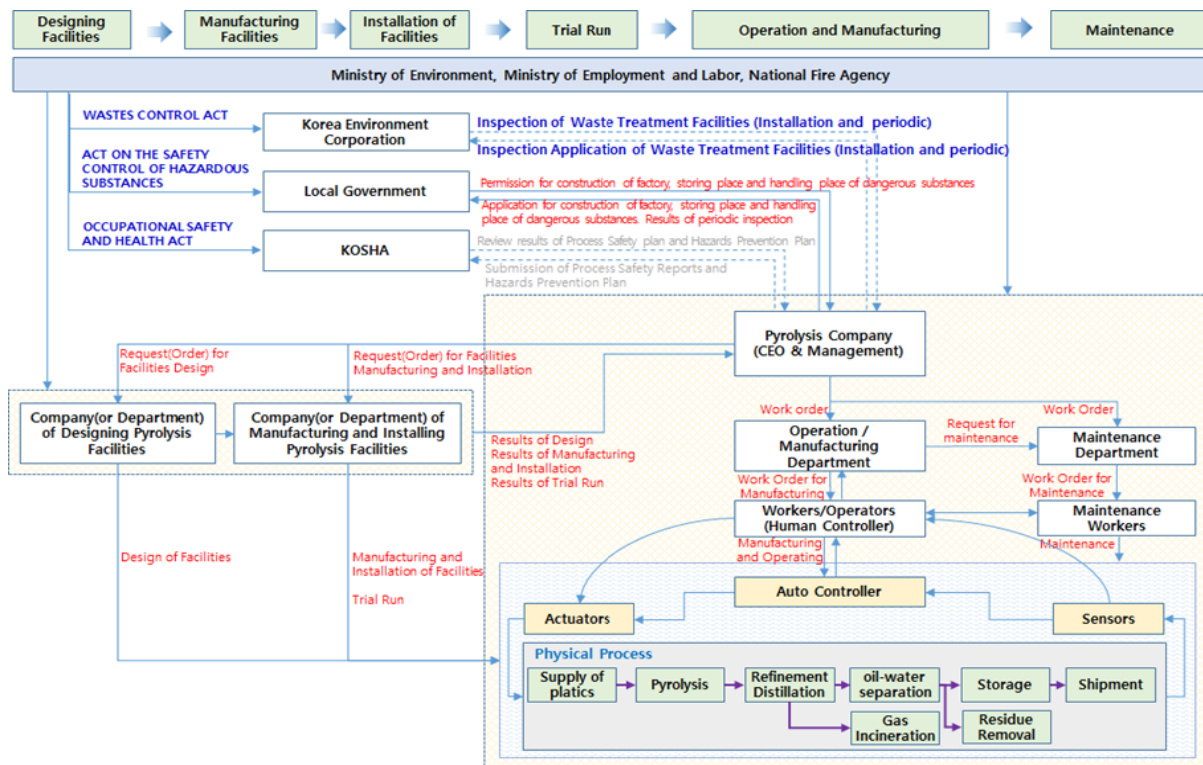
Fig. 1. Safety control structure of the waste plastic pyrolysis process and the related organization

재해조사보고서가 작성된 사고 분석 대상 사업장 7개소 모두 20인 미만의 소규모 사업장이어서 비슷한 조직구조를 가지고 있는 것으로 파악되었기 때문에 7개 사업장의 사고 분석을 위한 모델을 Fig. 1과 같이 하나로 통합하여 작성하

였다. 일부 업체는 자체적으로 설비를 설계하였고, 일부 업체는 중국에서 수입하거나 설비 제작업체에서 구매하여 설치하는 경우도 있었기 때문에 설비의 설계, 제작, 설치는 관련 업체 또는 부서로 표시하였다.

Table 4의 분석결과를 보면 4M 분석에서 제시된 사항 외에 정부 및 산하기관, 열분해설비 설계·제작·설치업체의 문제점과 열분해 업체의 문제점도 추가로 도출되었다. 정부 및 산하기관의 문제점은 주로 법적 또는 행정적인 사항 들이고, 열분해설비 설비의 설계와 제작, 설치업체 관련 문제점은 설계 시 자체 기준으로 설계 및 제작, 안전장치 미 반영, 관련 도면 및 자료 미제공, 방폭 기준 미적용, 설계 오류 등이었다.
