A Study on the Systematic Cause Analysis of Shipboard Fire Accident Case using STAMP Methodology

JeongMin Kim*, HyeRi Park**

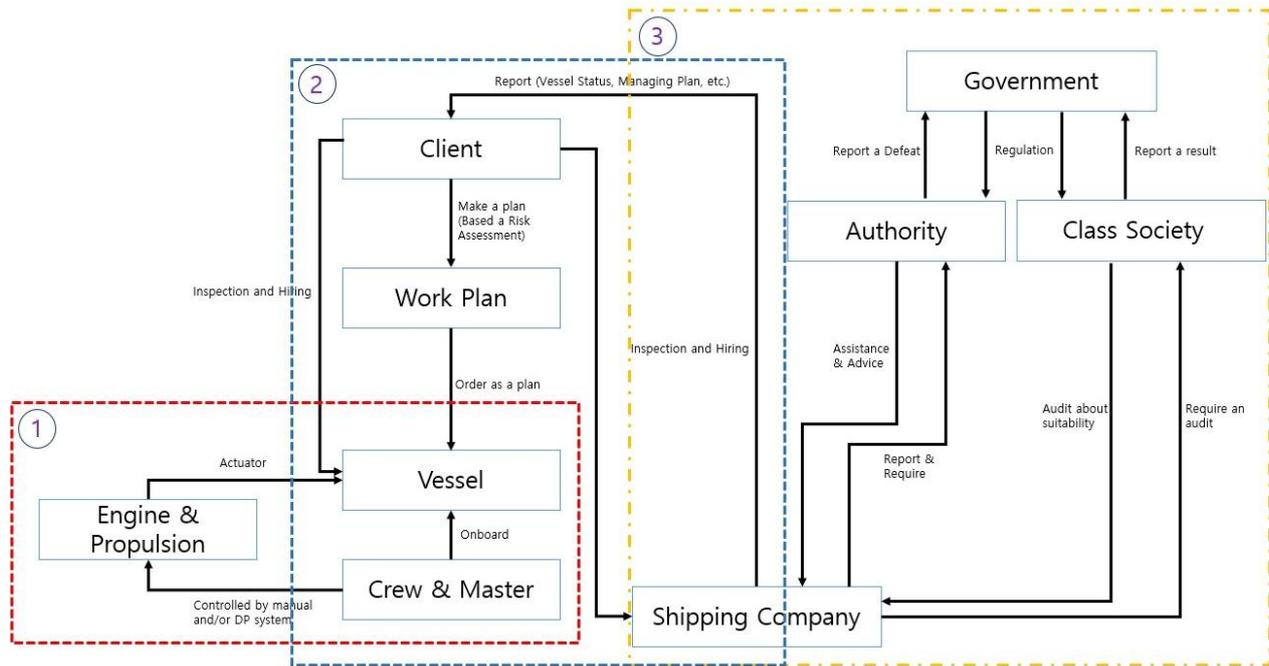
Fig. 2. Control Structure of Case Study

To conduct STAMP analysis for the accident, it has constructed a control structure for the ship and its operational system as depicted in Fig. 2.
