Preliminary Round Robin Test(RRT) for Program for the Inspection of Nickel Alloy Components(PINC) - Reactor Vessel Head Penetration (RVHP) -

Kyungcho Kim*[†], Sungsik Kang*, Hosang Shin*, Myungho Song*,
Haedong Chung* and Yongsik Kim**

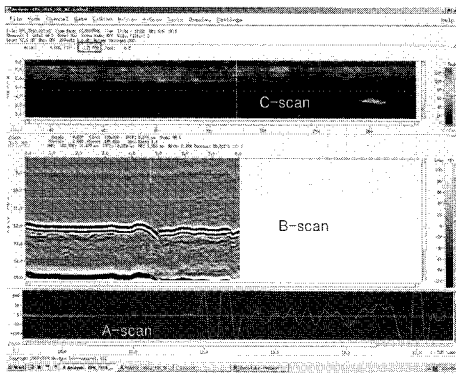
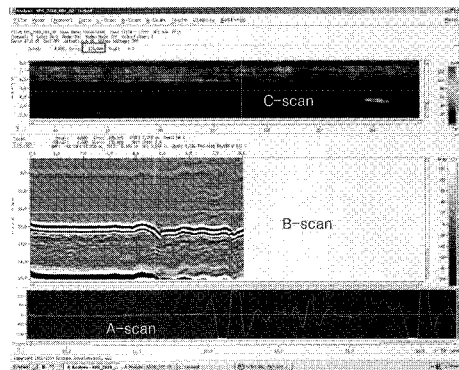
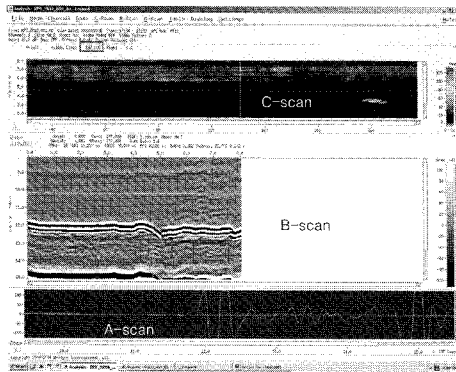
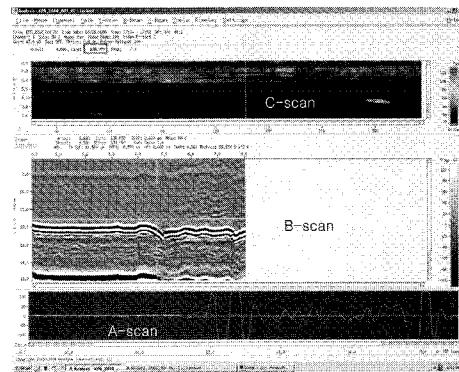
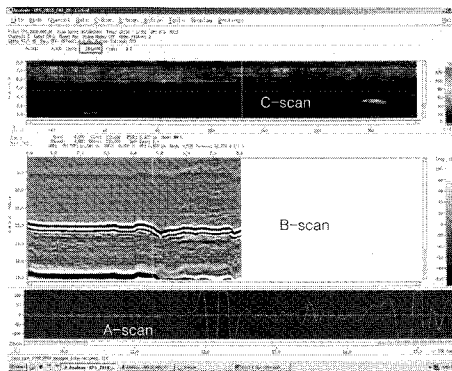
Fig. 3 A, B and C scan according to scanning time

For axial crack departed more than 12.8 mm from OD to J-weld outside, no vender found defects. One vender found axial crack departed less than 3.8 mm or 3.4 mm from OD to J-weld outside. In order to confirm the reason why B team could not find defect #1-3 and #4-3, A, B and C scan were shown according to scanning time in Fig. 3. In A-scan, vertical axis is

horizontal axis is the degree of nozzle circumferential direction. The resolution of horizontal axis is 1 degree(frame). In Fig. 3 (a), the rectangle box in B-scan is the location of the defect. If we focus on the rectangle in B-scan from frame 135 degree to 139 degree, the crack becomes bigger gradually and then becomes smaller. False indication near this red rectangle in frame 137 appears suddenly without reason. This defect was not easy to detect.

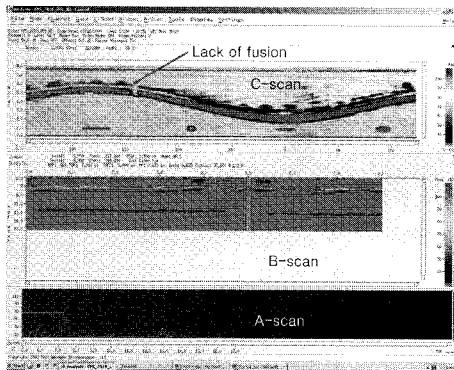
(a) A, B and C scan from leak path of mockup #1

Two venders found the leak path of mockup #1, but one vender found leak path of mockup #4. In order to check why the inspectors missed

the leak path, A, B and C scan of two leak paths were compared. Fig. 4 shows the two leak paths.

If we compare (a) and (b) of Fig. 4, we can confirm that team B did miss leak path of mockup #4.
