# Correlation between Physical Defects and Performance in AlGaIn/GaN High Electron Mobility Transistor Devices

Seong Yong Park, Taehun Lee, and Moon J. Kim<sup>†</sup>

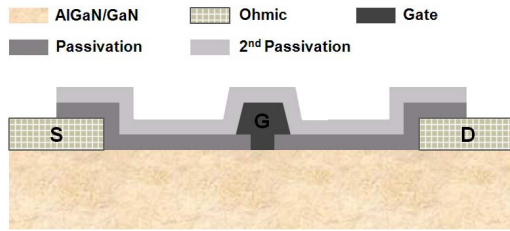
Fig. 1. Schematics of AlGaN/GaN high electron mobility transistor.

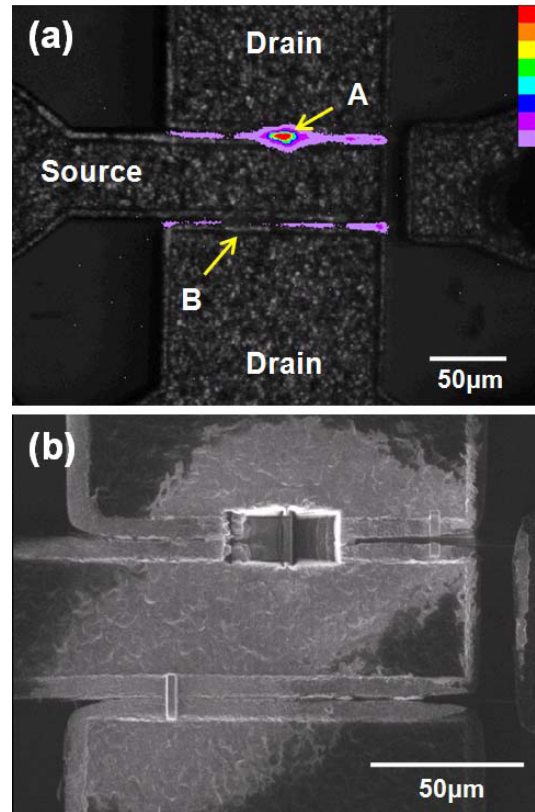
Fig. 2. (a) PEM image showing light emission in the transistor channels; emission intensity increases toward red color as indicated color bar in the upper right corner. (b) Site specific sample preparation using focused ion beam at the positions indicated by arrows in (a).

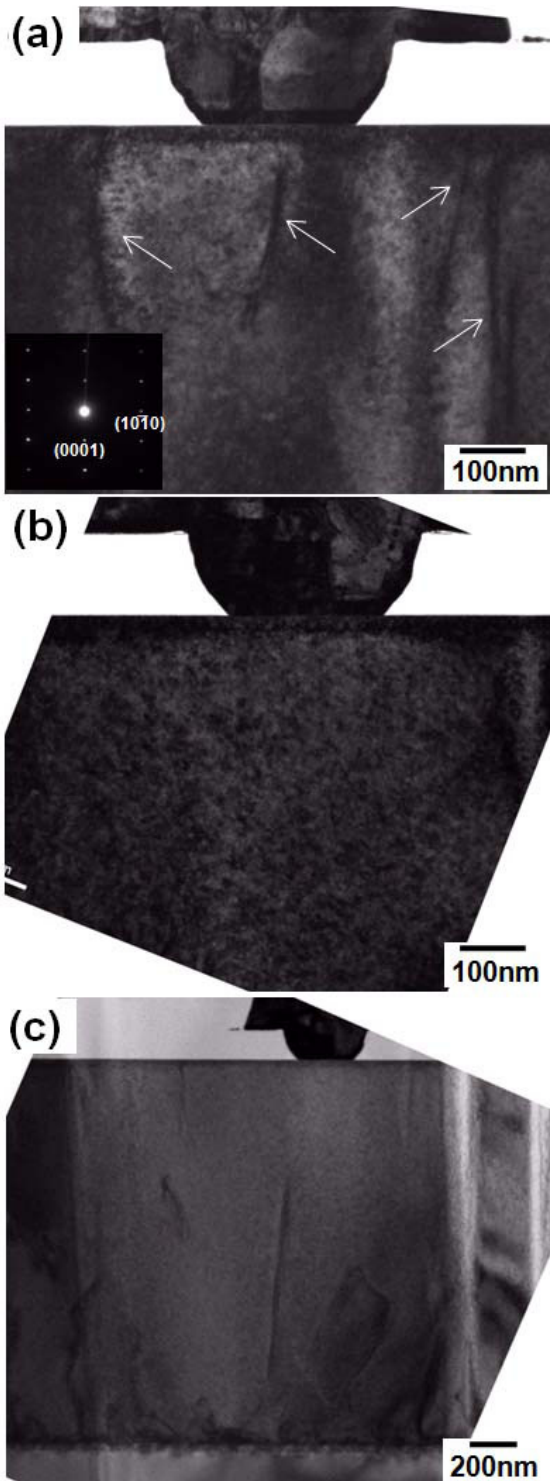
Fig. 3. (a) and (b) cross sectional bright field (BF) TEM images prepared at the spot A and B in the Fig. 2(a), respectively. Inset in the lower left of (a) is a selected area diffraction pattern from GaN. (c) Lower magnification BF image of (b) showing entire GaN layer.

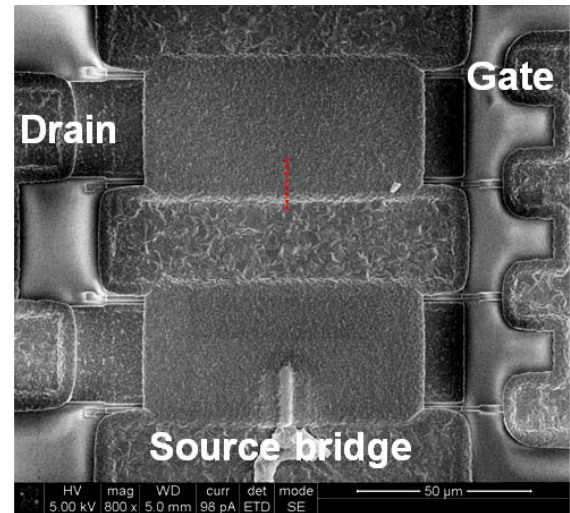
Fig. 4. Top view SEM image of high electron mobility transistor devices used in the reliability test. Transmission electron microscopy sample was prepared at the middle of center finger as indicated by red dotted line.

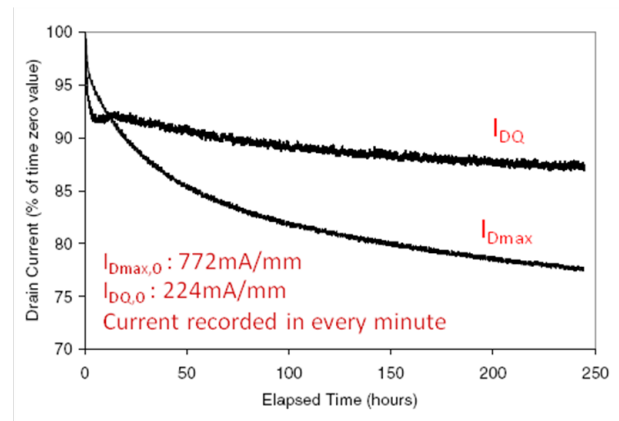
Fig. 5. Evolution of drain current ( $I_{DQ}$ ) during the reliability test under a 40 V drain bias and maximum drain current ( $I_{Dmax}$ ) recorded every hour under a 5 V drain bias and 1 V gate bias.

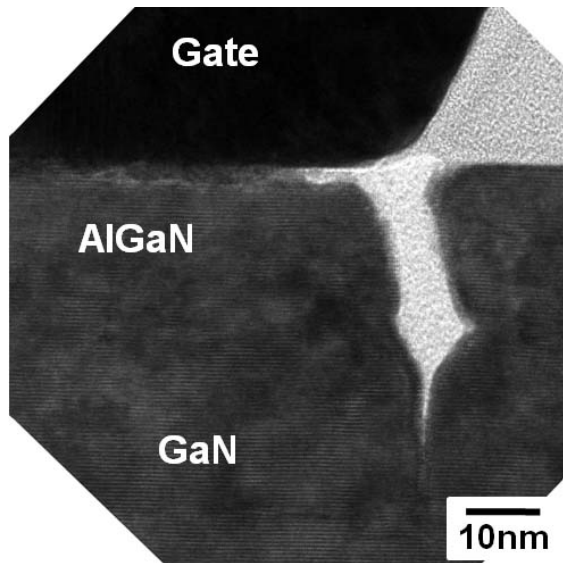
Fig. 6. Cross sectional high resolution electron microscope(HREM) image showing a defect formed in the channel under gate edge in drain side.

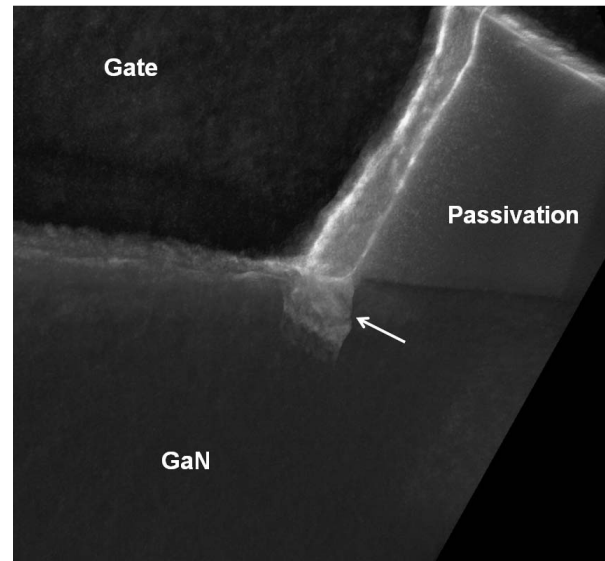
Fig. 7. TEM tomography image showing three dimensional morphology of the defect observed in Fig. 6.
