Reconsidering the “MR Unsafe” breast tissue expander with magnetic infusion port: A case report and literature review

Case Report

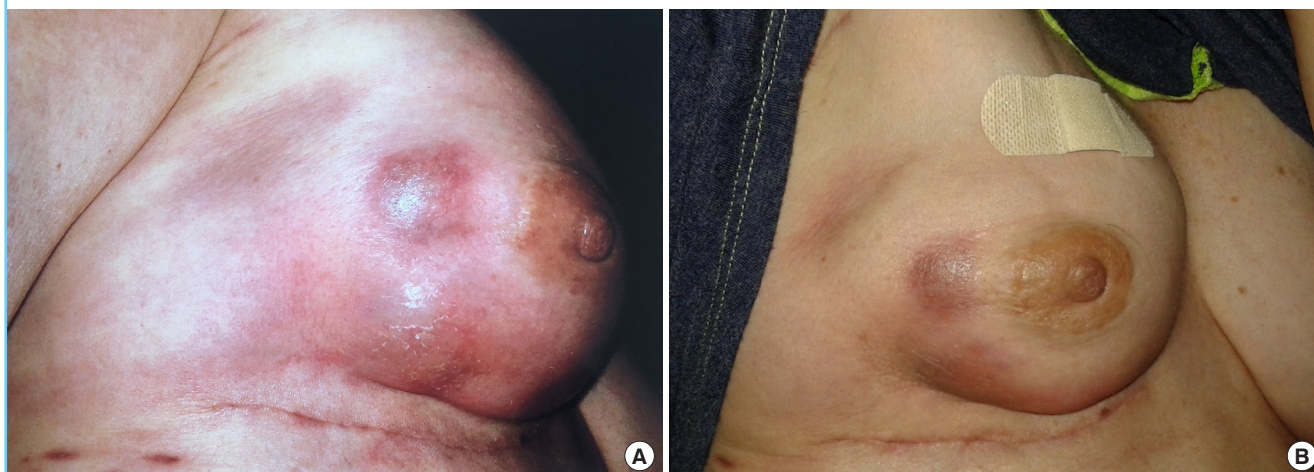
Fig. 1. Expander loss following vehicular accident and MRI

At 8 weeks postoperative, the patient was struck by a motor vehicle while crossing the street. She presented to an emergency department, where physical examination demonstrated "very mild erythema" of the right breast with no signs of injury or point tenderness. Due to right shoulder pain, her primary care physician ordered an MRI. During pre-MRI screening, the patient informed the MRI technologist that she had a breast TE. Despite the presence of that implant, the MRI examination was performed. During MRI, the patient reported an uncomfortable sensation in her right breast and the scan was immediately aborted. The reason for the patient's discomfort could not be determined.

Five days later, the patient presented to the emergency department with right breast pain. On physical exam, the breast had two lesions, 2 cm in diameter, and associated erythema and swelling. She was diagnosed with cellulitis and was prescribed clindamycin. The cause of the cellulitis was likely associated with the trauma sustained from the traffic accident. The patient presented to her plastic surgeon the following day who also noted right inframammary fold erythema and the small lesions (Fig. 1). The saline in the TE was removed. Despite these maneuvers, the right breast continued to worsen and by 3 weeks post-MRI, the patient had impending TE exposure and required

(A, B) Clinical photographs showing inframammary fold erythema and blistering of the patient's right breast following motor vehicle collision with the patient as a pedestrian and subsequent magnetic resonance imaging (MRI).
