# MEASUREMENT OF COASTAL EROSION ON THE EAST SEA USING CORONA SATELLITE IMAGERY

Heedae Park, Jong-Hong Kim, Joon Heo

Yonsei University, School of Civil Engineering,  
E-mail : parkheedae@yonsei.ac.kr, kkdevil@hanmail.net, jheo@yonsei.ac.kr

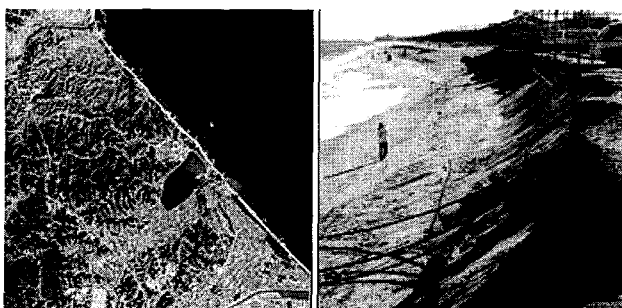
Figure 1. Kangmoon Beach's location and present image

Kangmoon Beach, the research objective of this study, is located in Kangneung, Korea. Originally it had length of 400m and area of 16,000 m<sup>2</sup>, but severe coastal erosion which occurred in 2000 removed about 200m of sand beach and nearby parking lot, eventually the beach didn't open in that season. In the end of 2000, 90m-length groin was constructed and it contributed to temporal beach recovery, but after one year, the erosion occurred again and it threatened not only sand beach but also a residential area. Hence, if related data is easy to collect, this area has a potential to observe 1960's and 1990's coastal line change through a rapid development, and dynamic appearance of change with temporal effect of groins which was constructed to prevent erosion and re-erosion. Fig. 1. shows the location of research area, Kangmoon beach(an area with red dotted) and present image in 2006, after erosion.
