# 공기 압축기 고체음 저감에 대한 연구

A study on the reduction of structure-borne noise from air condensing compressor

**Key Words :** 고체음(Structure-borne Noise), 왕복동식 공기압축기(Reciprocating Air Condensing Compressor)

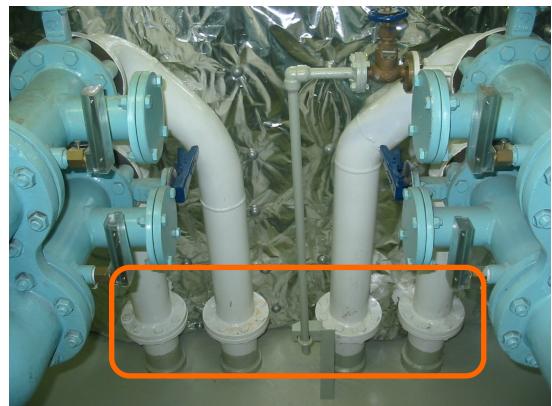
Figure 4

배관 pipe 경로

Fig. 4

Fig. 4  
(flexible joint)  
(steel deck)  
(U - bolt support)

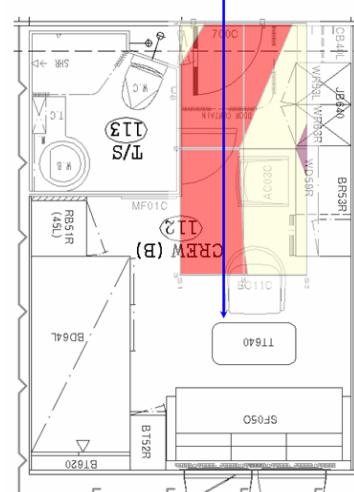
Figure 5

crew(B)

( : 55~60dB, : 50~55dB,  
500Hz)

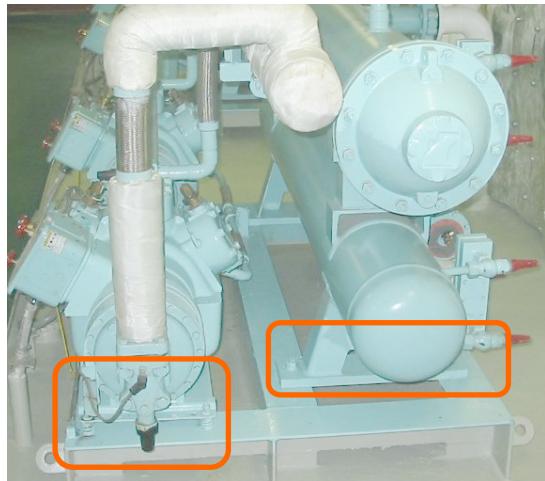
Figure 6

(structure - borne noise)

Fig. 6

가  
(condenser)

가  
(common bed)  
(steel deck)

Fig. 6  
(resilient mount)

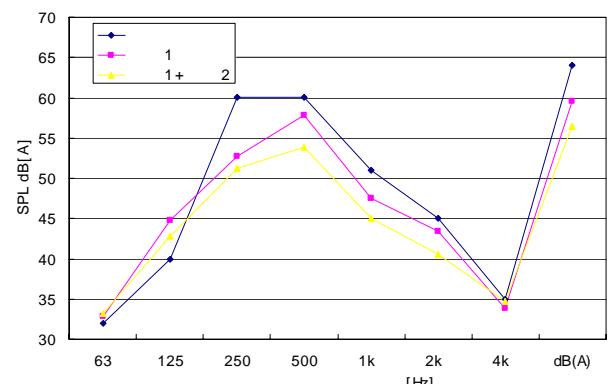
Figure 7 crew(B)

Fig.7

7dB(A) 가 crew(B) 가
