Evaluation of Spent Fuel Damage in Actually Happenable 15 m Drop Accident Test

Woo-seok Choi^{1*}, Sangsoon Cho¹, Yun-young Yang¹, Sanghyeok Han², Jae-hoon Lim¹, and Daesik Yook³

¹Korea Atomic Energy Research Institute, Daedeok-daero989ben-gil 111, Yuseong-gu, Daejeon, Republic of Korea

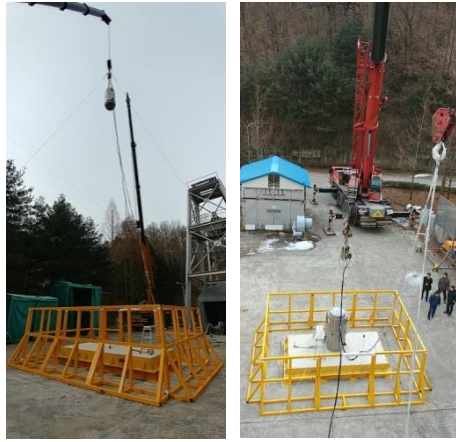
Fig. 3. Preparation for drop test.

The scenario we want to simulate is to drop cask without impact limiter onto a concrete pad, which represent the second floor of a building. Therefore, we will construct the concrete pad laid over the ground through reinforcement work on the empty space of test facility. The protecting structure will be installed to prevent accidents caused by the rebound of the transport cask after the impact. We decided to use a portable heavy car crane to lift the cask to a

height of 15 m and to drop it. A lot of budget was required for the series of works such as modifying of test facility, performing drop test, and restoration of facility after test. The preparation and layout for the test are shown in Fig. 3.

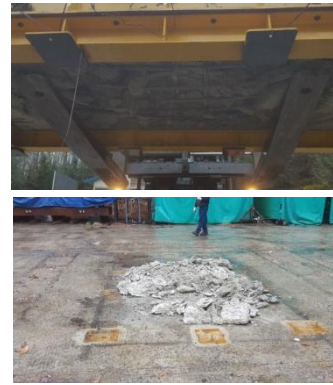
Fig. 4. Damage and deformation of concrete pad.

On the other hand, concrete pads were observed to be considerably damaged. If it were not for the reinforcing bars in the concrete pads, it would probably have been penetrated. The deformed shape of the damaged concrete is shown in Fig. 5.

It was found that no leakage occurred in the leak test performed after the drop test. It is considered that most of the impact energy was absorbed by the concrete pad and the cask was not subjected to large impact energy.

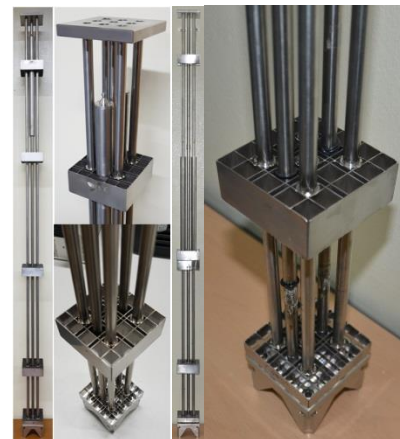
(a) Before drop (b) After drop

Fig. 5. Displacement and velocity time history.

Additional concentrated masses were attached with at the top end of the fuel rod to simulate the mass of the original length of fuel rod. After the test, the welding part of the concentrated mass was broken and hit the spacer grid at the below. We observed that the spacer grid was pushed down to the next spacer grid. However, buckling was not observed at the bottom span of the fuel rod, and it was found that the lateral deformation was small. The shape of the fuel assembly before and after the drop impact test is shown in Fig. 4.
