Failure Mechanisms for Zirconia Based Thermal Barrier Coatings

Eui Y. Lee and Jong H. Kim

Dept of Materials Science and Engineering, Andong National University
Andong, Kyungbuk, 760-749, Korea

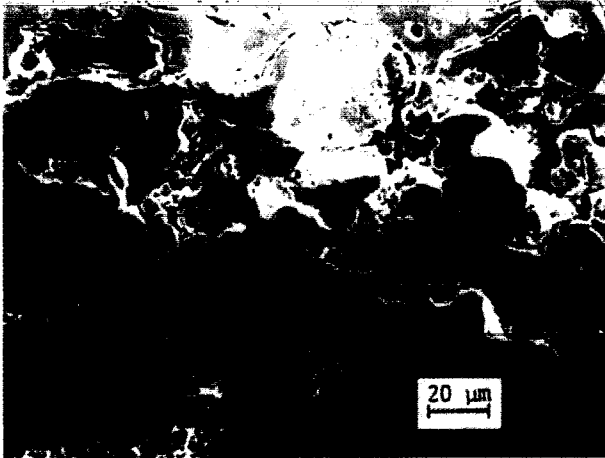
After thermal cyclic oxidation for 230 cycles, the top surface of the psz ceramic coating was significantly degraded, showing the granular structure as seen in Fig. 3. A large quantity of bond coat oxidation product (primarily Al_2O_3) is observed at the psz ceramic/bond coat interface as

Fig. 4. Cross-sectional SEM photomicrograph of the thermally cycled TBC with psz coating of ZrO_2 -8wt.% Y_2O_3 .

seen in Fig. 4. A significant quantity of cracks developed within the psz ceramic coating after the thermal cyclic oxidation. The porosities and cracks in the thermally cycled psz coating provide the transport of oxygen, resulting in the oxidation of the underlying metallic bond coat. In addition, cracking is observed to have developed at the interface between the ceramic coating and the oxidation product and within the oxidation products as seen in Fig. 4. Fig. 5 presents the cross-sectional backscattered electron image (BEI) of the oxidation products formed at the psz ceramic/bond coat interface. In Fig. 5, the light grey region at the bottom portion is the bond coat and the dark grey region is the bond coat oxidation products. According to the EDXS analysis, the light grey region within the oxidation products contains Al, Cr, Ni and oxygen while the dark grey region contains primarily Al and oxygen. The EDXS data suggest that the grey region in the oxidation products would be a spinel such as $NiCr_2O_4$ or $Ni(Al,Cr)_2O_4$ and the dark region is Al_2O_3 . The white particles within the oxidation products are either

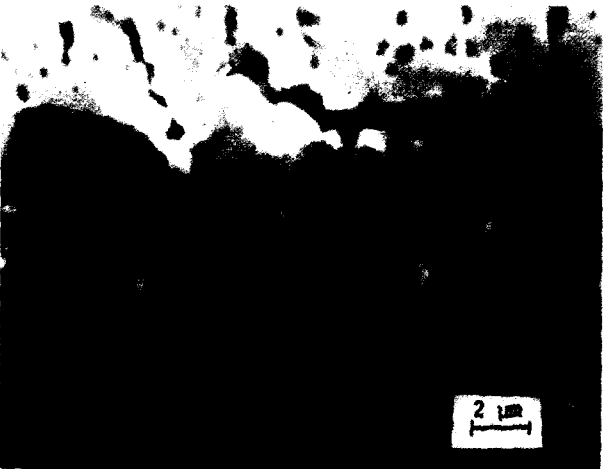
Fig. 9. Cross-sectional BEI of the oxidation products in the thermally cycled EB-PVD TBC.

The cross-sectional BEI photomicrographs of the oxidation products for the thermally cycled EB-PVD TBC specimen are presented in Fig. 8 and 9. In Fig. 8, the upper region is the psz ceramic coating and the lower region is the bond coat. The dark region in the center of the figure is the oxidation products. In Fig. 8, the grey region within the oxidation products is observed to consist of Al, Cr, Ni and oxygen and the dark region is Al_2O_3 . The Cr/Ni rich oxide developed near the psz ceramic coating would be formed by the outward diffusion of metal ion. The Al depletion in the bond coat due to the selective oxidation as well as the interdiffusion between bond coat and substrate lead to the coincident enrichment of other metals such as Cr and Ni in the bond coat. As a consequence, the selective oxidation of Al would not take place and the oxidation of other metal components (Cr, Ni) would begin. A continuous and dense Al_2O_3 layer

formed by the selective oxidation would depress the transport of oxygen through the Al_2O_3 layer, resulting in the outward diffusion of metal ions (such as Cr^{+3} , Ni^{+2}) through Al_2O_3 . These metal ions would form the oxides within the pre-existing Al_2O_3 near the ceramic coating. The white particles are mostly metal particles as seen in the plasma thermal sprayed TBCs. It is observed that cracking took place primarily at the interface between the dark region (Al_2O_3) and the grey region (Cr/Ni rich oxide) within the oxidation products as seen in Fig. 8. In Fig. 9, voids are found to have developed at the interface between the grey region (Cr/Ni rich oxide) and the dark region (Al_2O_3). This observation indicates that the formation of the voids at the interface between two different oxides should lead to the cracking within the oxidation products during cyclic oxidation.
