# The Use of Monolithic Refractories and Microwave Drying for RH Steelmaking Vessels

Tsuneo Kayama\*, Seiji Hanagiri and Shiro Sukenari

Monolithic refractory technology has been developed for RH vessels, with the purpose of reducing the total refractory cost. The technology includes the use of an improved monolithic refractory and microwave drying. The improved monolithic refractory was an alumina-spinel composition, of the type used in steel ladles, to which fine alumina was added to increase the density and corrosion resistance. The microwave drying method, previously developed and used to dry the monolithic lining in steel ladles<sup>1)</sup>, was modified for use in drying the dense, 500mm thick lining in RH vessels. This work has resulted in significant cost savings.

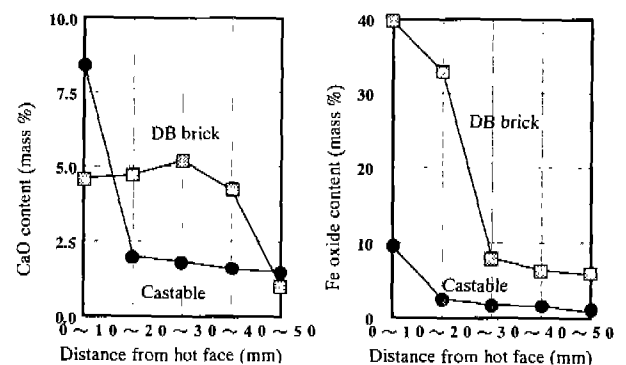
Results of the preliminary refractory comparison test are shown in Figs. 2 and 3. Fig. 2 shows the corrosion rate and depth of slag penetration, and Fig. 3 shows the change in chemical composition of the refractories tested.

Fig. 3. Chemical profile of the hot face region of a typical ladle castable and direct-bonded magnesia-chrome brick, after service.

On the other hand, the iron oxide penetration of the sidewall refractory was less than that of the original alumina-spinel castable tested (see Fig. 3). It was apparent that the improved monolithic refractory was superior to the original material for an RH vessel.

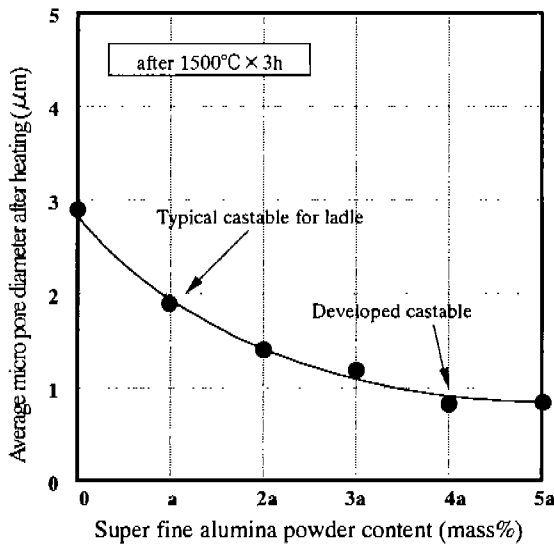
**Fig. 4.** Relationship between the content of ultrafine alumina powder and the average pore diameter.

It was necessary to make the refractory denser to improve the resistance to penetration, corrosion, and erosion. Ultrafine alumina powders were added to the alumina-spinel monolithic refractory that was used in the preliminary test to reduce the pore diameter. Fig. 4 shows the relationship between the amount of ultrafine (under 10 µm) alumina powder added and the pore diameter of the refractory structure, after heating for three hours at 1500°C. It was found that the pore diameter was less than half that of the initial refractory body for a 4 a mass% addition of ultrafine powder. Fig. 5 shows the relationship between ultrafine powder content, corrosion index, and hot modulus of rupture at 1500°C. It was observed that the refractory structure was much denser and 30 mass% more resistant to corrosion than the initial material. The higher modulus of rupture indicates not only higher density but also higher corrosion resistance.

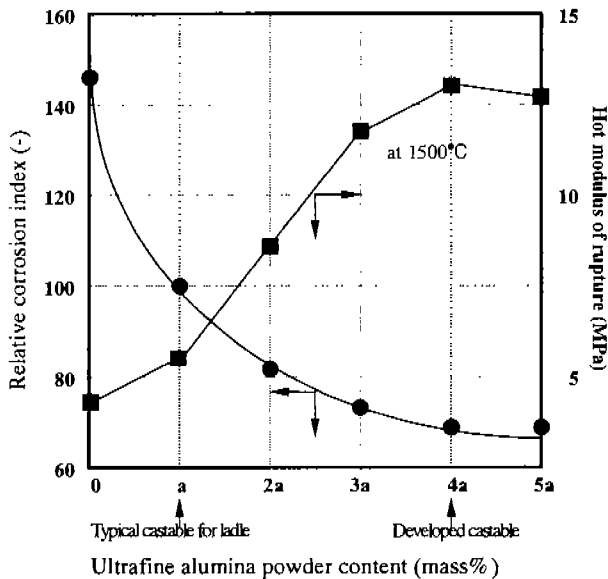
**Fig. 5.** Relationship between the content of ultrafine alumina and the corrosion index and hot modulus of rupture.

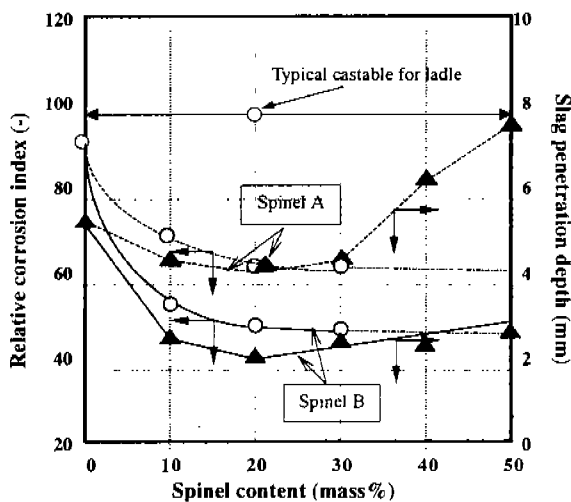
The initial alumina-spinel monolithic refractory tested contained polycrystalline spinel (spinel-A). A comparative test was run in which spinel-A was replaced by single crystal spinel (spinel-B), which is purer than spinel-A. Fig. 7 shows the effect of spinel-A and -B on the corrosion and slag penetration. The laboratory test results indicate that the monolithic refractory containing spinel-B has better resistance to corrosion and penetration. The improved monolithic refractory was estimated to have two times better corrosion resistance and four times better slag penetration resistance than these of the initial monolithic refractory, respectively.

Fig. 7. Relationship between spinel content and the corrosion index and depth of slag penetration.

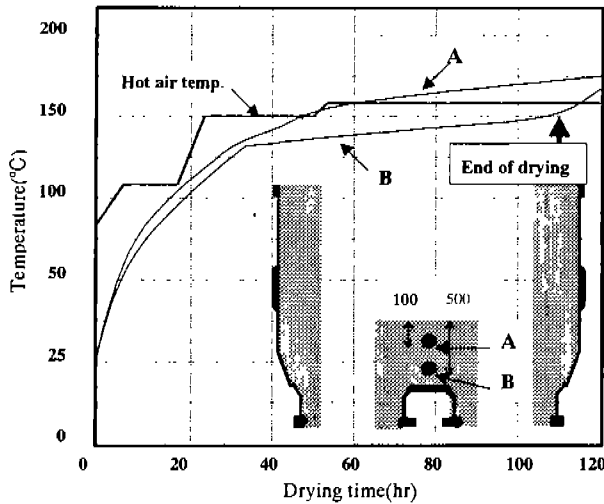
The typical temperature change of the monolithic refractory in the RH vessel during drying is shown in Fig. 9. The point at which the temperature went up from a constant

Fig. 9. Temperature changes during microwave drying.

level, where there was evaporation of contained water, was judged to be the end point of drying. It was confirmed by actual trials that the RH vessel lining could be dried without any accident. The drying period was established based on the trial results, and it was adopted in actual operation.

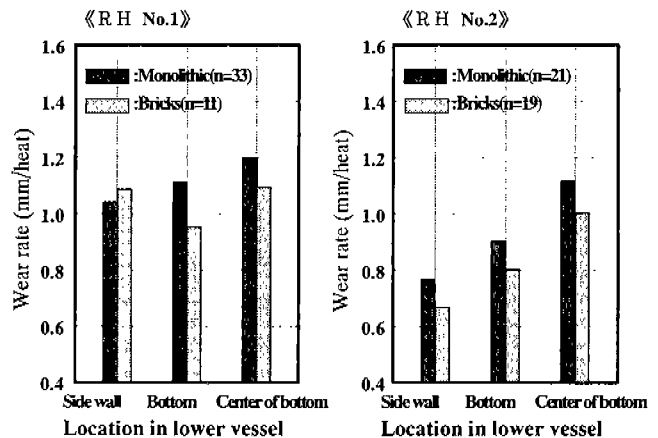
The monolithic refractory lining was examined after 315 heats. It was confirmed that there were not any unusual defects, such as large cracks or peeling, as shown in Fig. 11. The wear rate of the monolithic refractory in the RH vessels was slightly higher than that of the conventional direct bonded magnesia-chrome bricks, as shown in Fig. 12, but

Fig. 12. Comparison of the wear rates for different location in the developed castable and brick linings in RH vessels 1 and 2.

the difference is not considered to be significant for actual use.

not many cracks in the sidewall refractory, and the depth of slag penetration was only about 2mm. These observations indicate that the bottom was worn not only by slag corrosion but also by structural spalling, which might be responsible for the higher wear rate in the bottom center, as shown in Fig. 12.
