에너지 흡수 장치를 부착한 트라이빔 가드레일 시스템의 거동

Performance of Thrie-Beam Guardrail System with Impact Attenuator

고 만 기¹⁾ · 김 기 동¹⁾

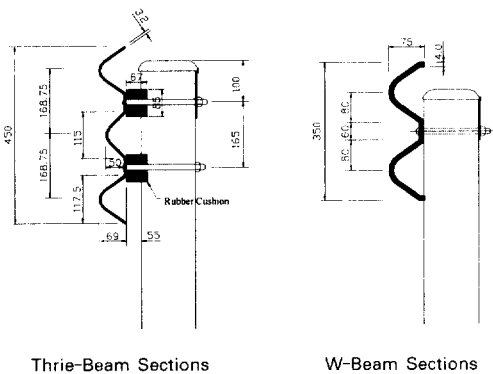
Fig. 1 Thrie-Beam and W-Beam Sections

The dimensions and section properties of the W- beam and developed thrie-beam systems are presented in Table 1 and Fig.1.

Conclusively, the thrie-beam system with rubber cushions showed the best performance when compared to the W-beam system and the thrie-beam system without rubber cushions. The stiffness of the thrie-beam system was significantly superior to that of the W-beam system while in computer simulations the difference between the stiffnesses of the two systems was negligible. Therefore, the thrie-beam system with rubber cushions shown in Fig. 1 is determined as the final trial section for a crash test.

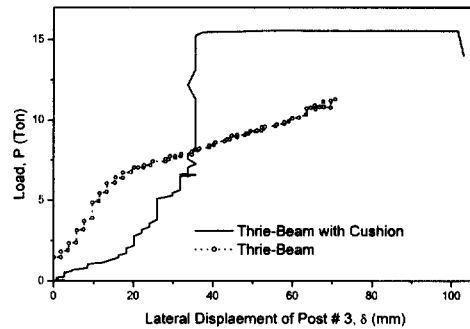
Fig. 14 Load - Post Displacement Relation for Tests 1 and 6

Figures 13 and 14 show the responses of Tests 1 and 6. Both of the two systems consist of thrie-beams and circular posts. But one has rubber cushions (Test 6) and the other (Test 1) does not. Looking into Fig. 13, for the system of Test 1 the stiffness decreases at the load of 1.5 ton due to beam yielding, and then the stiffness increases due to stiffening until the stiffness decreases at 7 ton due to yielding of the post (See Fig.14). The response of Test 6 shows that the system with rubber cushions is more flexible up to 1.5ton as compared to the result of Test 1, which is attributed to the

serial connection of the cushion to the post. Looking at Fig. 14, the post stiffness of Test 6 from 1.5ton to 7 ton is very similar to the corresponding stiffness of Test 1. This may be attributed to the fact that up to 1.5ton the deformation of the cushion is used up, and beyond that load level the post stiffness of Test 6 is the same as that of Test 1. From Fig. 13, it can be shown for the range from 1.5 ton to 7 ton that the stiffness of Test 6 is much higher than that of Test 1 even though the post stiffness for the two cases were almost the same. This is attributed to the bending action of the
