A STUDY ON SURFACE ALTERATION OF IMPLANT SCREWS AFTER FUNCTION

Statement of problem. Surface alteration of the implant screws after function may be associated with mechanical failure. These metal fatigue appears to be the most common cause of structural failure.

Purpose. The purpose of this study was to evaluate surface alteration of the implant screws after function through the examination of used and unused implant screws in SEM(scanning electron microscope).

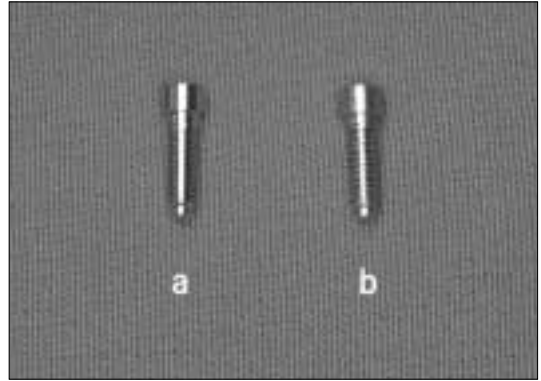
Fig. 2. The 3i abutment screws selected for this study. (a: new, unused screw, b: old, used screw)

The Steri-oss abutment screw(Bausch & Lomb compony) was retrieved from the patient. The loading time before retrieval was 4.4 years. The 3i abutment screw(Implant Innovations Incorporated™) was also retrieved from the patient. The loading time before retrieval was 1.6 years. Each of the old, used abutment screws was retrieved with a

screwdriver. New, unused steri-oss and 3i abutment screws were prepared for control group(Fig. 1, 2).

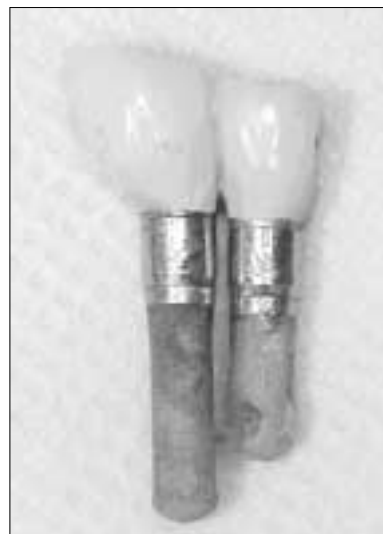
Fig. 5. Retrieved implant complex of Steri-oss system.

second molars was retrieved due to peri-implantitis from the patient(Fig. 5). The loading time before retrieval was 4.4 years. Implant complex was retrieved with a trephine. The abutment screws and retaining screws were not unscrewed. The retrieved implant complex and surrounding tissues were washed in saline solution and immediately fixed in 10% buffered formalin.

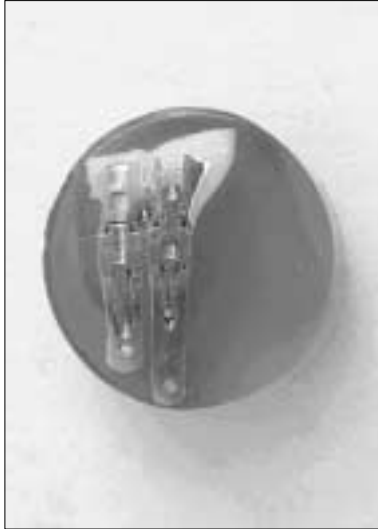
Fig. 6. Cross-sectioned sample of retrieved implant complex.

Cross-section of the retrieved implant complex was made by mounting the sample in a translucent thermoses type liquid unsaturated polyester. The mounting media(Epovis, Cray Valley Inc) is a 2-part system made up of a resin and hardener. The two components were mixed together and poured over sample and allowed to cure overnight. Once the mount was hardened, sample was ground using a silicone carbide-type sandpaper(120 grit of finer). Mounts were ground through a series of progressively finer grit papers down to a 4000 grit finish. Final polishing was carried out with a plano cloth and 1 μ m Al₂O₃.

The retrieved implant complex was cross-sectioned until one retaining screw and one abutment screw were gone(Fig. 6).
